Pre-Demolition Asbestos Survey Report

Proposed Alder Taylor Retail Project
17783 Taylor Avenue
Bloomington, California 92316

March 24, 2026 | Terracon Project Number: LA267070

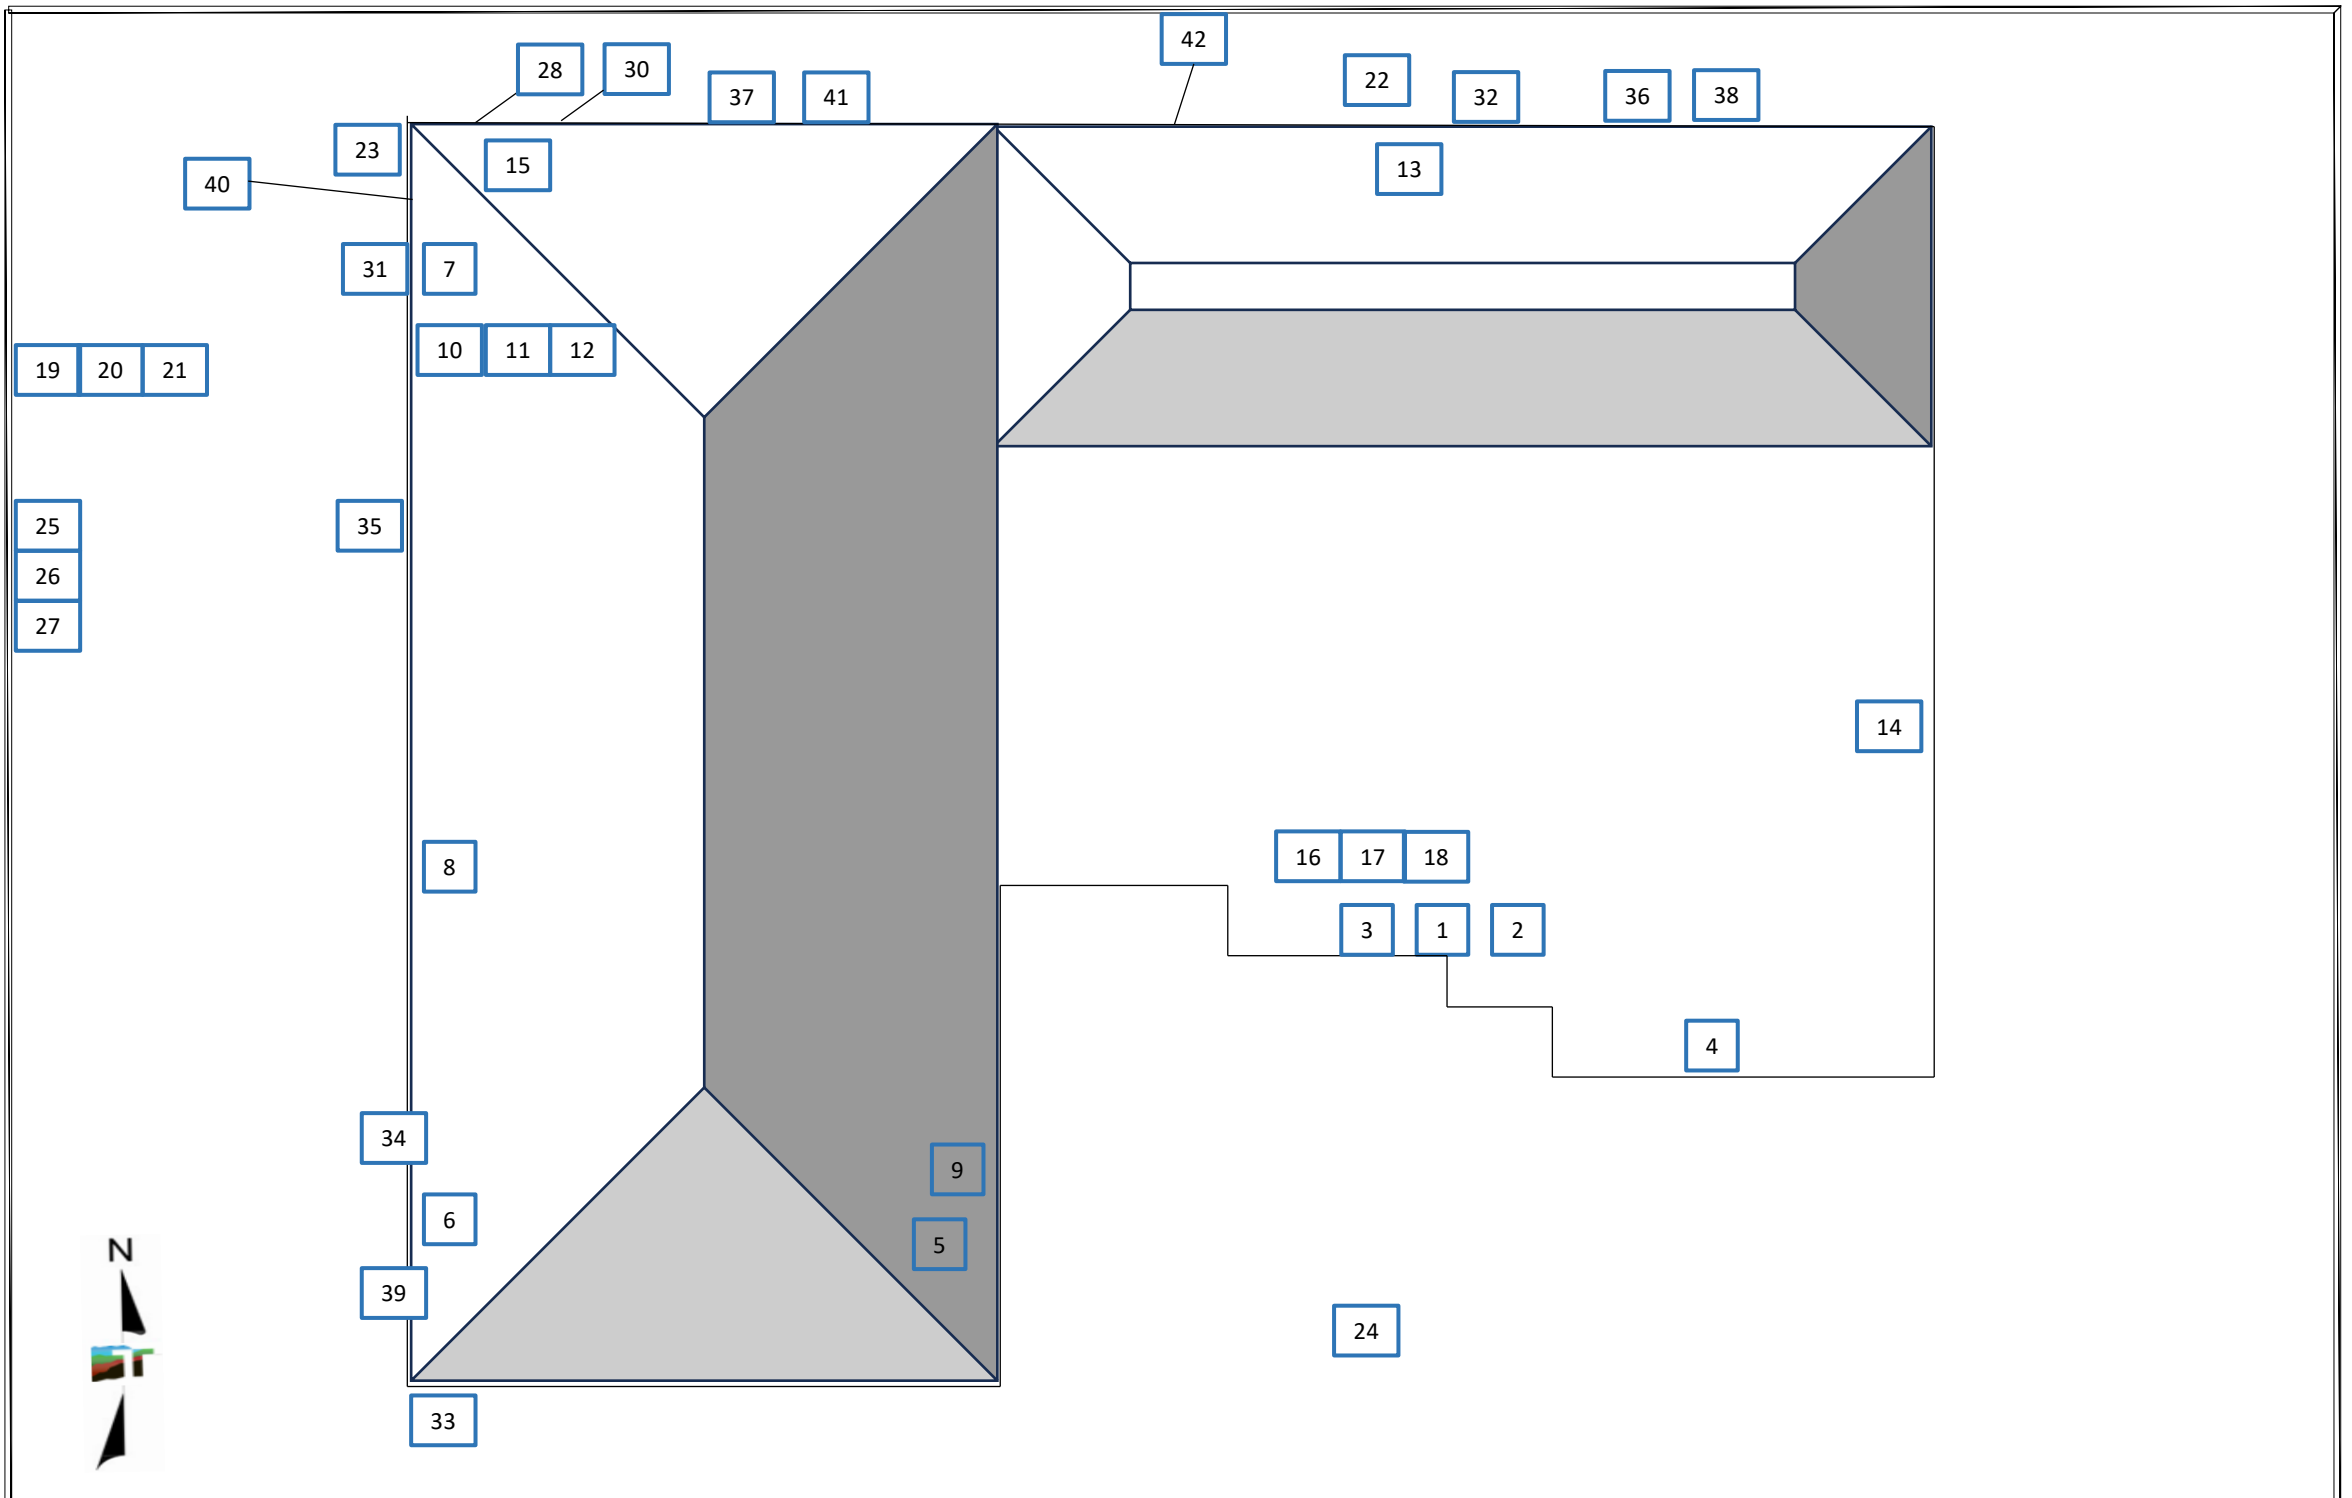
HA	Material Description	Material Location	Result	NESHAP Classification	Condition	Approximate Quantity*
2	Gray Asphalt Rolled Roofing	Roof	Shingles – ND Felt – ND White Roofing – 6% CH	Cat. I	Good	1,000 SF

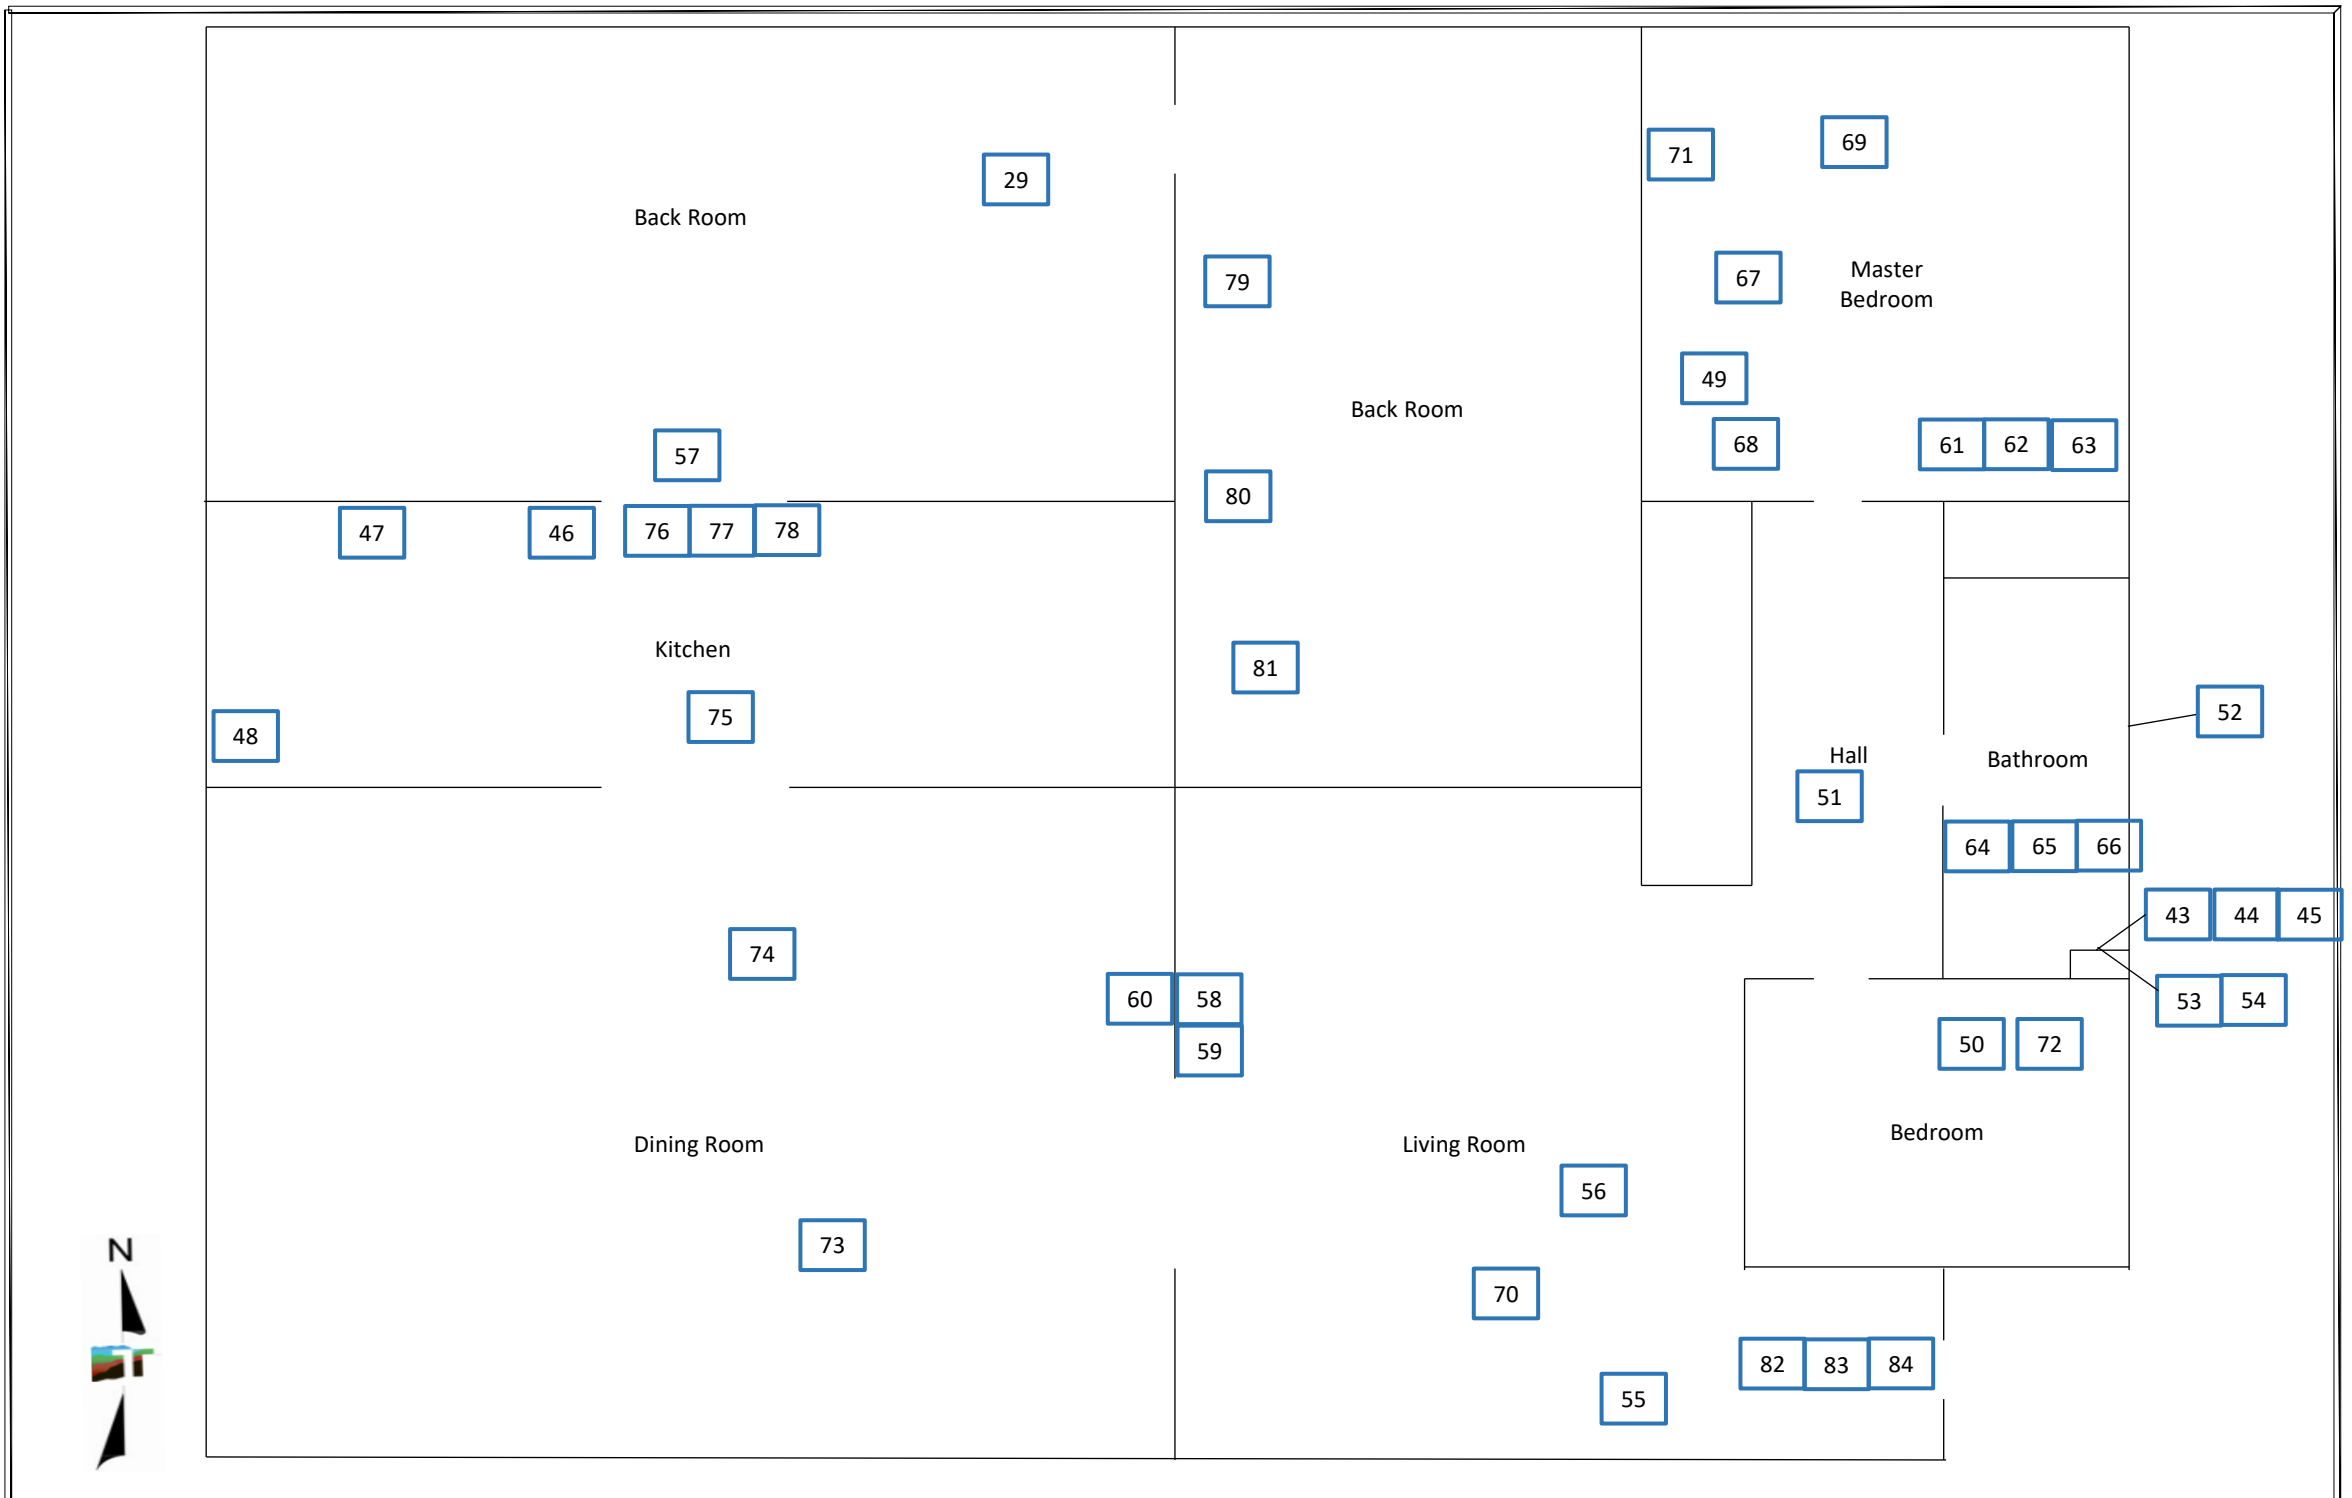
HA	Material Description	Material Location	Result	NESHAP Classification	Condition	Approximate Quantity*
20	Heater Insulation Wrap	Living Room, Dining Room	35% CH	RACM	Damaged	50 SF
24	Wallboard with Joint Compound	Throughout	Joint Compound – 2% CH Drywall - ND	RACM	Significantly Damaged	2,700 SF
25	9"x9" Red Vinyl Floor Tile with Black Mastic (Multiple Layers)	Dining Room and Kitchen	Red Tile – 3% CH Black Mastic – ND Beige Sheet Flooring – ND Brown Mastic - ND	Cat. I	Significantly Damaged	400 SF

Since the damaged ACM materials have been identified, South Coast Air Quality Management District, Rule 1403 requires that a Procedure-5 Abatement Work Plan must be developed to facilitate the removal of the damaged asbestos-containing materials.
