LEAD PAINT INSPECTION REPORT

Elias Pet Shop
18010 Valley Boulevard
Bloomington, Ca 92316

REPORT NUMBER: S#03429- 01/18/13 12:02
INFOTOX# 132009

INSPECTION DATE: January 18, 2013

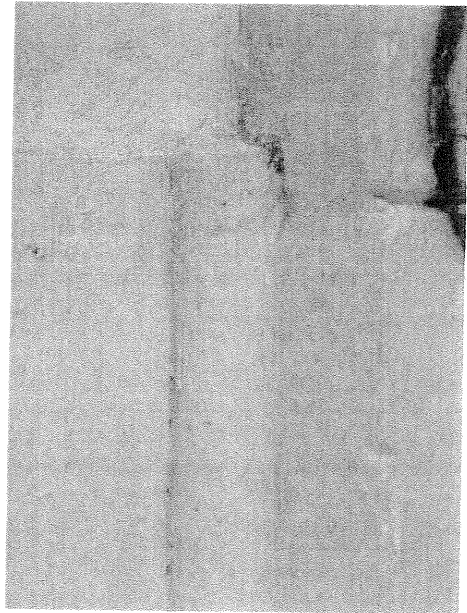
PHOTO # 1
Window Sill

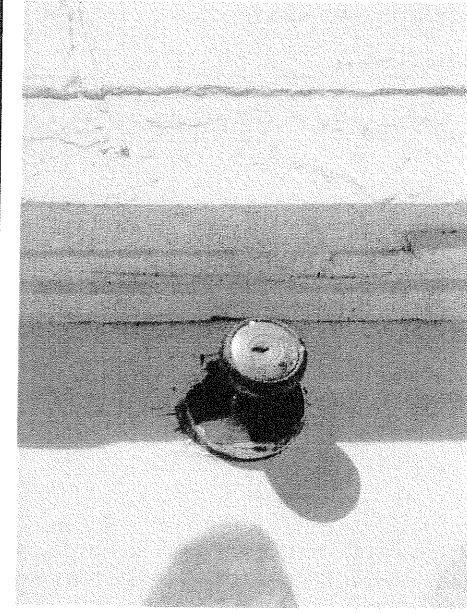
PHOTO # 2
Door Casing and Jamb

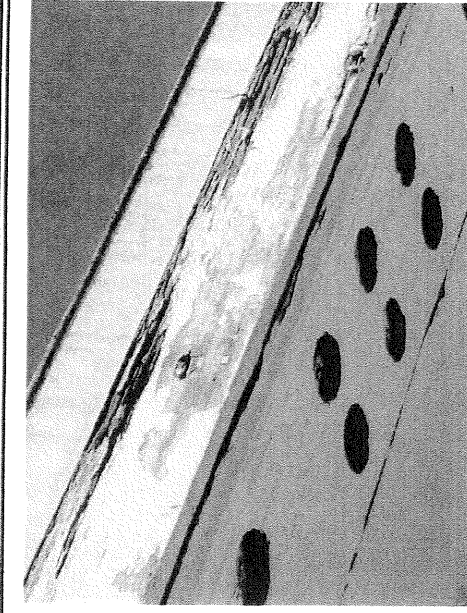
PHOTO # 3
Soffit and Fascia

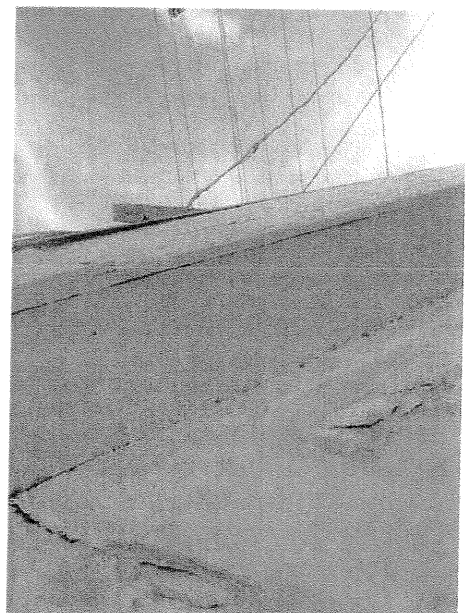
PHOTO # 4
Soffit and Fascia

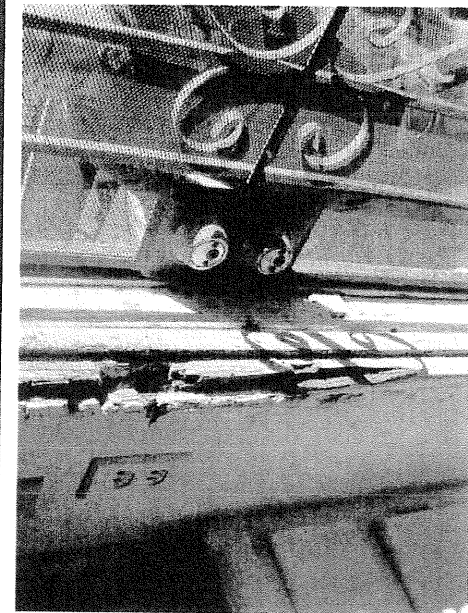
PHOTO # 5
Door Jamb

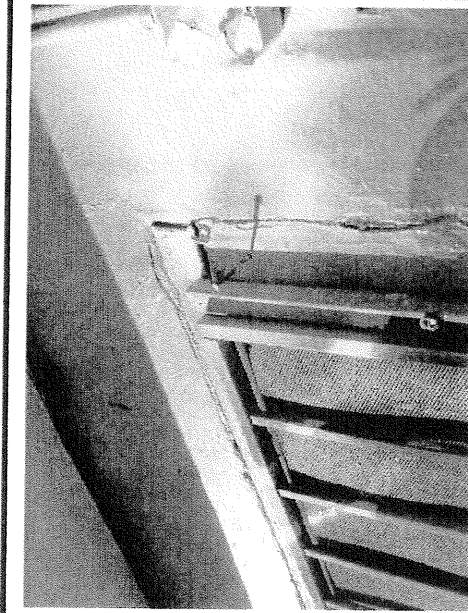
PHOTO # 6
Door Casing

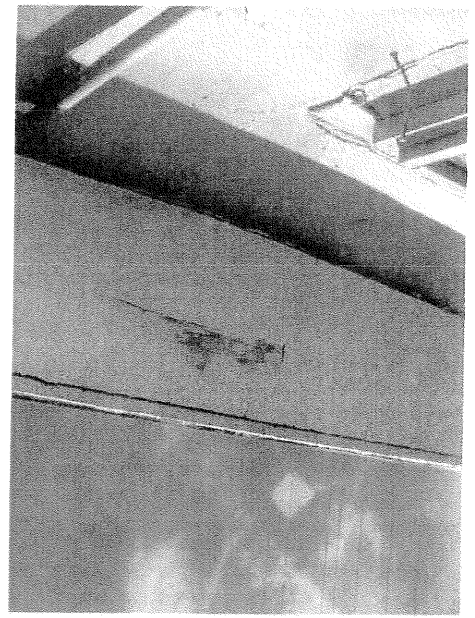
<p>PHOTO # 7 Soffit</p>

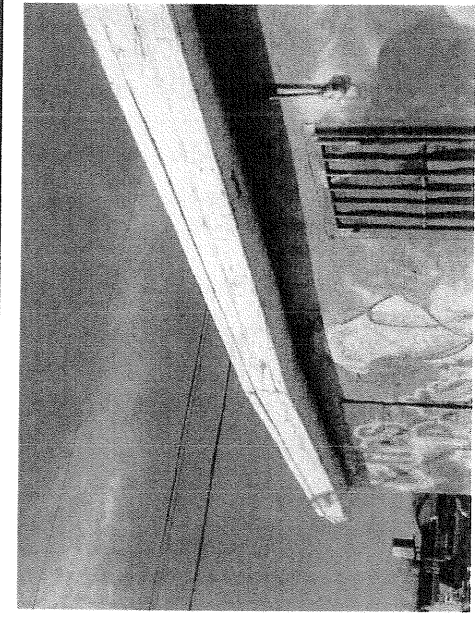
<p>PHOTO # 8 Fascia</p>

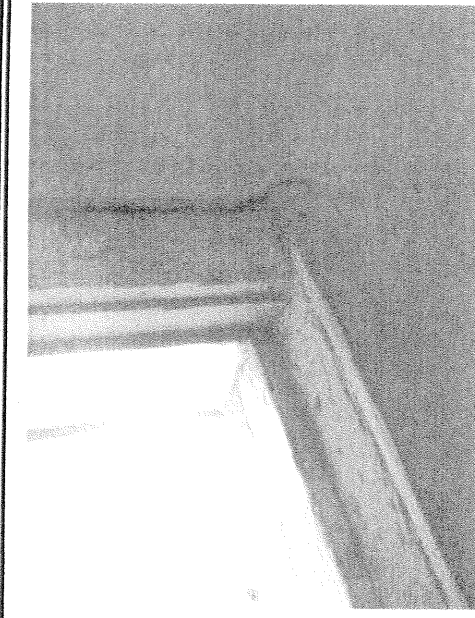
<p>PHOTO # 9 Window Sill, Casing and Jamb</p>

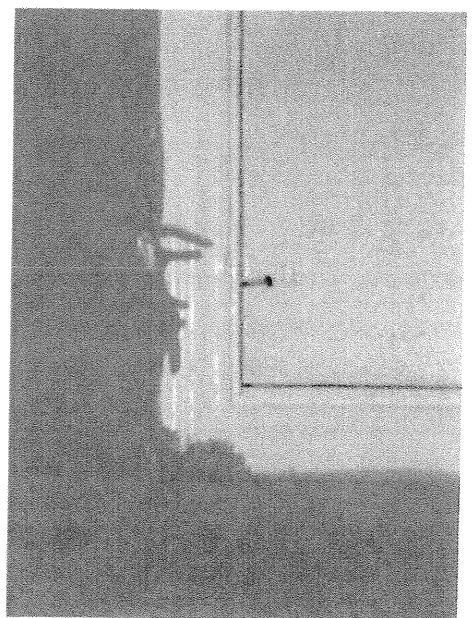
<p>PHOTO # 10 Door Casing</p>

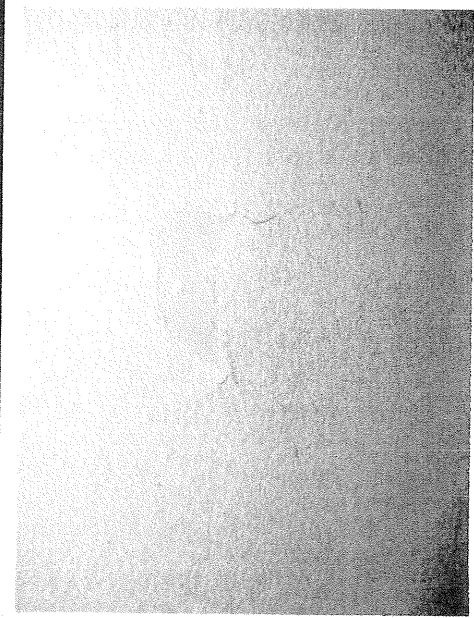
<p>PHOTO # 11 Ceiling</p>

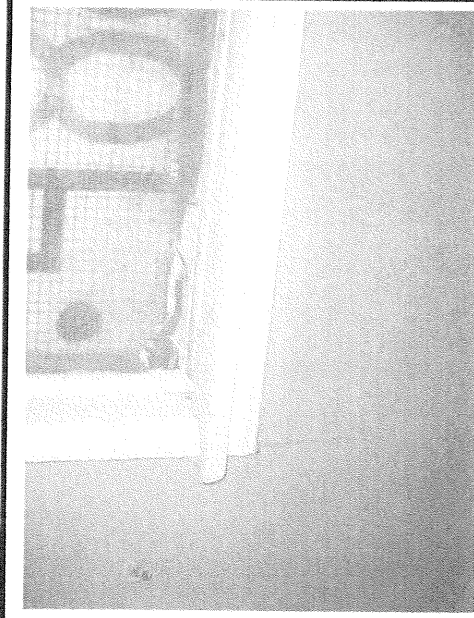
<p>PHOTO # 12 Window Apron, Sill, Casing and Jamb</p>

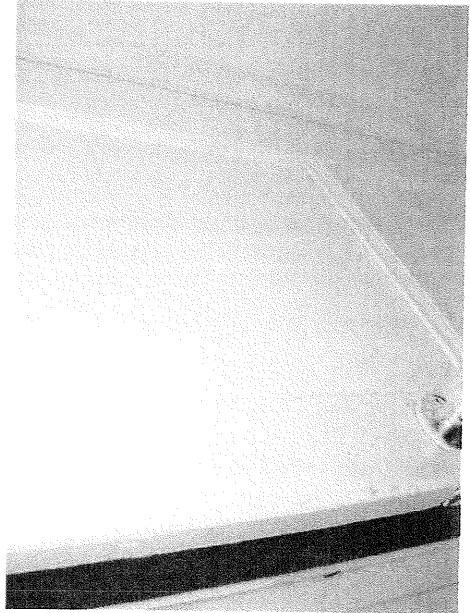
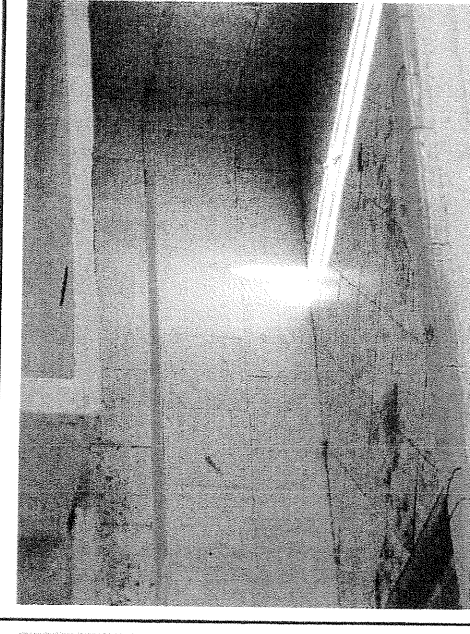
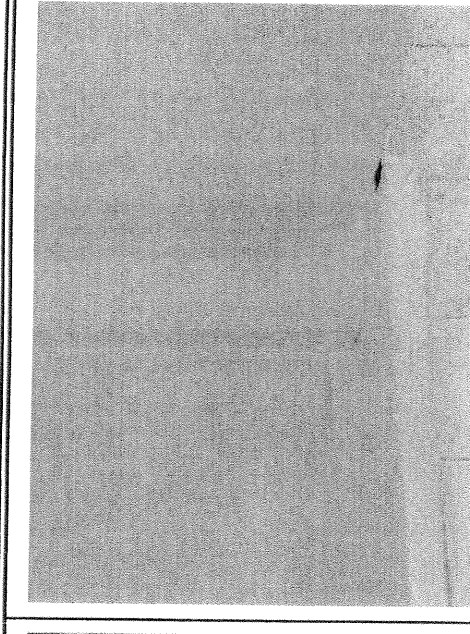
Many ceramic tiles contain lead in pigment and glaze. Although they were not painted, as part of AAA LEAD'S normal inspection process, we also tested tile surfaces. This information may be useful if any abatement or demolition will take place on these surfaces. **THE CERAMIC TILE INSIDE OF ROOM 7 TESTED POSITIVE FOR THE PRESENCE OF LEAD ABOVE THE HUD GUIDELINES.** See the Summary Tables section of this report for locations.

<p style="text-align: center;">PHOTO # 13 Door</p>	<p style="text-align: center;">PHOTO # 14 Ceramic Tile Counter Top and Wall</p>	<p style="text-align: center;">PHOTO # 15 Window Sill and Jamb</p>
<p style="text-align: center;">Intentionally Left Blank</p>	<p style="text-align: center;">Intentionally Left Blank</p>	<p style="text-align: center;">Intentionally Left Blank</p>
<p style="text-align: center;">PHOTO # 16</p>	<p style="text-align: center;">PHOTO # 17</p>	<p style="text-align: center;">PHOTO # 18</p>
