Project No. 21003

**Subject: Geologic Slope Stability Evaluation Report for A Mine and
Reclamation Plan Renewal
Wine Rock Quarry (CA Mine ID #91-36-004)
Newberry Road
N ½, NE ¼, Section 9, T. 8 N., R. 3 E.
Newberry Springs, California**

**GEOLOGIC SLOPE STABILITY EVALUATION
REPORT FOR A MINE AND
RECLAMATION PLAN RENEWAL
Wine Rock Quarry (CA Mine ID #91-36-004)
Newberry Road
N ½, NE ¼, Section 9, T. 8 N., R. 3 E.
Newberry Springs, California**

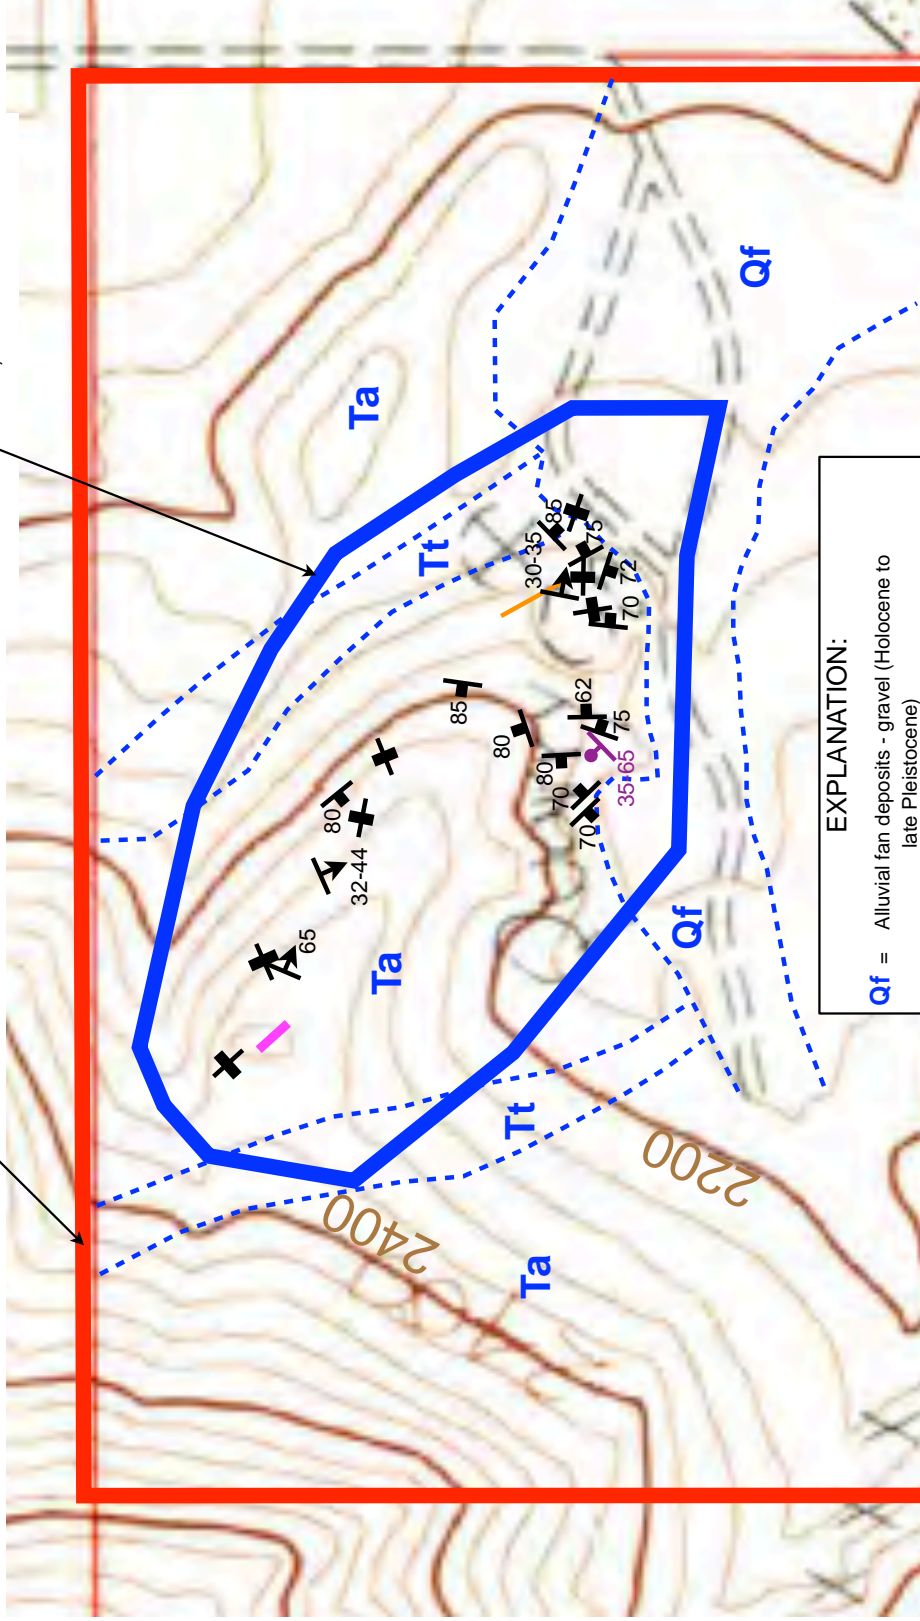
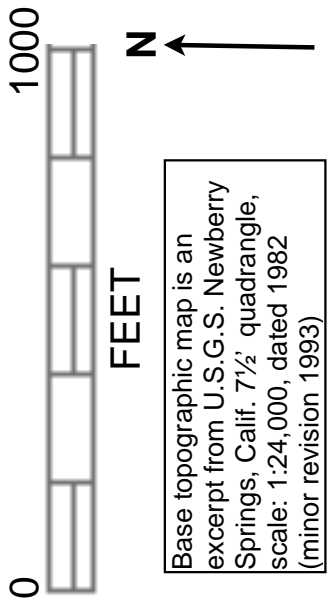
FIGURE NO. 4:
SITE GEOLOGIC MAP NO. 1
Wine Rock Quarry
Newberry Springs, CA

As a Certified Engineering Geologist, I mapped geologic features as exposed in the existing quarry and in undisturbed outcrop along the ridge on the site on February 22, 2021, accompanied by Mr. Fred C. Johnson, a mining consultant geologist from Virgin, Utah. The mapping included measuring the orientation of geologic structures including joints, fractures/shears, and dikes using a Brunton compass and digital inclinometer. Site photographs were also obtained (see Photos 1 and 2 in Appendix B). The structural data and other features were plotted on the two site geologic maps, attached as Figure Numbers 4 and 5 in Appendix B of this report.

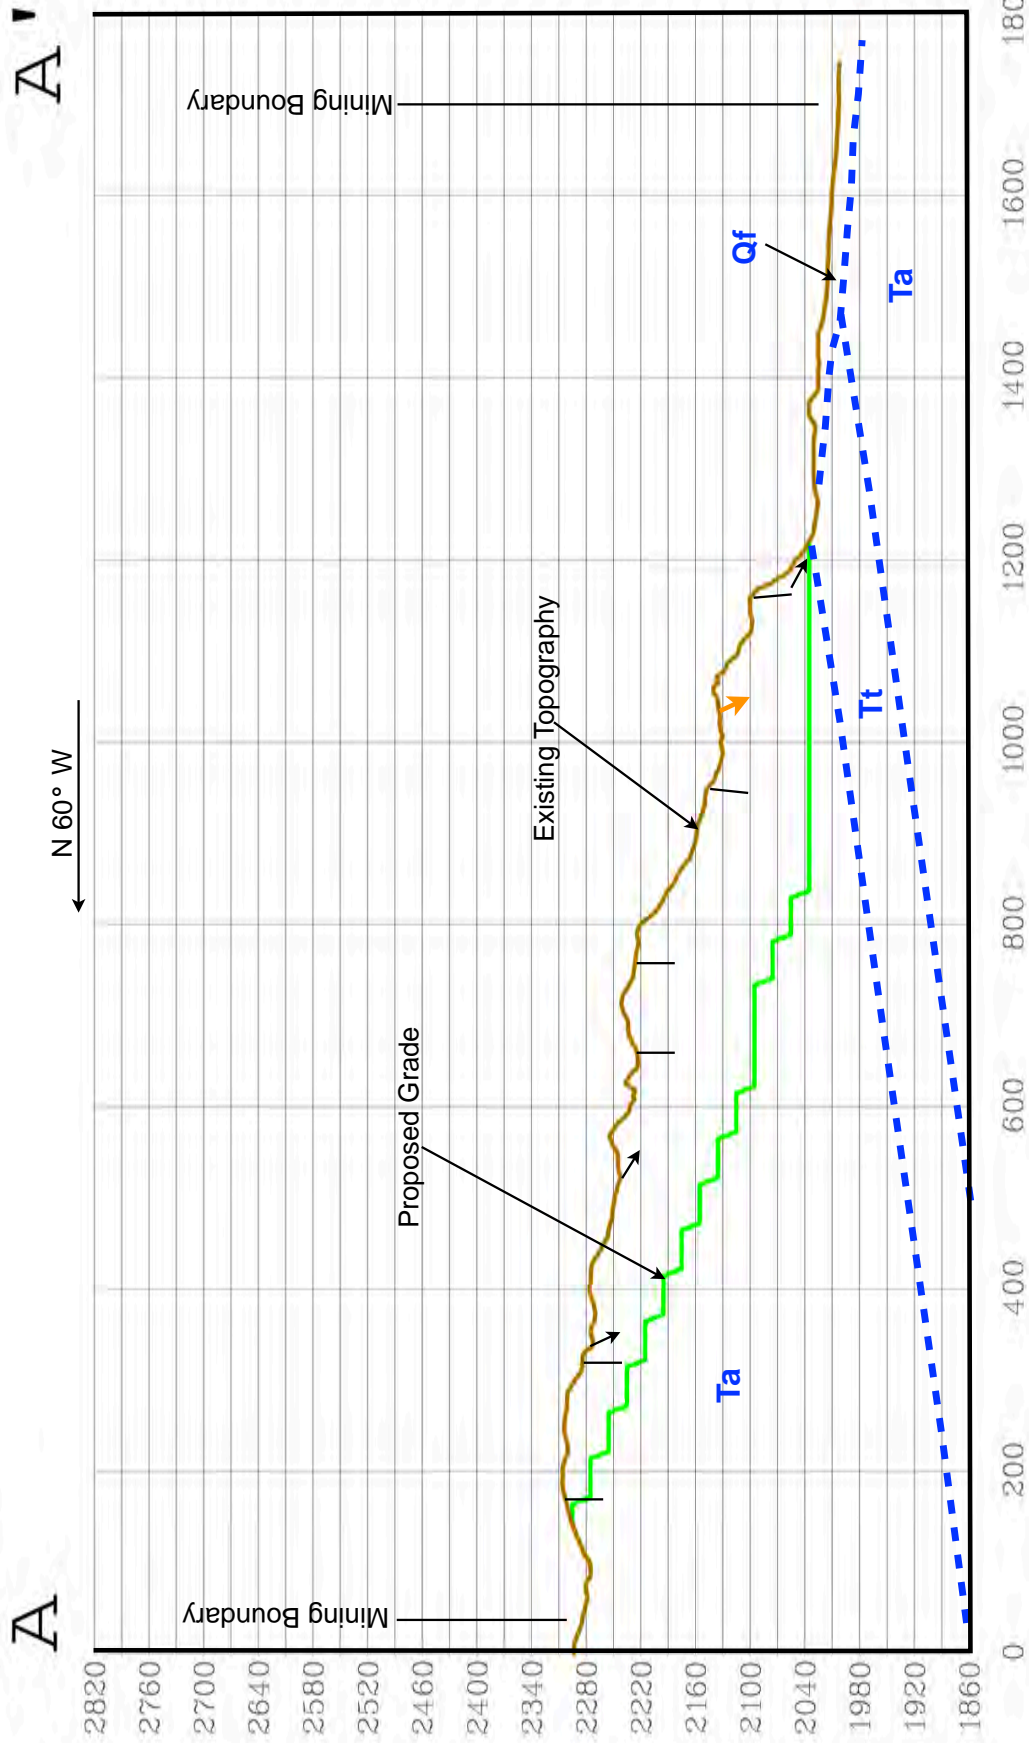
FIGURE NO. 6:
GEOLOGIC CROSS-SECTION A-A'
 Wine Rock Quarry
 Newberry Springs, CA
 Stephen E. Jacobs, C.E.G.

Slope stability evaluations were performed for the proposed reclamation rock slopes shown on the geologic cross sections (Figure Numbers 6 through 8) presented in Appendix B of this report. A small slope (wedge) failure was noted along a southeasterly dipping (approximately 30-35 degrees) fracture or shear in the existing steep (about 20-foot high) cut face of the quarry (see Photo 2). Potential slope failures at the site include wedge failures that could occur along shallow dipping fractures, and slumps and topples that may occur along near-vertical joint surfaces in steep cut slopes.

The steeply to near-vertically dipping joint planes in the andesite rock material are generally considered not susceptible to wedge failures in the proposed 2.5:1 reclaimed cut slopes. However, toppling along joints in near-vertical bench cuts would be anticipated. Small wedge failures are possible along localized southeasterly dipping fractures that dip less than approximately 20 degrees out of the proposed 2.5:1 reclaimed cut slopes.

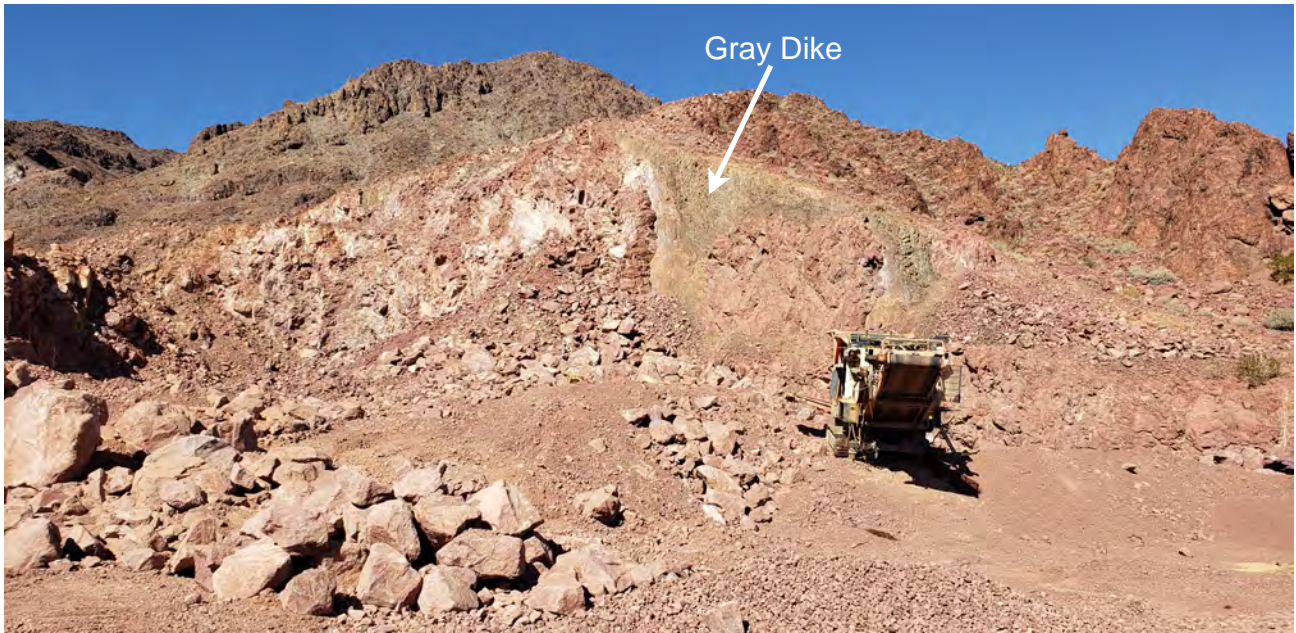
The majority of the site is mapped as underlain by the volcanic rock called andesite. Dibblee and Bassett (1966, p. 2) described this material as “Dark-reddish-brown to gray, massive porphyritic volcanic rocks, mostly andesite, but ranging to latite.” In the existing quarry area, the andesite appears mostly hard, pale reddish brown or pink with an approximately 3-foot thick moderately to highly fractured, medium to dark gray andesite dike; some orange-brown to maroon colored iron-oxide staining was noted on one of the joint surfaces within the dike (see Photos 1 and 2).

Photo 1. Existing rock quarry face viewed toward the northwest showing reddish brown andesite rock material and gray andesite dike

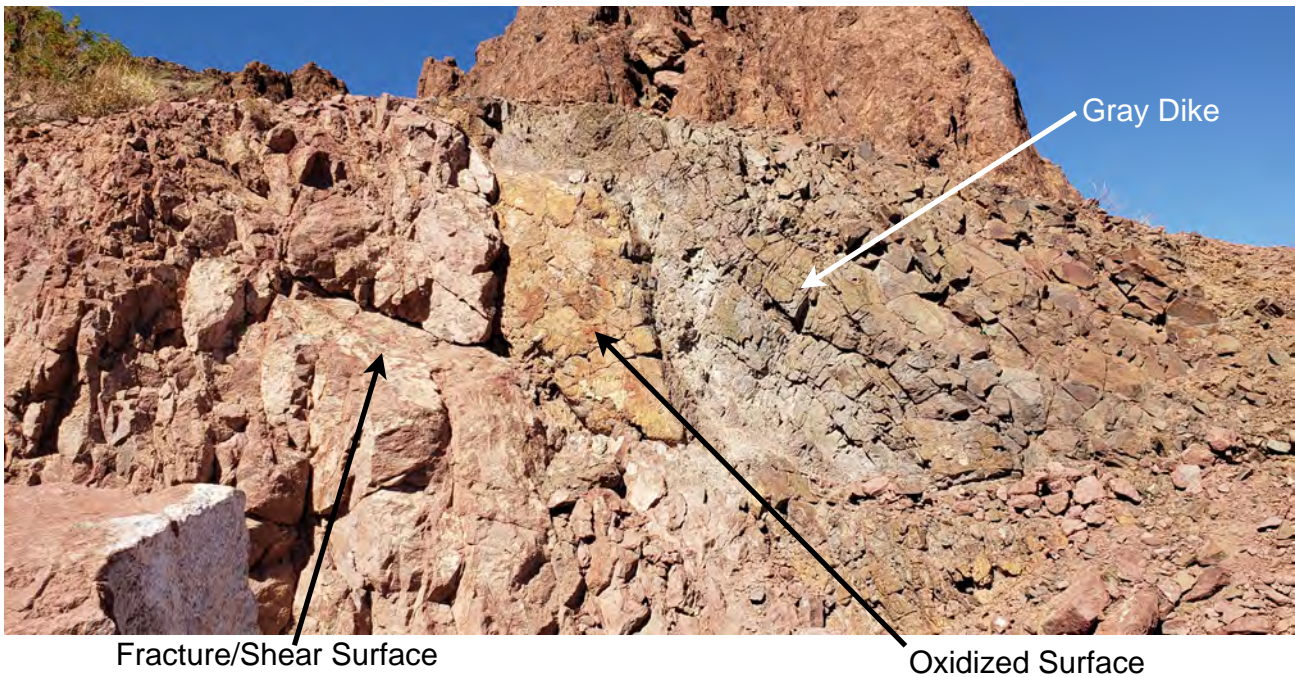
Localized seepage is anticipated along fractures and joints, as past seepage is evidenced by the iron-oxide staining on a joint surface in the gray andesite dike exposed in the quarry face (see Photo 2).

Photo 2. Closeup of existing rock quarry face viewed toward the northwest showing jointed reddish brown andesite rock material and highly fractured gray andesite dike with orange oxidized joint surface. Note localized fracture/shear surface.
