Jurisdictional Delineation

February 15, 2024
Revised October 22, 2024
Rincon Project No: 23-15079

**Subject: Jurisdictional Delineation for the Proposed Lear Avenue Solar Project
County of San Bernardino, California**

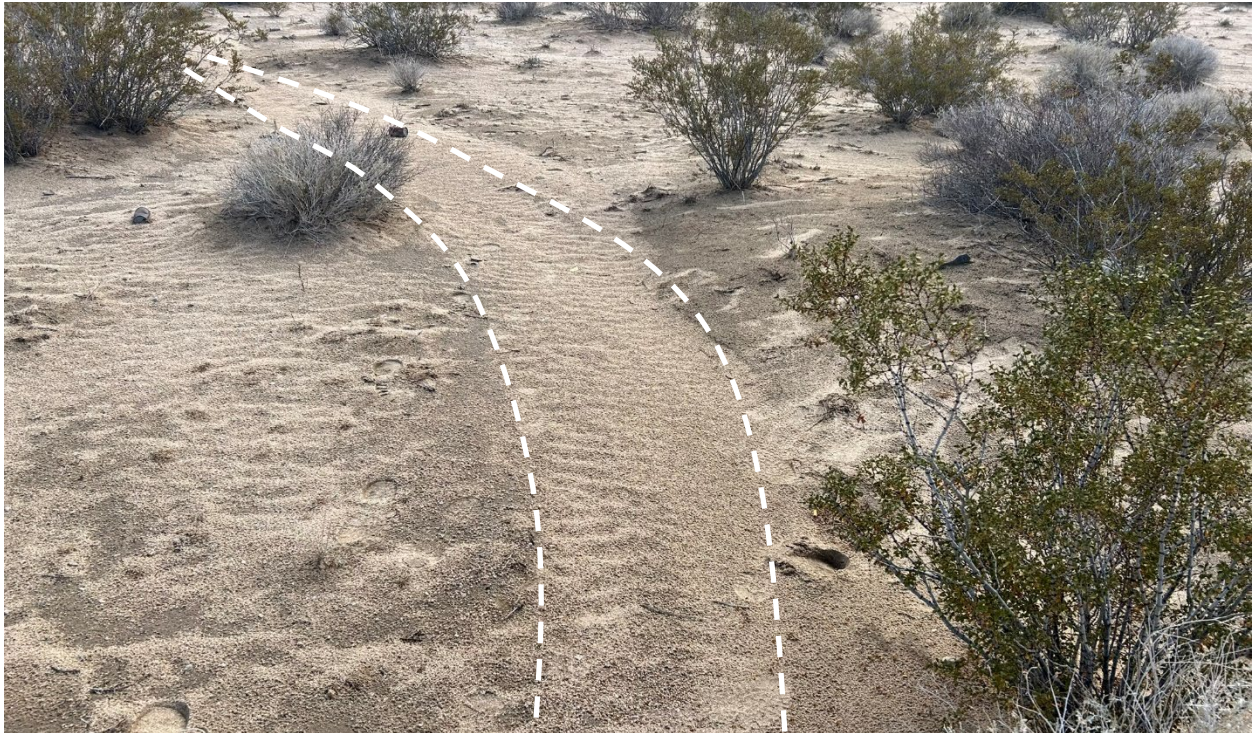
Photograph 1. Northwest facing photo of the single thread ephemeral stream at OHHM SP1. A significant rain event occurred a day prior to the field delineation; resulting in out of channel sheet flow.

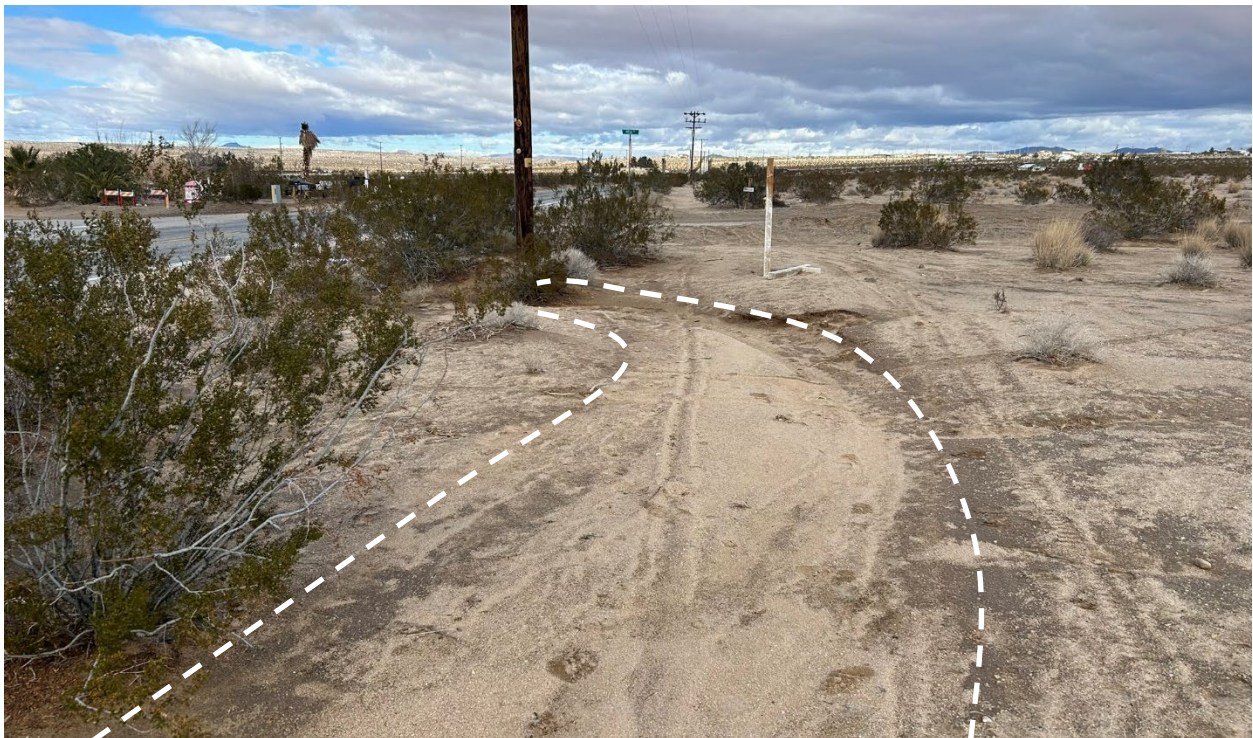
The shallow compound channel flows from south to north and begins at the terminal convergence of the southern, continuous, ephemeral stream network. It is approximately 110 feet long and travels along a dirt road, which appears to introduce vehicular disturbance. Its OHWM channel ranges from three to 12 feet wide, averaging six feet wide. The compound channel contains a low flow channel and an active floodplain. The low flow channel contains a bed and bank and the active floodplain was observable through benches, ripples, and surface relief; the average sediment texture of both floodplain units is sand (OHWM SP2; Attachment 4). The top of bank of the compound channel extends approximately three inches on either side of the OHWM channel, with an average width of 6.5 feet. The average depth is three to four inches. The compound channel terminates at the intersection of Lear Avenue and Mesa Drive, where ESC also terminates. Water appears to sheet flow northwest across the intersection and continue down Mesa Drive along a non-definable berm where it is eventually lost through infiltration and/or evaporation. ESC does not support hydrophytic or wash endemic vegetation, and the vegetative coverage along ESC was uniform with the coverage throughout the remainder of the Study Area.

Photograph 2. North facing photo of the compound channel at the northern terminus of ESC. A significant rain event occurred a day prior to the field delineation.

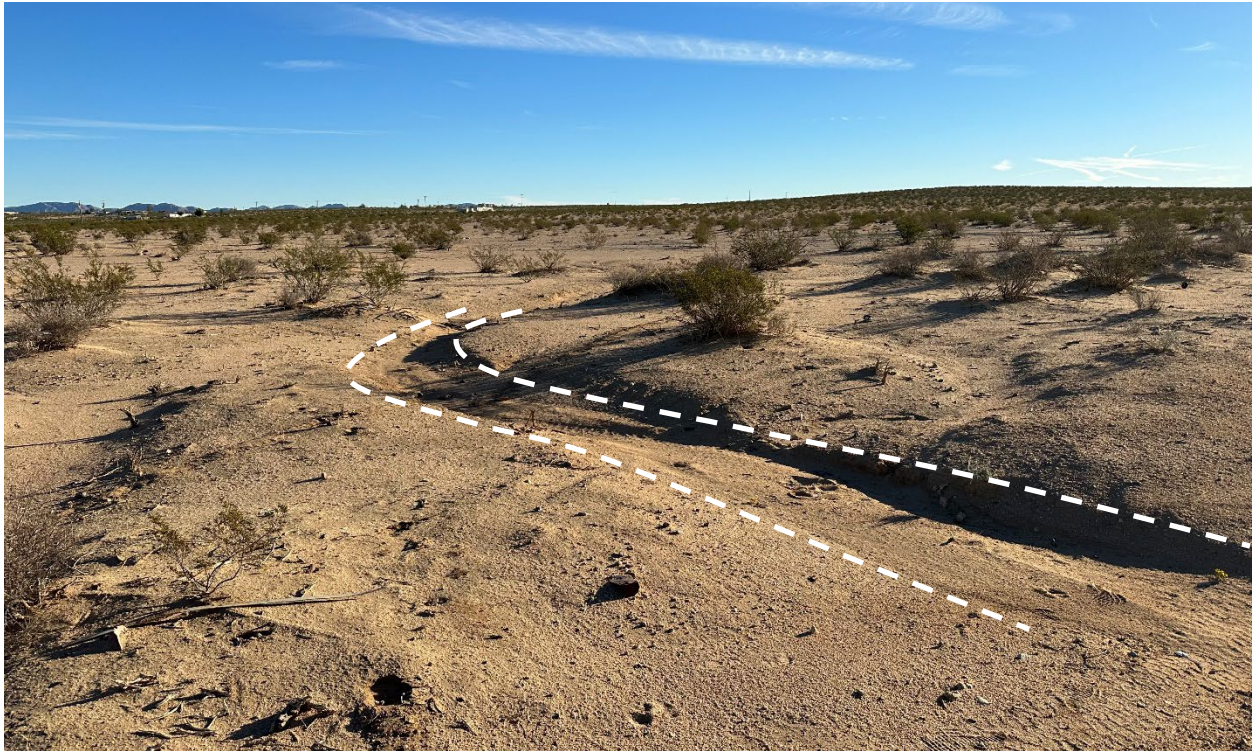
IES is located within the southwestern corner of the Project site and is a discontinuous ephemeral stream, which was determined through an assessment of environmental site conditions and as summarized in the OHWM datasheet (e.g., lack of supported hydrophytic vegetation, shallow stream channel, discontinuous nature, location within a dry climate with mild topography, mild OHWM indicators), only flows during and immediately following rain events. IES is approximately 110 feet long and flows from northeast to southwest. The OHWM width is two feet wide on average, only contains a low flow channel, and was observable through a break in bank slope and a change in average sediment texture (OHWM SP3; Attachment 4). The top of bank extends approximately three inches on either side of the OHWM channel, with an average width of 2.5 feet. The average depth of IES is four inches. The upstream extent of the stream appears to have been disturbed by vehicle traffic. The stream terminates at Cove View Road where the water sheet flows onto the road and infiltrates into the soil and/or evaporates. IES does not support hydrophytic vegetation and the coverage adjacent to the stream was uniform with the coverage throughout the remainder of the Study Area.

Photograph 3. Northeast facing photograph taken at the southern terminus of IES.

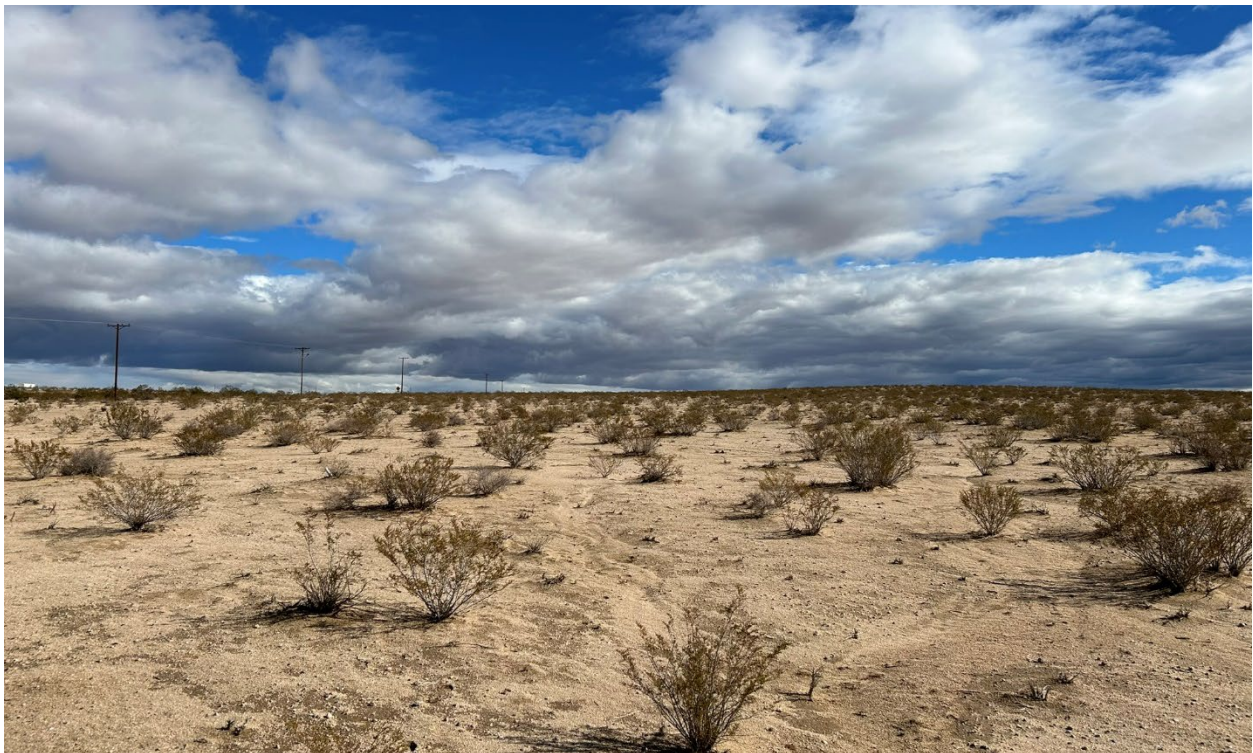
Photograph 4. East facing representative photo of the western portion of the Project site. A significant rain event occurred a day prior to the field delineation that resulted in a sheet flow down the slope.

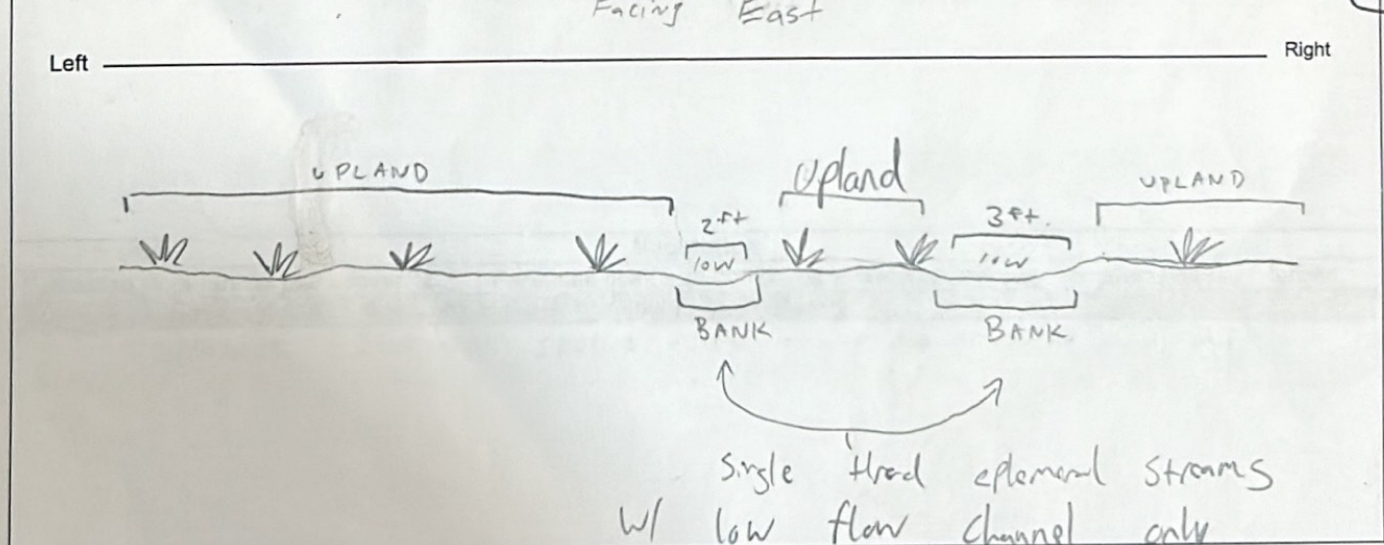
Summary Site Description and Cross-section Sketch: View across the channel from watercourse-edge to dirt roads watercourse-edge. Identify channel(s), banks, islands, interfluves, floodplains, terraces, and uplands where present. Note approximate width and elevation differences between features indicated. transsect throughout.
