APPENDIX H2: PHASE I ENVIRONMENTAL SITE ASSESSMENT FOR SITE 1

Phase I Environmental Site Assessment of the Bloomington Business Park - Block 1 Properties, Bloomington, San Bernardino County, California

RG Bloomington LLC
c/o Rockefeller Group Development Corporation

June 2021

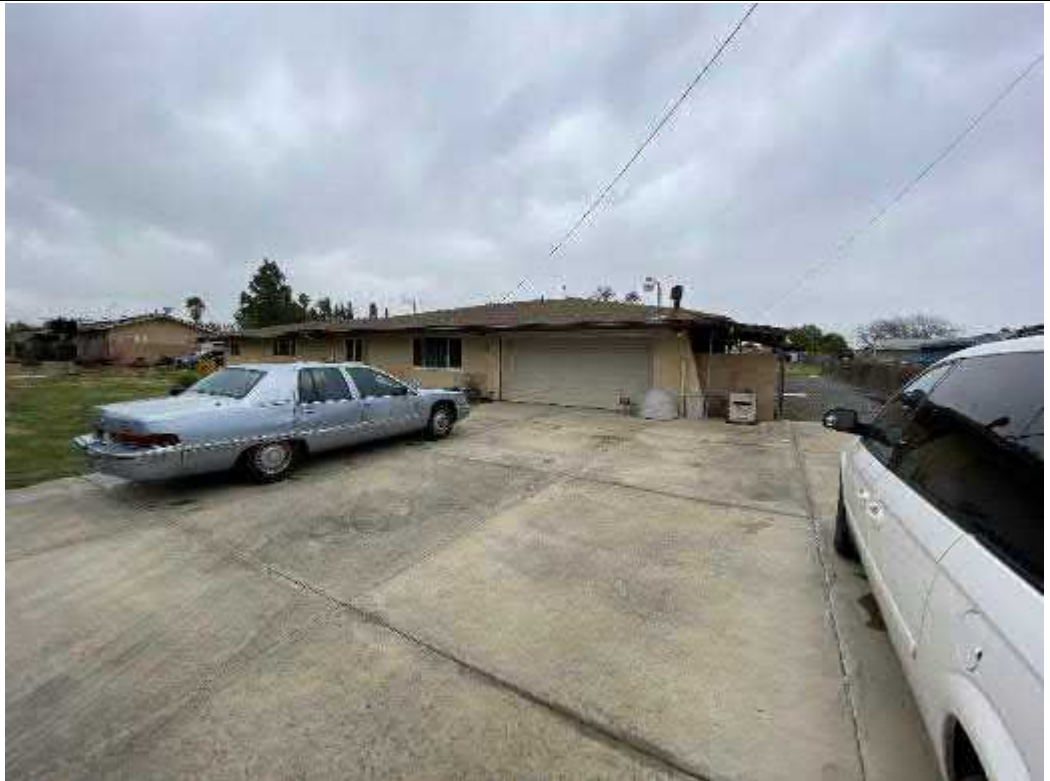
Photo No. 1	Date: 3/3/21
Direction Photo Taken: Northeast	
Description: View of the residence at Site No. 20 (11219 Maple Avenue) located in the northwestern corner of the subject property.

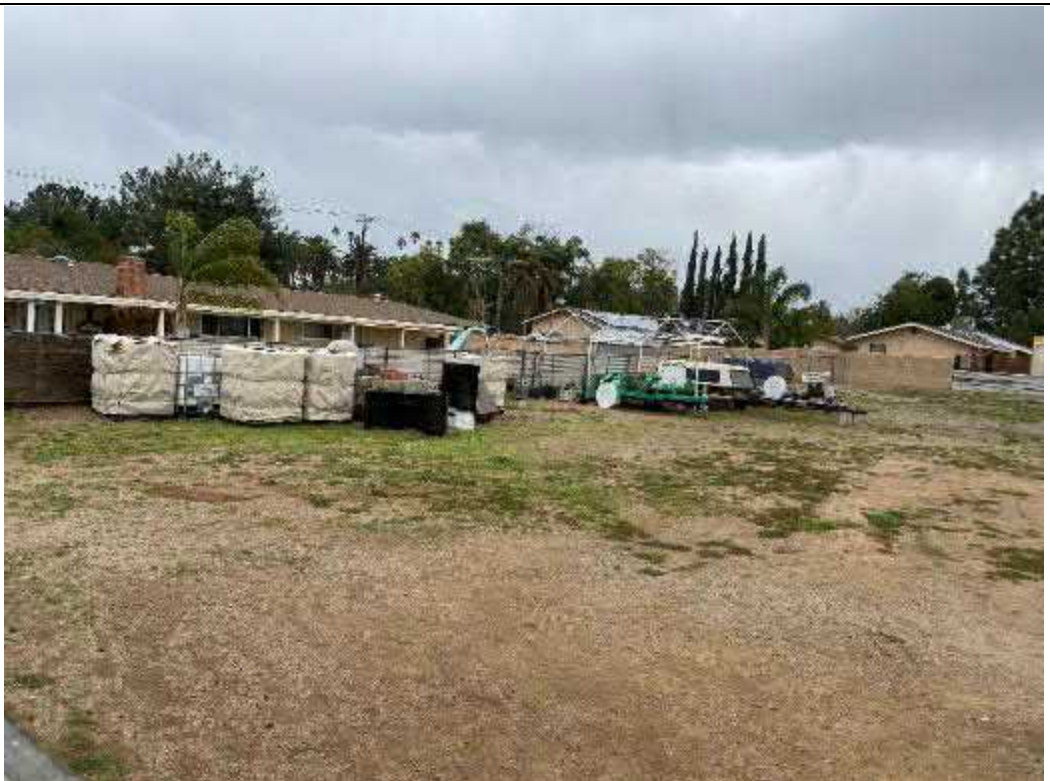
Photo No. 2	Date: 3/3/21
Direction Photo Taken: Northwest	
Description: View of five (5) empty 250-gallon polyethylene totes (formerly ArmorCoat paint protection coating) located in the central portion of Site No. 20.

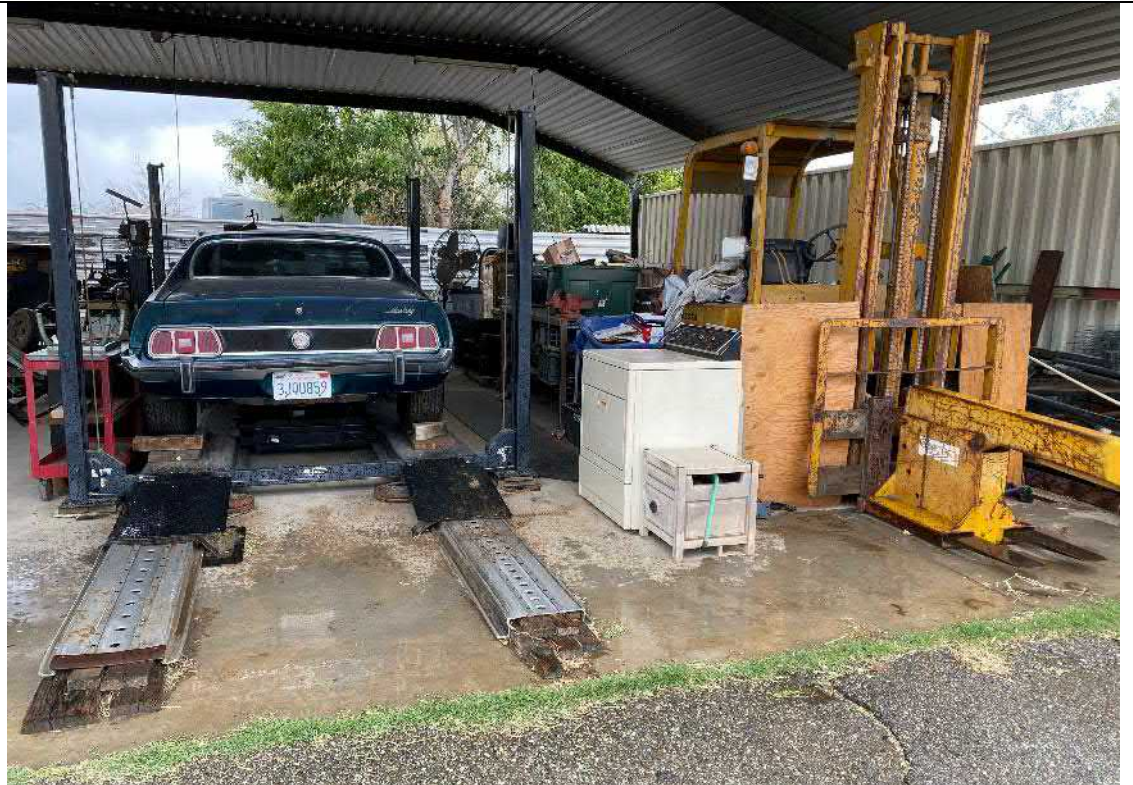
View of the aboveground hydraulic lift in the open metal shed used for minor personal vehicle repairs in the backyard area of Site No. 20.

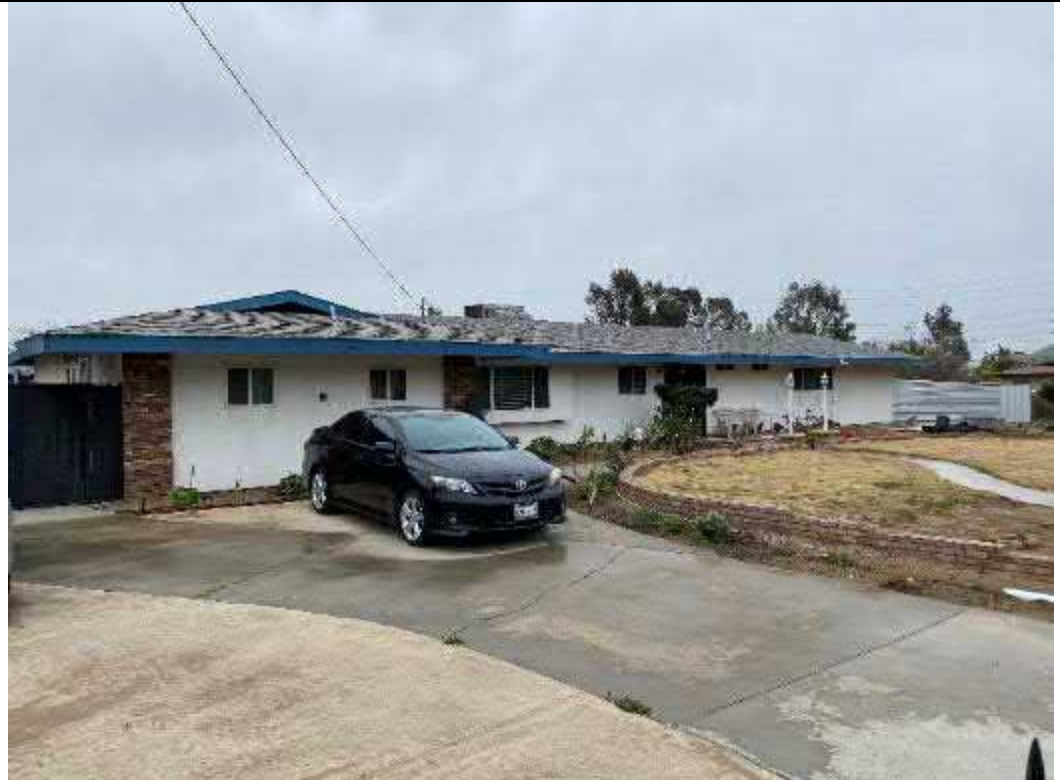
View of the residence at Site No. 21 (11241 Maple Avenue) located in the northwestern portion of the subject property.

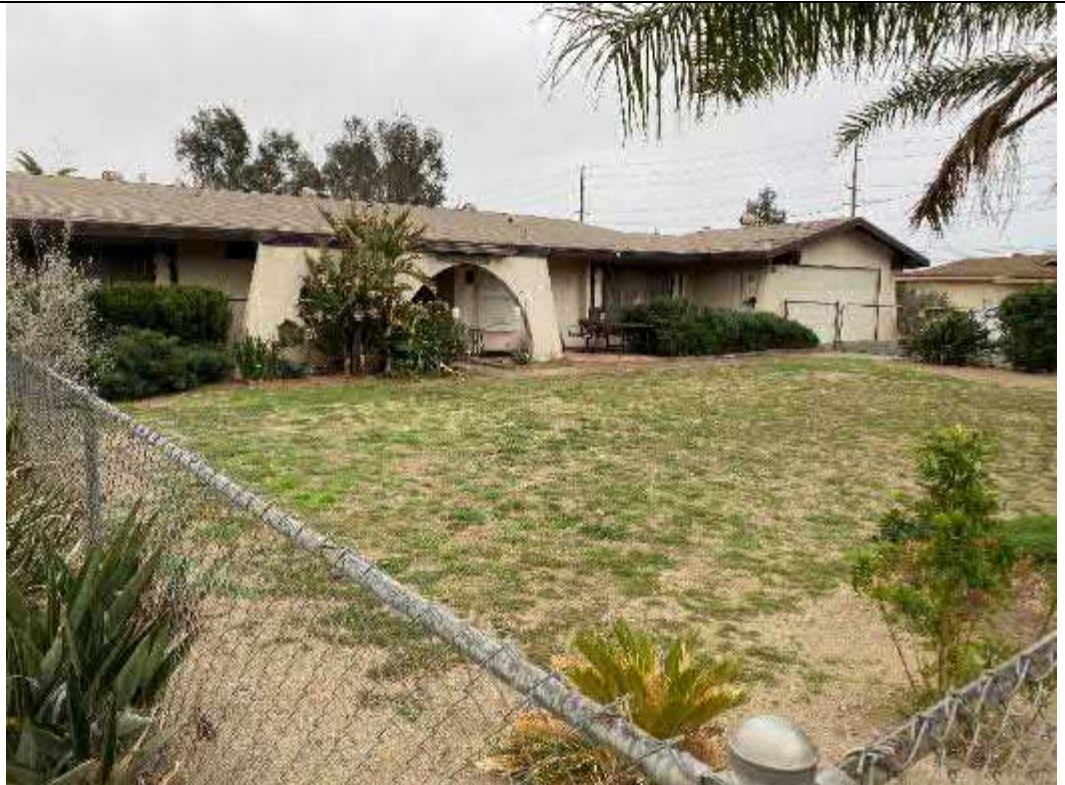
View of the residence at Site No. 22 (11265 Maple Avenue) located in the southwestern portion of the subject property.

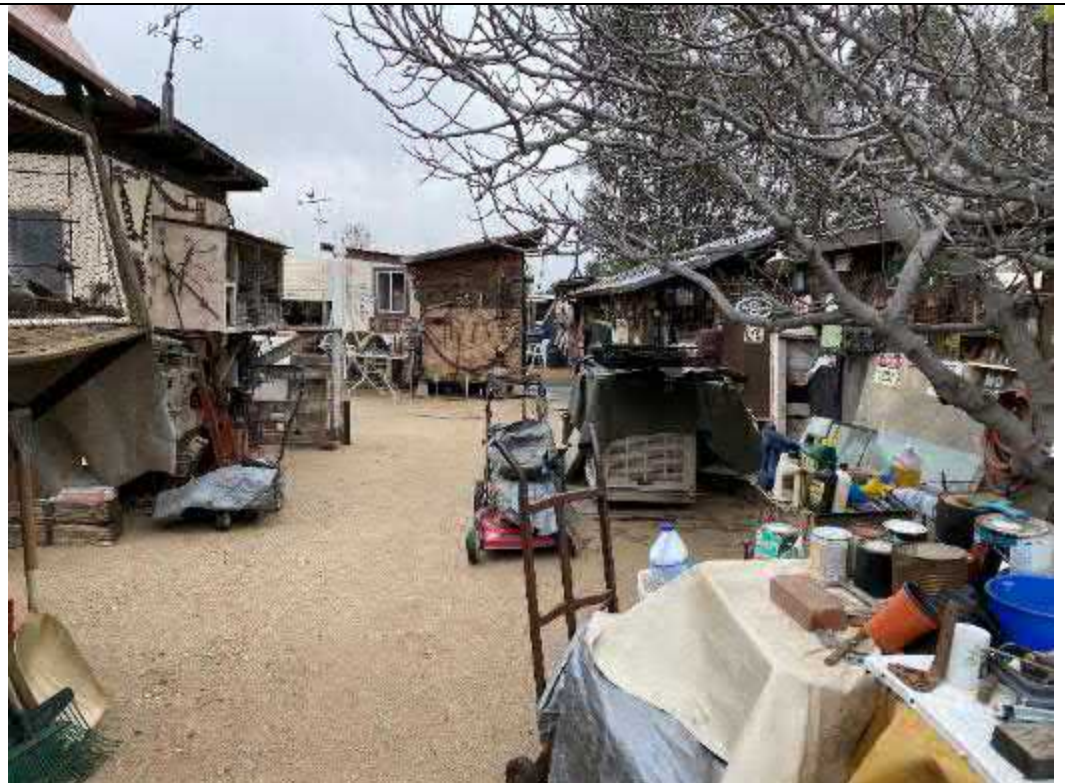
View of several wooden sheds and decorative yard ornaments observed throughout backyard area of Site No. 22.

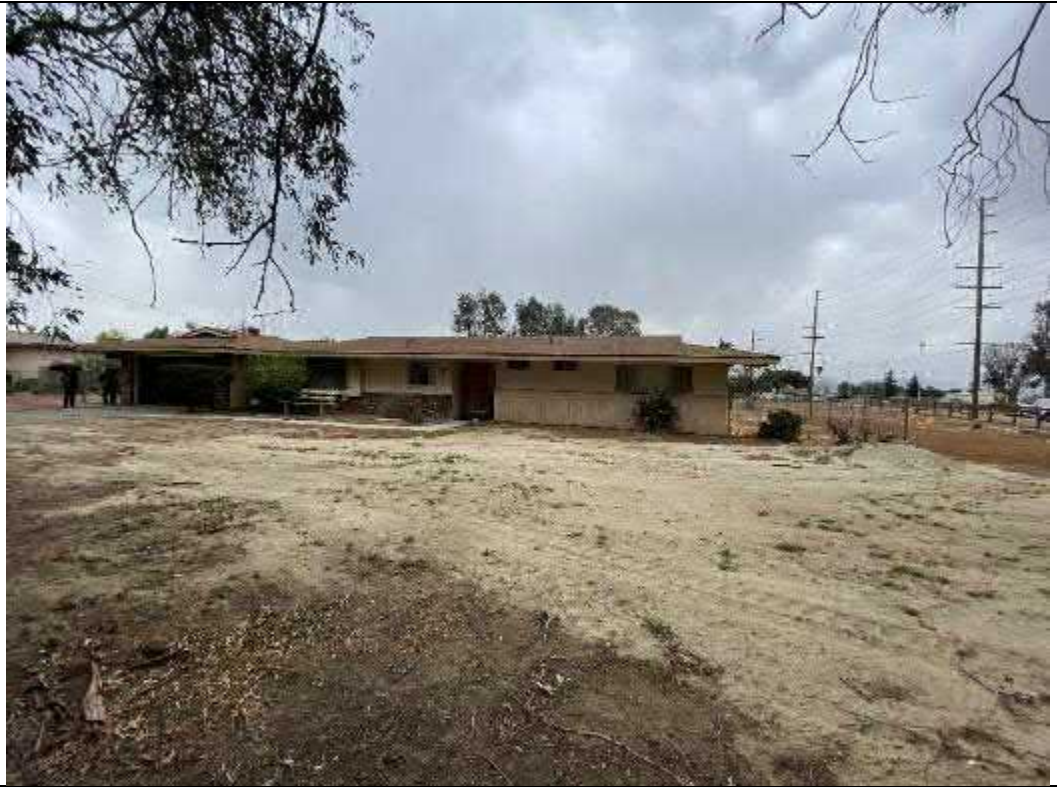
Photo No. 7	Date: 3/3/21
Direction Photo Taken: East	
Description: View of the residence at Site No. 23 (11287 Maple Avenue) located in the southwestern corner of the subject property.

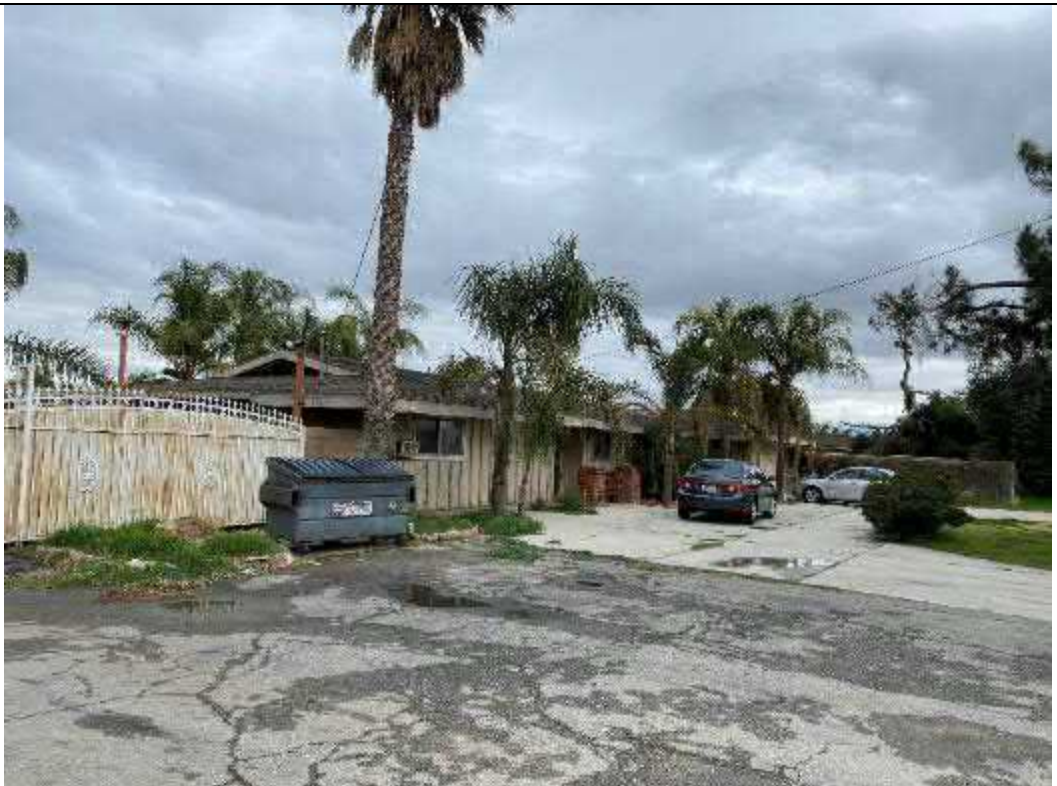
Photo No. 8	Date: 3/3/21
Direction Photo Taken: Northeast	
Description: View of the residence at Site No. 24 (18358 Jurupa Avenue) located in the west-central portion of the subject property.

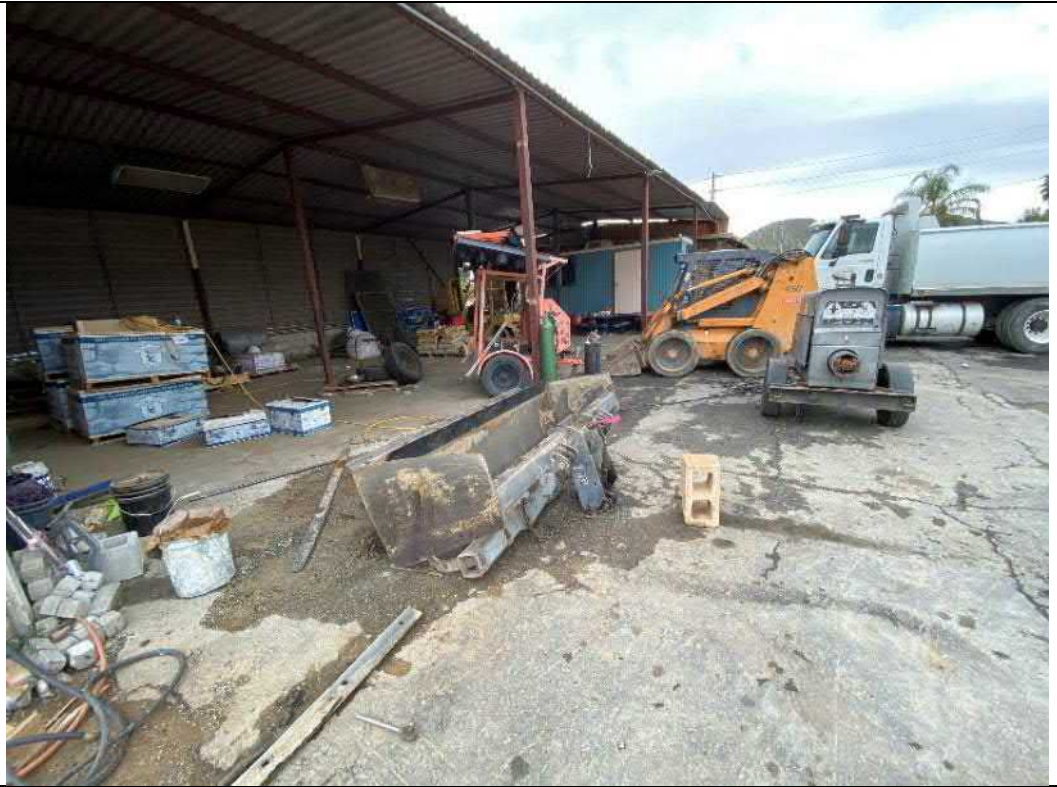
Photo No. 9	Date: 3/3/21
Direction Photo Taken: Northwest	
Description: View of the shop structure used for minor vehicle/equipment repair activities located in the backyard area of Site No. 24.

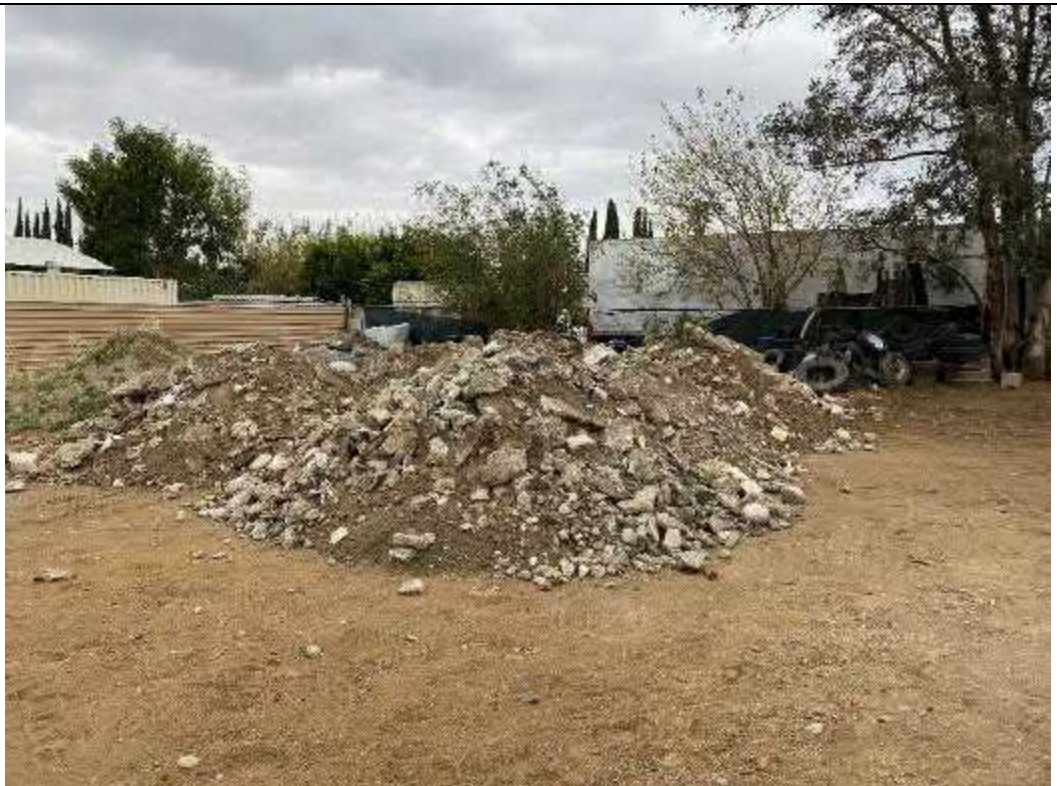
Photo No. 10	Date: 3/3/21
Direction Photo Taken: Northwest	
Description: View of construction and demolition debris piles and tires observed in the northwestern corner of Site No. 24.

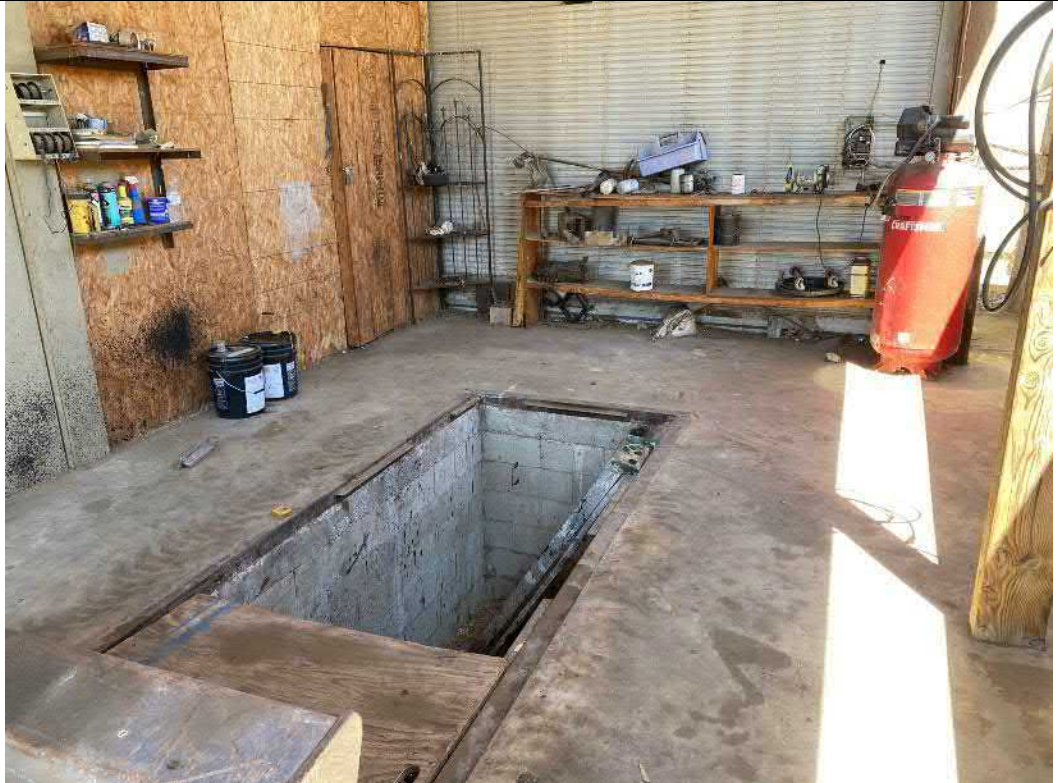
- During the follow-up site visit, AECOM was able to make observations of the concrete pit identified during the Kennedy Jenks 2020 previous assessment, which was located in the southern portion of the shop structure at Site No. 24 (18358 Jurupa Avenue). The pit was approximately 11 feet long by 4 feet wide by 5 feet deep and appeared to be used as a subgrade oil change bay/equipment repair structure. The sidewalls of the concrete pit were observed to be intact (i.e., no cracks or deficiencies); however, AECOM could not observe the base of the pit as approximately 3 inches of debris and sediment covered the bottom of the pit. Based on the lack of available information regarding the integrity of the structure and potential historical uses (e.g., equipment repair, oil change bay, etc.), the concrete pit is considered to represent a REC in connection with the subject property, in AECOM's opinion.

View of the concrete pit (approximately 11 feet long by 4 feet wide by 5 feet deep) located in the southern portion of the shop structure at Site No. 24.

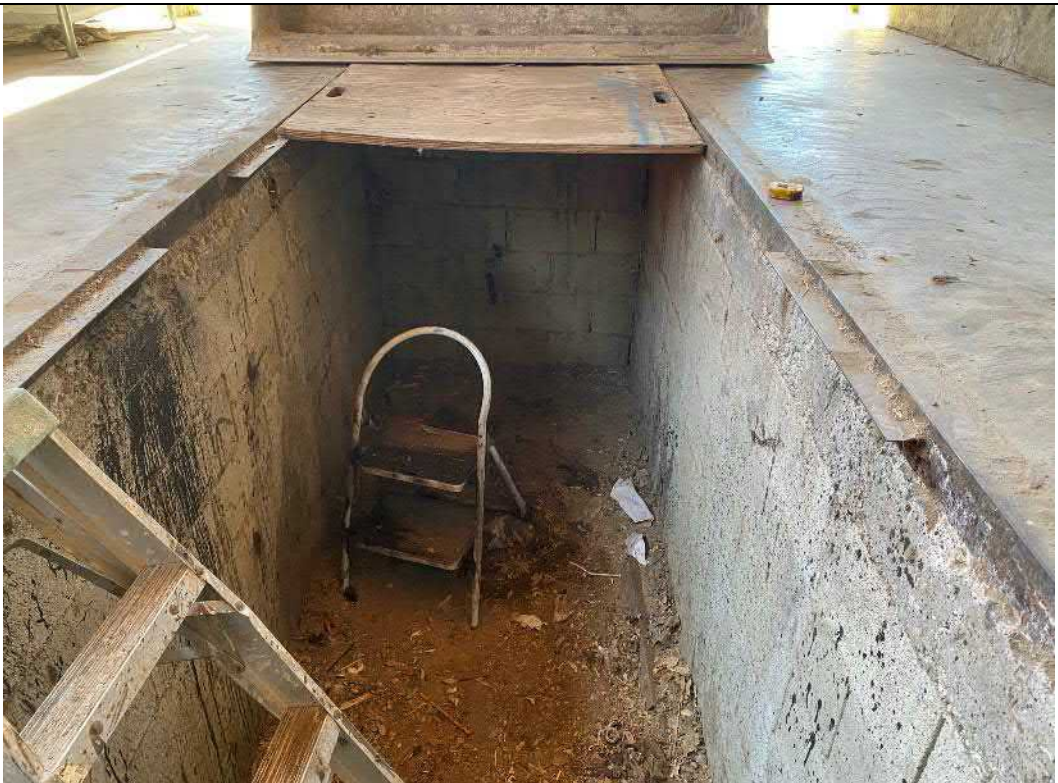
Photo No.
12

Close-up view of the interior of the concrete pit. Approximately 3 inches of sediment and debris was observed covering the bottom of the pit.

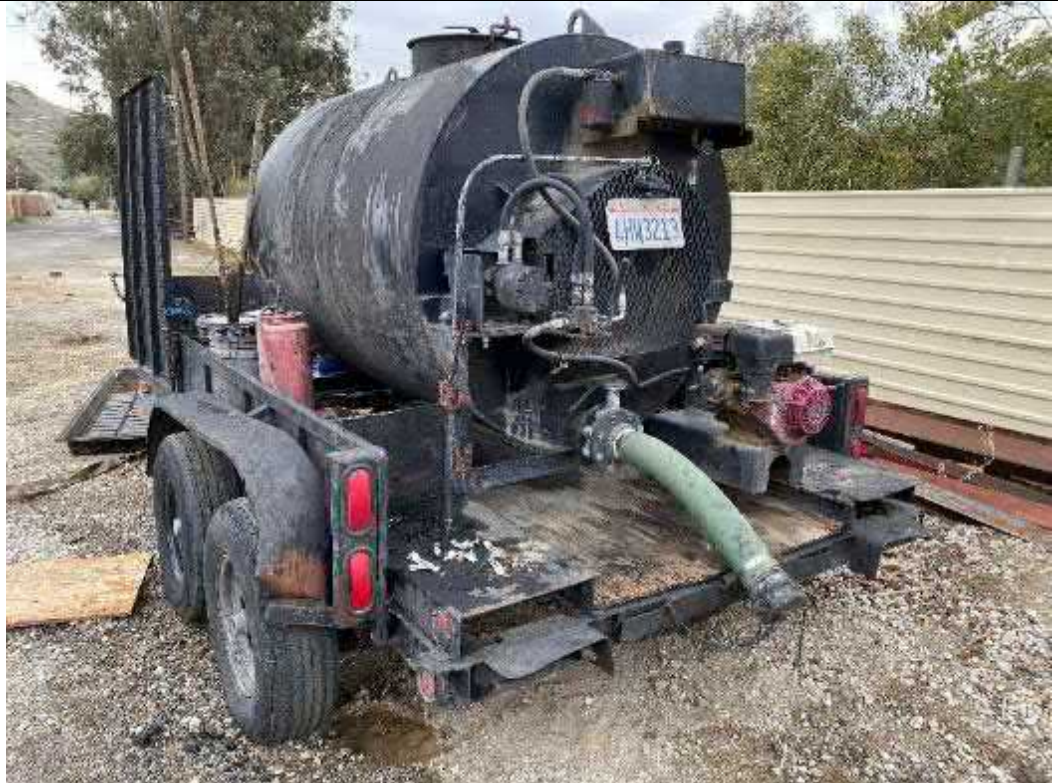
- De minimis tar-like staining (approximately 3 feet by 3 feet) was observed on the unpaved ground surface in the area of the asphalt-paving equipment along the central western boundary of Site No. 24 (18358 Jurupa Avenue) in the west-central portion of the subject property.

View of asphalt-paving equipment and de minimis staining located along the western boundary of Site No. 24.

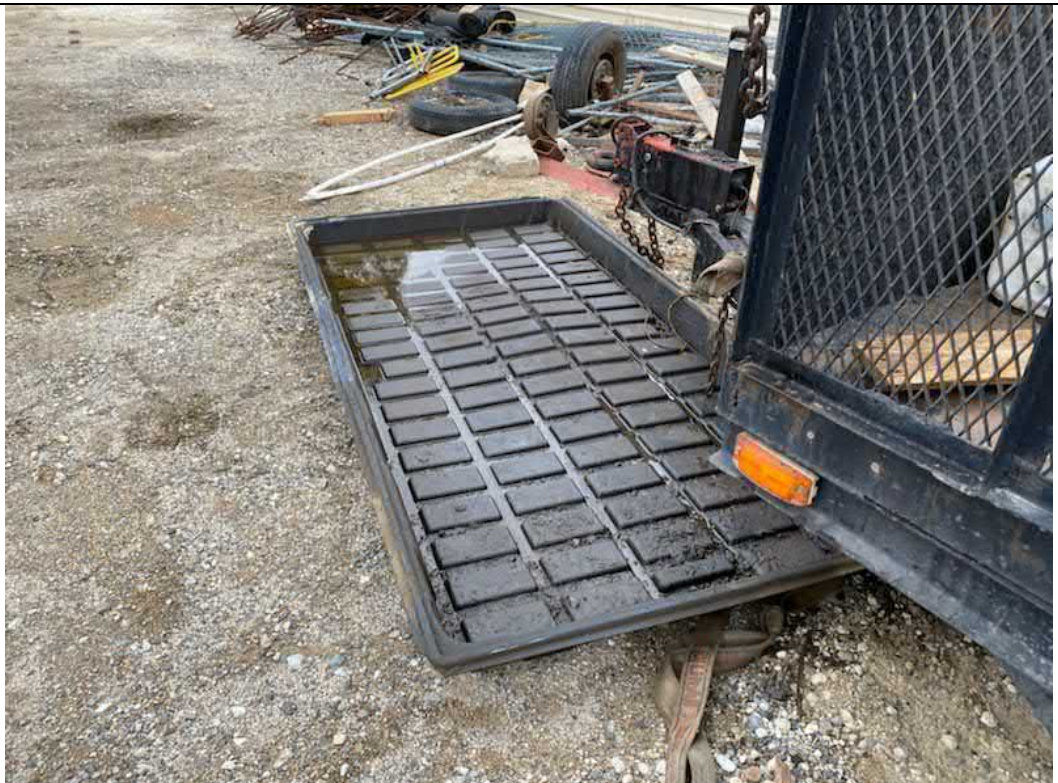
Photo No.
14

Close-up view of de minimis staining and drip pan associated with asphalt-paving equipment located along the western boundary of Site No. 24.

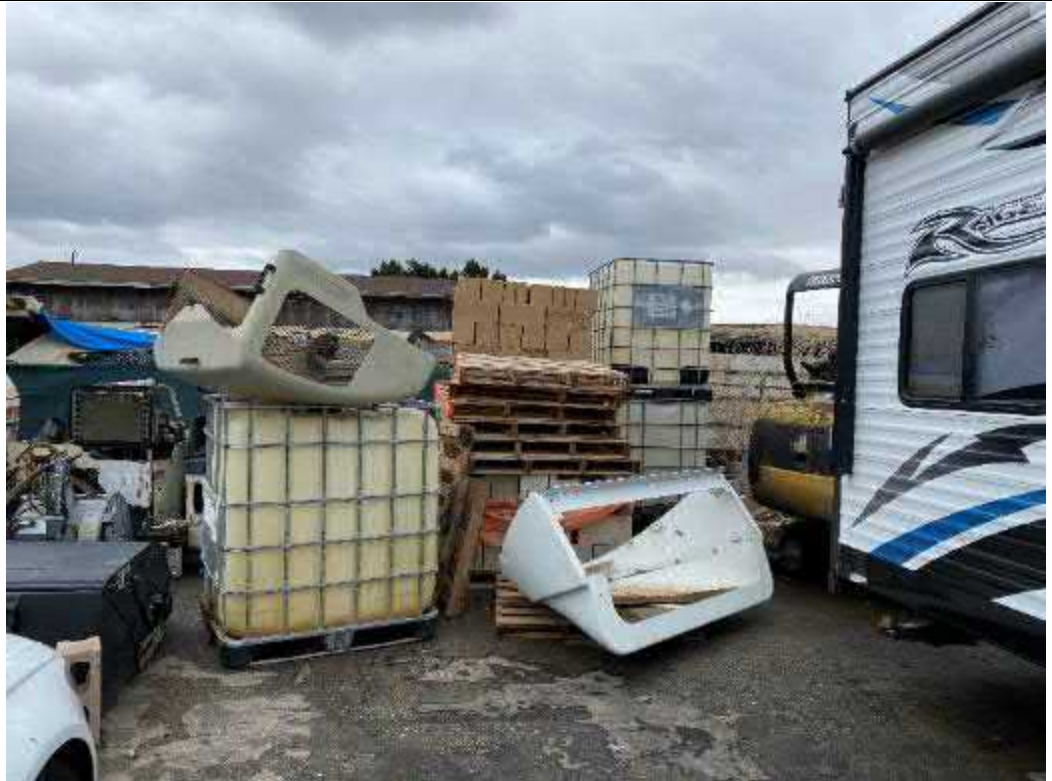
View of 250-gallon polyethylene totes containing sodium hydroxide solution observed along the eastern boundary of Site No. 24.

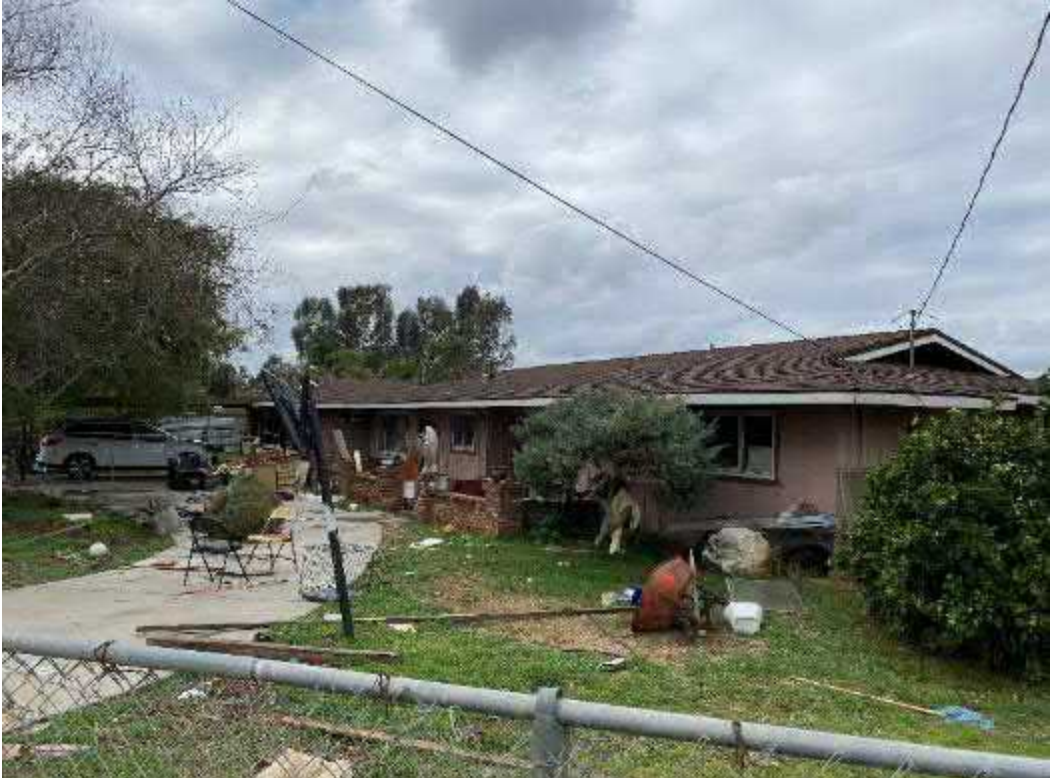
View of the residence at Site No. 25 (18382 Jurupa Avenue) located in the central portion of the subject property.

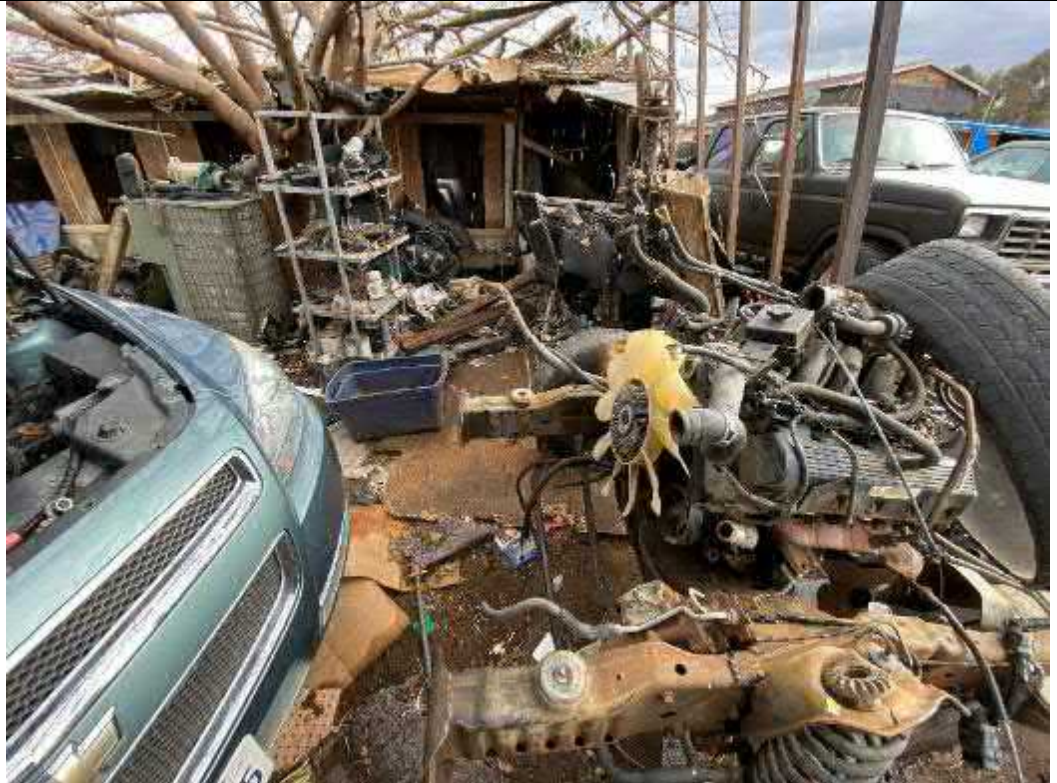
- De minimis oily-type staining (approximately 5 feet by 5 feet) was observed on the unpaved ground surface adjacent to the south of the vehicle repair area along the eastern property boundary of Site No. 25 (18382 Jurupa Avenue) in the north-central portion of the subject property.

View of vehicle repair area and de minimis oily-type staining located along the eastern boundary of Site No. 25.

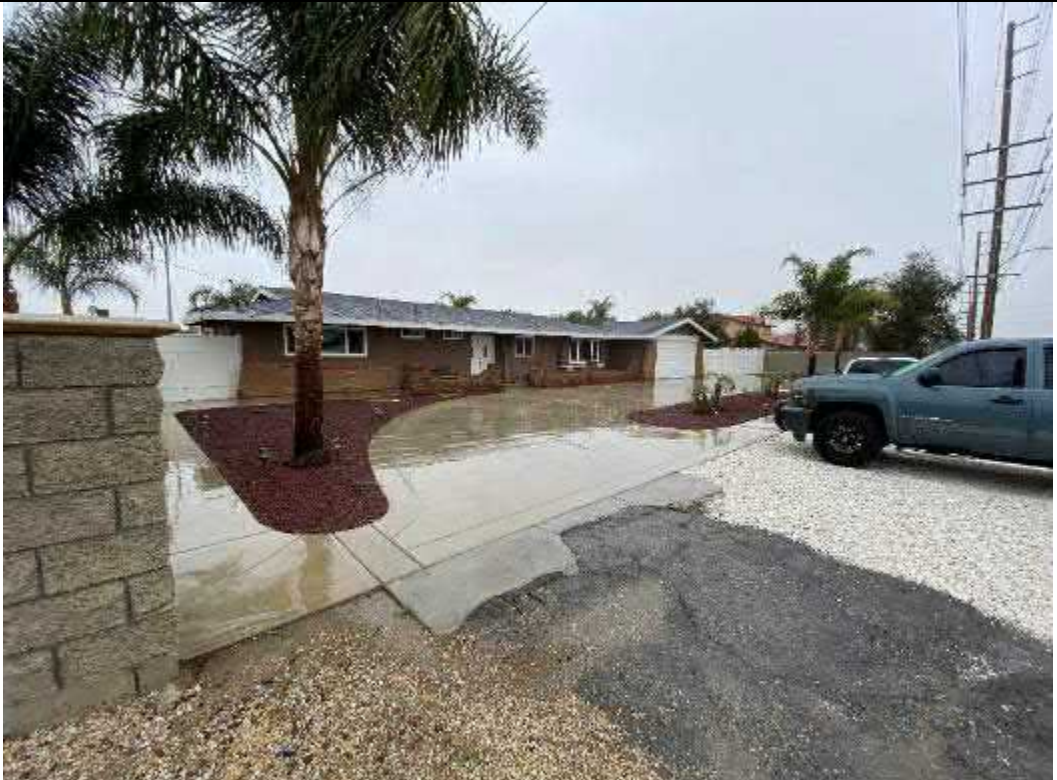
View of the residence at Site No. 26 (18414 Jurupa Avenue) located in the central portion of the subject property.

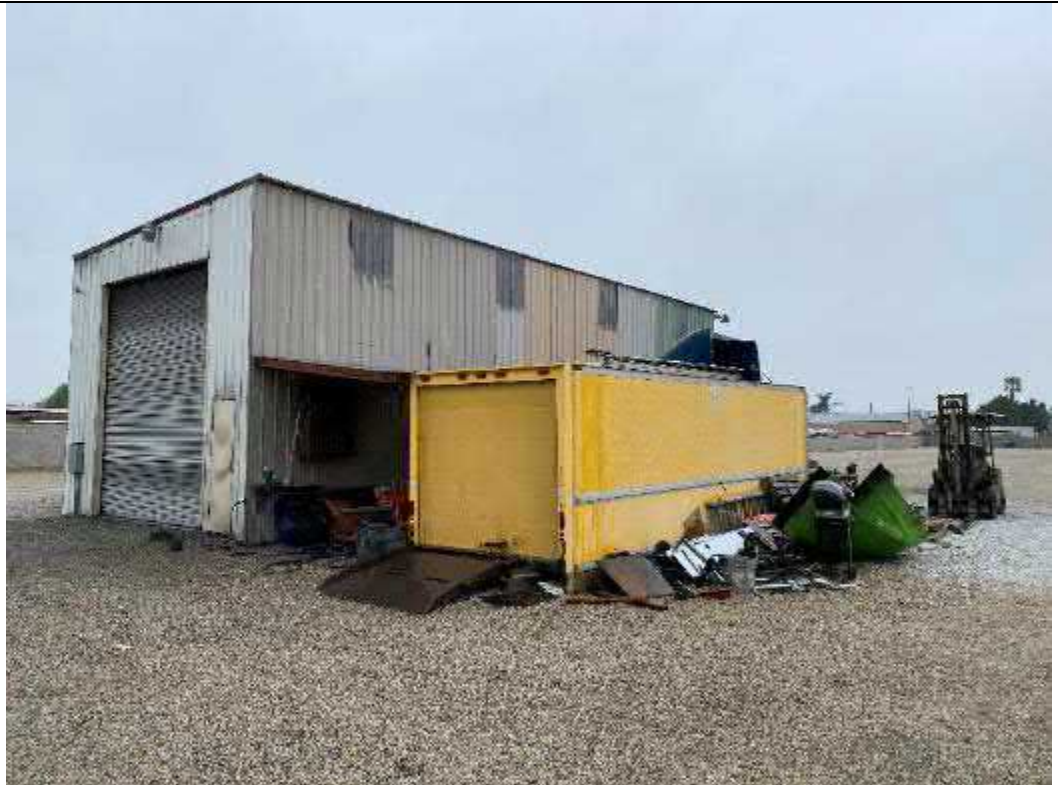
- De minimis oily-type staining (approximately 5 feet by 5 feet) was observed near the roll-up door to the large metal storage garage/warehouse structure, which was partially covered by gravel, in the south-central portion of Site No. 26 (18414 Jurupa Avenue).

Photo No. 19	Date: 3/3/21
Direction Photo Taken: Northwest	
Description: View of large metal storage garage/warehouse with a roll-up door and a storage container located in the southern portion of Site No. 26 to the north of the residence. Note de minimis oily-staining near roll-up door to large metal structure (ground surface was wet at the time of the site visit due to rain). The interior of the structures were inaccessible.

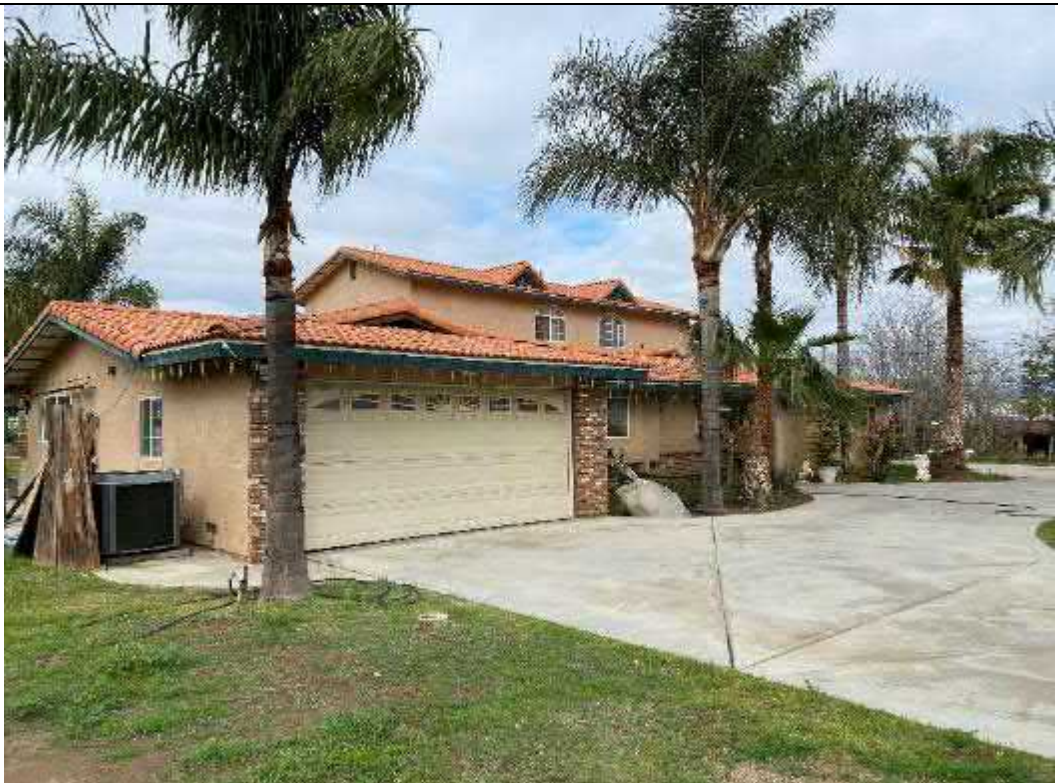
Photo No. 20	Date: 3/3/21
Direction Photo Taken: Northeast	
Description: View of the residence at Site No. 27 (18438 Jurupa Avenue) located in the east-central portion of the subject property.

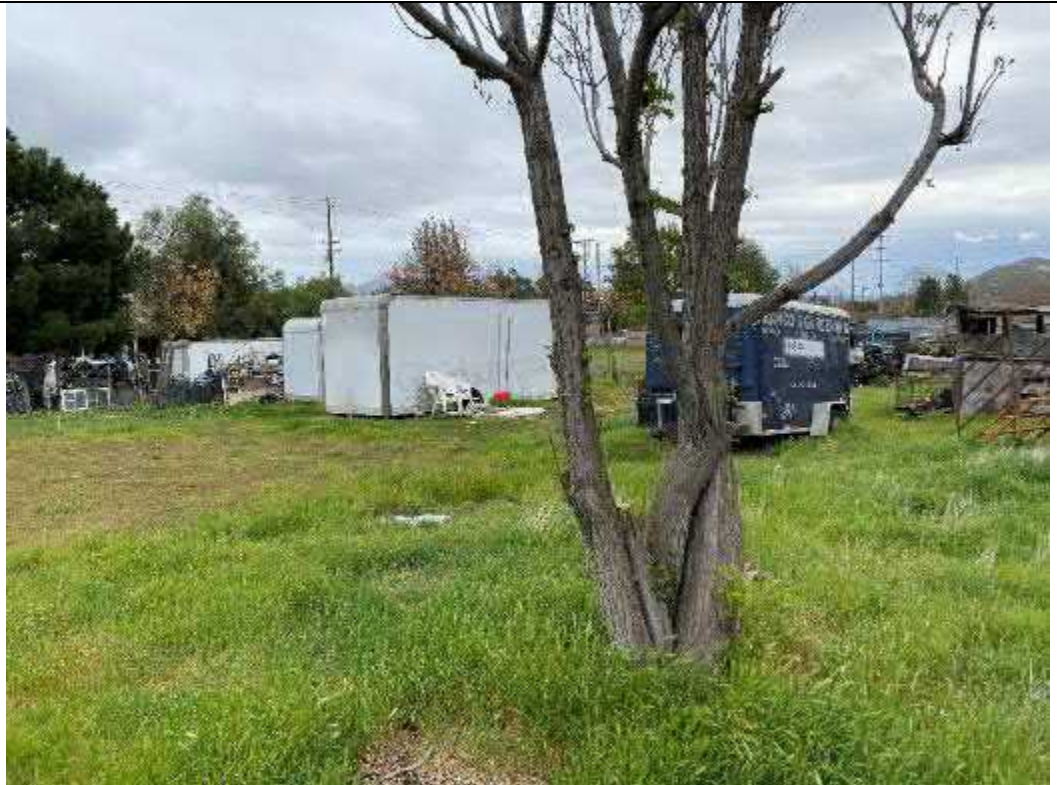
View of trailer storage area located in the central portion of Site No. 28.

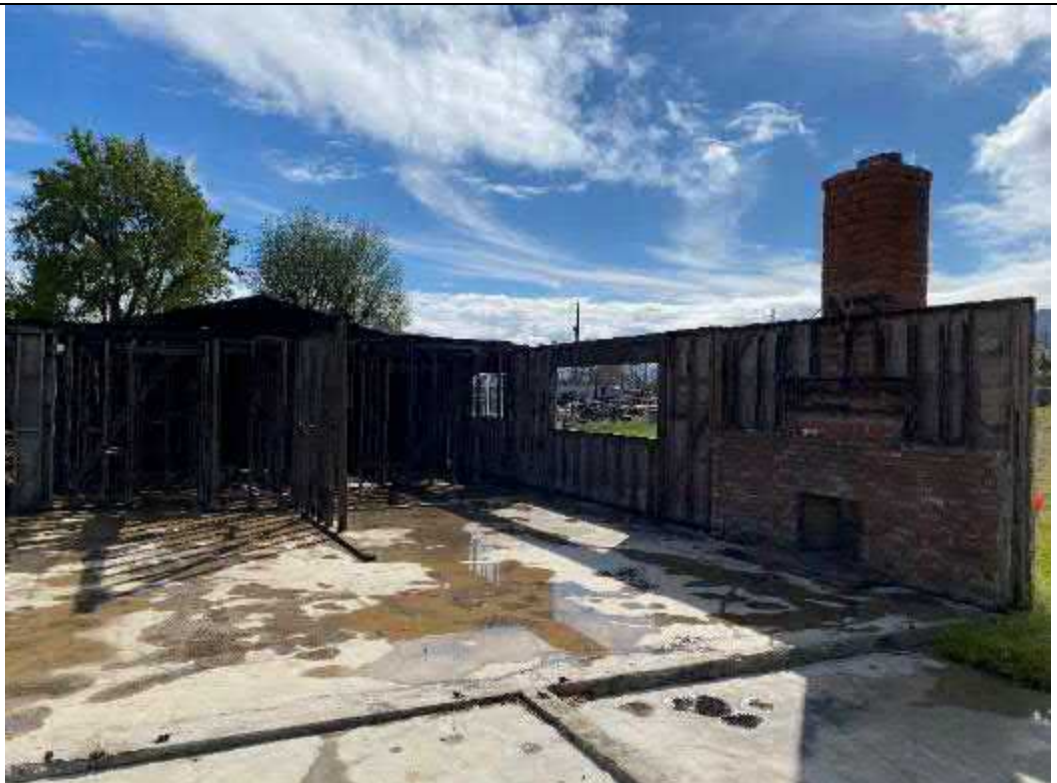
Photo No.
24

View of Site No. 29 (11244 Linden Avenue) located in the northeastern portion of the subject property, which was observed to contain a fire-damaged residential structure.

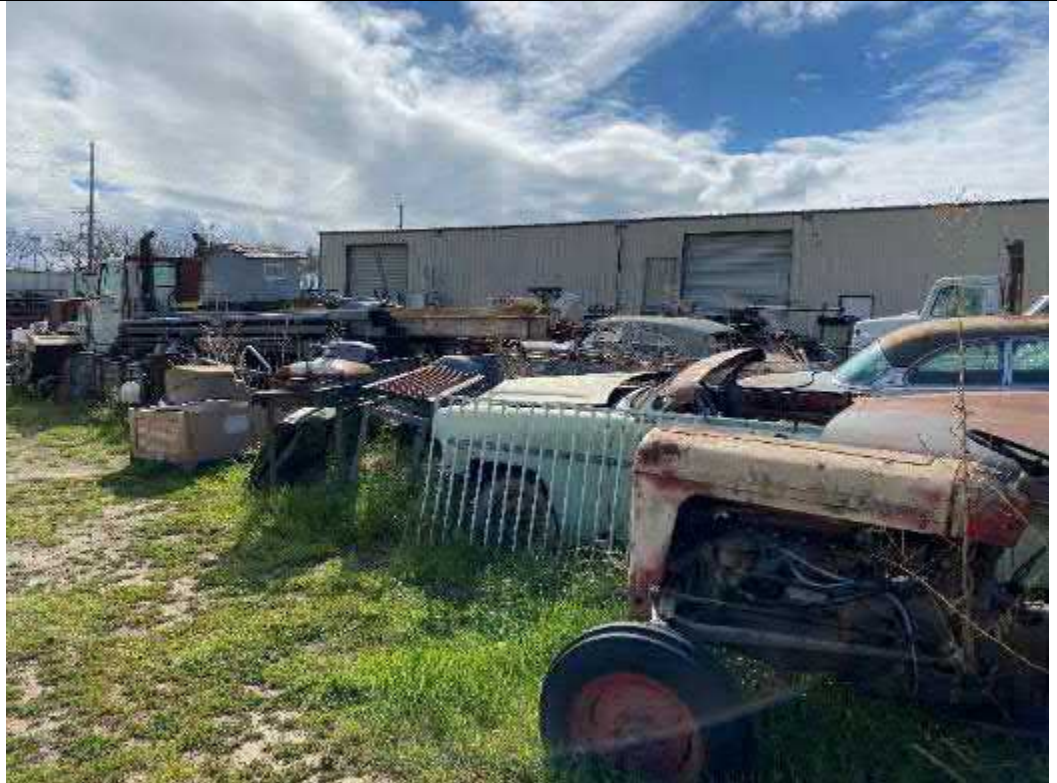
View of scrap yard (central portion) and large metal storage garage/shop (western portion) located on Site No. 30.

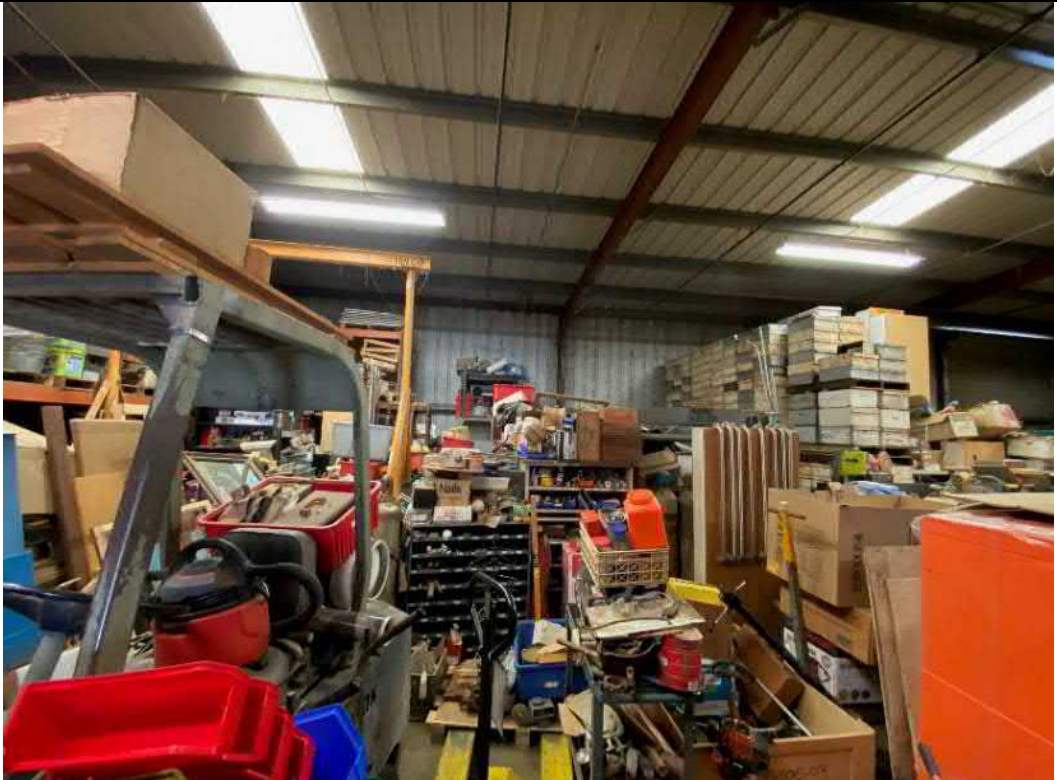
Interior view of the shop/storage garage located in the western portion of Site No. 30.

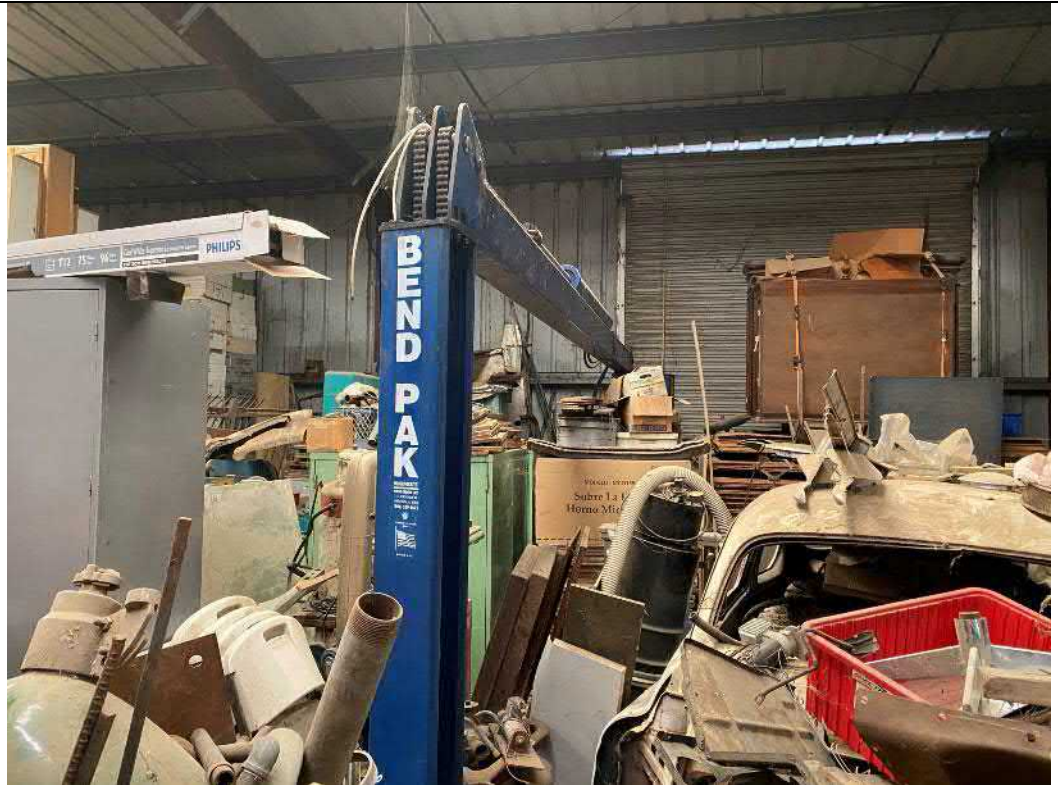
View of the aboveground hydraulic lift observed in the northwestern portion of the shop/storage garage on Site No. 30 during the follow-up site visit.
