APPENDIX H2: PHASE I ENVIRONMENTAL SITE ASSESSMENT FOR SITE 1

Phase I Environmental Site Assessment of the Bloomington Business Park - Block 1 Properties, Bloomington, San Bernardino County, California

RG Bloomington LLC
c/o Rockefeller Group Development Corporation

June 2021

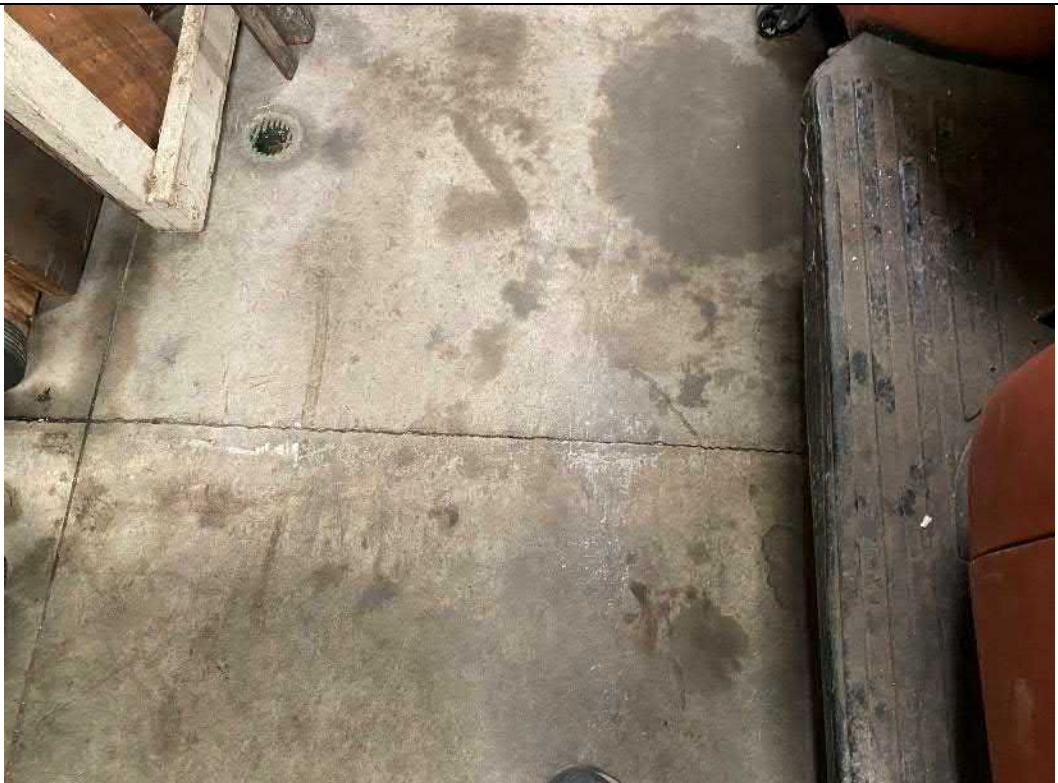
Photo No.
30

- During the follow-up site visit, AECOM was able to make observations of the floor drain identified during the Kennedy Jenks 2020 previous assessment, which was located in the northwestern portion of the shop/storage garage in the western portion of Site No. 30 (11266 Linden Avenue). The floor drain was observed to be approximately 2 inches in diameter and the property tenant reported that the floor drain is capped and no longer in use. The discharge point of the drain was not known. The subject property is not connected to a municipal sewer system and the residence on the subject property is serviced by a septic tank system. Based on the former activities conducted in the shop/storage garage (i.e., auto repairing) and the unknown discharge point, the floor drain is considered to represent a REC in connection with the subject property, in AECOM's opinion.

- De minimis oily-type staining (approximately 1 foot by 1 foot in size) was observed on the intact concrete flooring of the shop/storage garage in the western portion of Site No. 30 (11266 Linden Avenue) at the time of the follow-up site visit.

View of the approximately 2-inch floor drain and de minimis dark oily-type staining (approximately 1 foot by 1 foot in size) located to the east of the aboveground hydraulic lift in the shop/storage garage on Site No. 30.

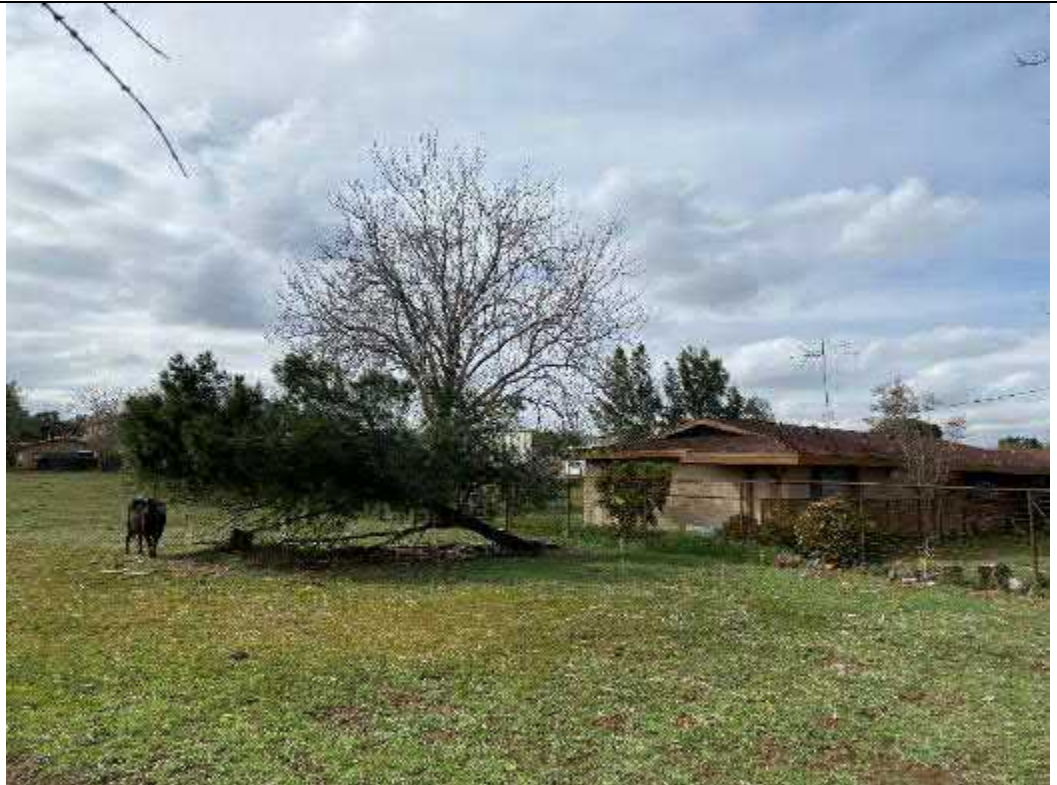
Photo No. 31	Date: 3/3/21
Direction Photo Taken: Northeast	
Description: View of Site No. 31 (11290 Linden Avenue) located in the southeastern corner of the subject property.

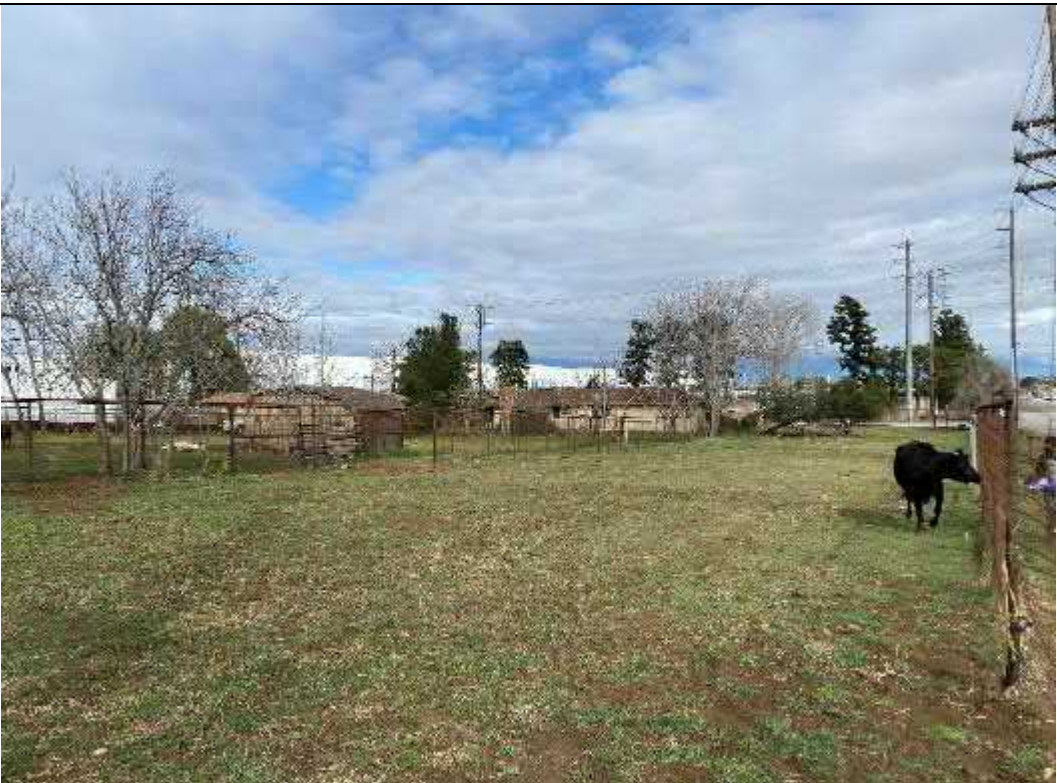
Photo No. 32	Date: 3/3/21
Direction Photo Taken: East	
Description: View of cow grazing area located in the western portion of Site No. 31.

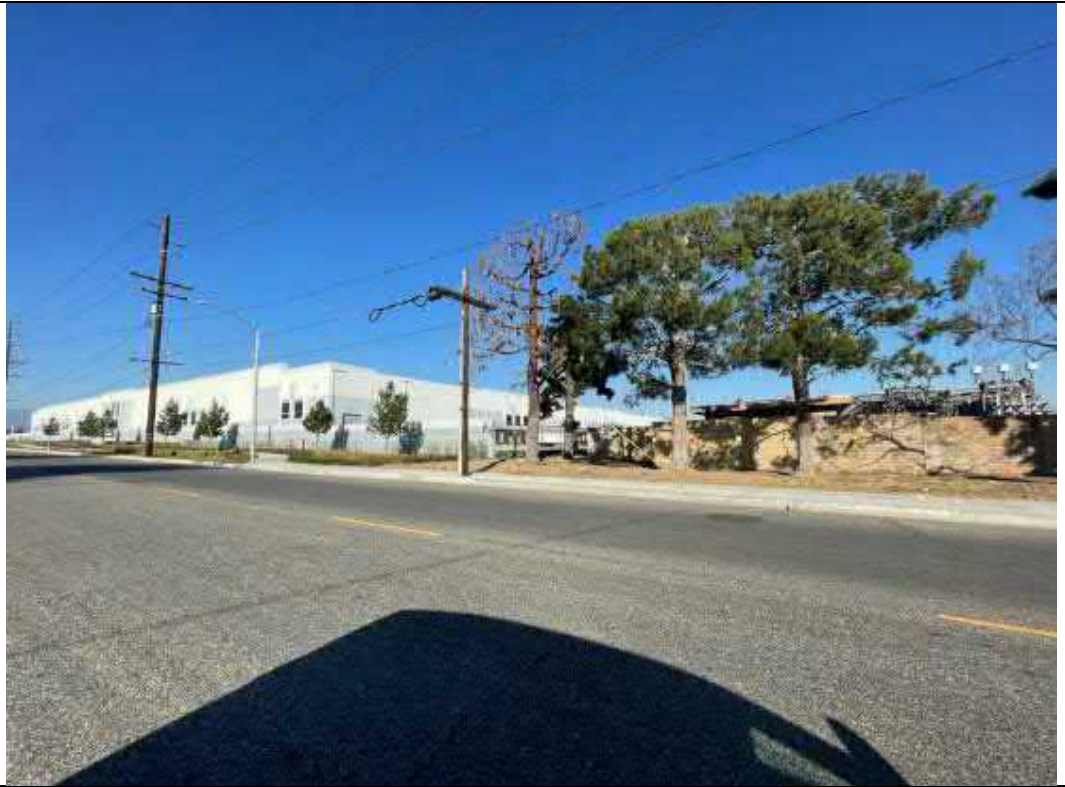
Photo No. 33	Date: 3/3/21
Direction Photo Taken: Northeast	
Description: View of the Pitney Bowes Business Center (11260 Cedar Avenue) located adjacent to the east of the subject property, across Linden Avenue.

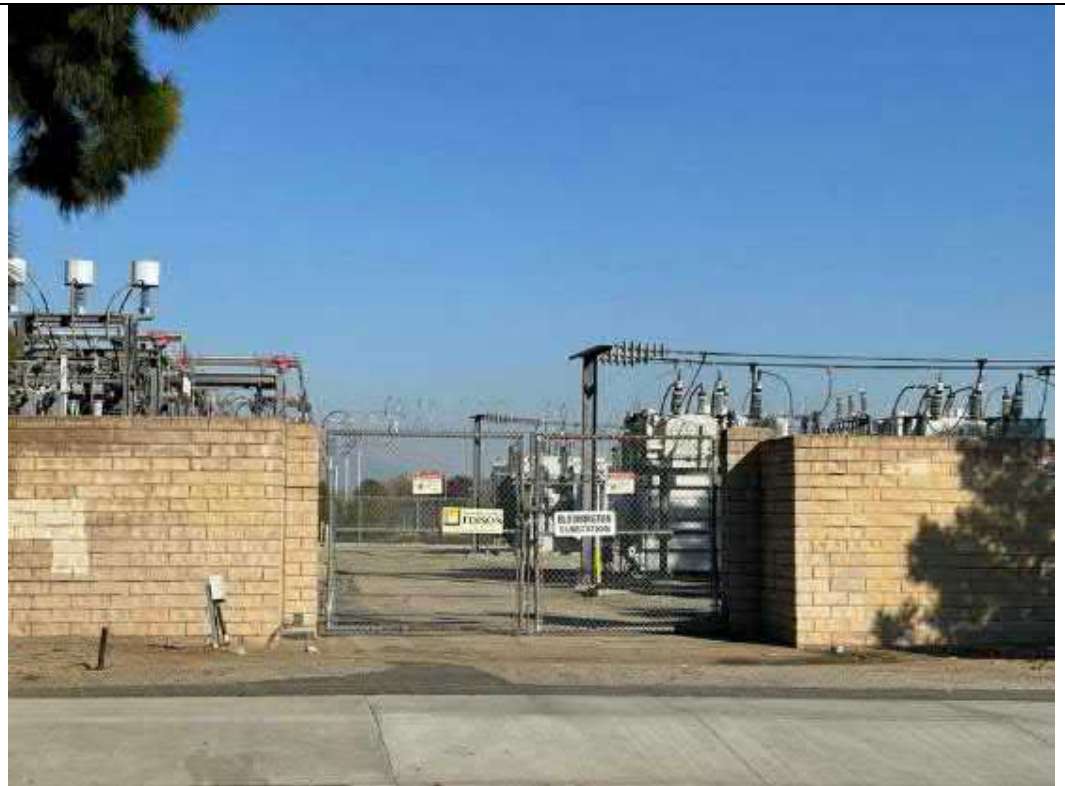
Photo No. 34	Date: 3/3/21
Direction Photo Taken: East	
Description: View of the Southern California Edison (SCE) Bloomington Substation (18564 Jurupa Avenue) located adjacent to the east of the subject property, across Linden Avenue.

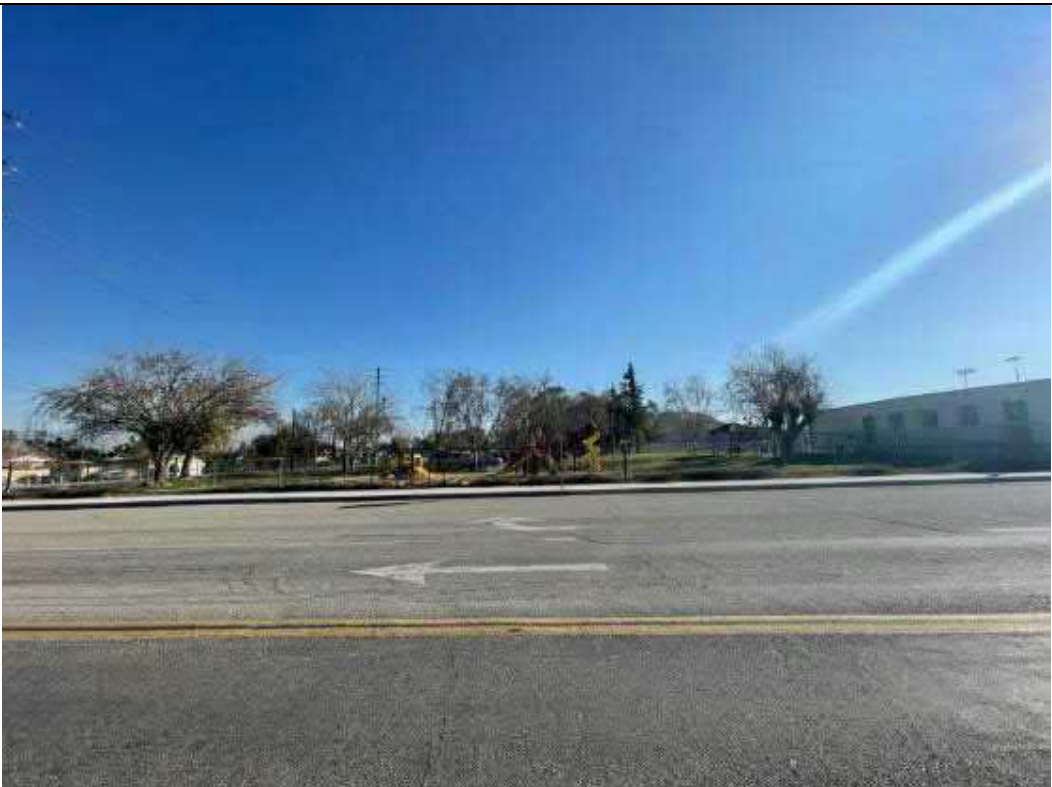
Photo No. 35	Date: 3/3/21

Direction Photo Taken: South		
Description: View of Kessler Park with Bloomington Recreation & Park District Office (18401 Jurupa Avenue) located adjacent to the south of the subject property, across Jurupa Avenue.

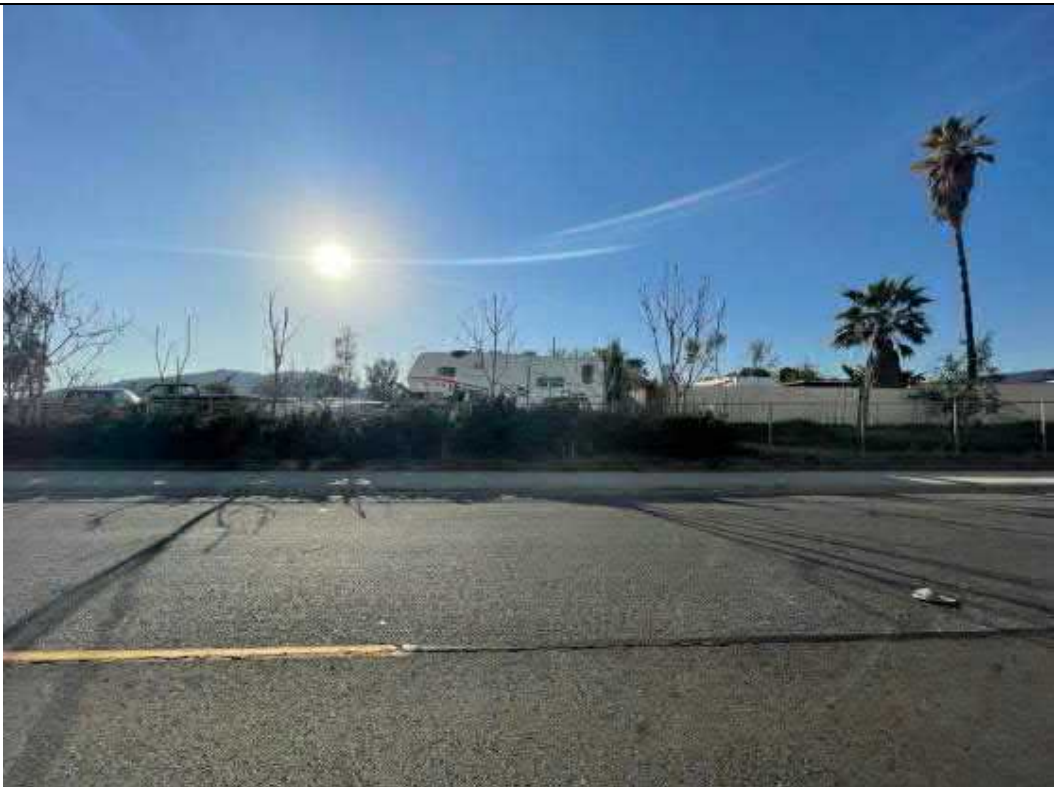
Photo No. 39	Date: 3/3/21

Direction Photo Taken: West		
Description: View of the residential property (11191 Linden Avenue) located adjacent to the north-northeast of the subject property.

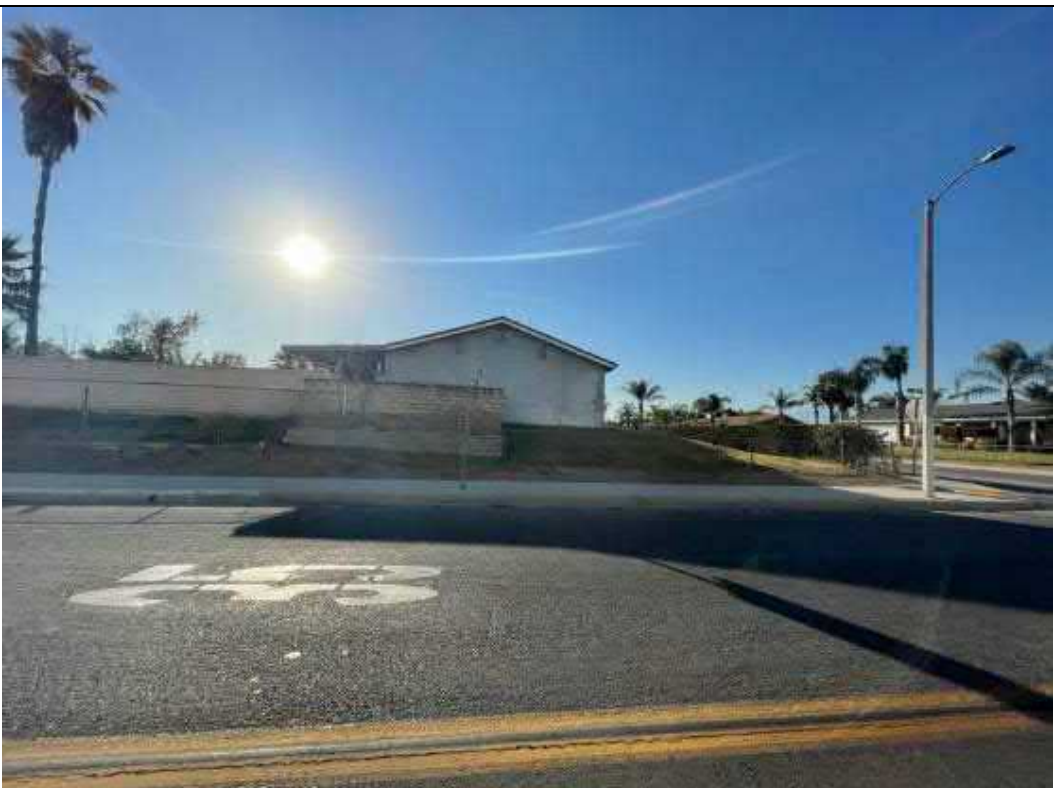
Photo No. 40	Date: 3/3/21

Direction Photo Taken: South		
Description: View of the residential property (18484 Stallion Lane) located adjacent to the north of the subject property.
