# Phase I Environmental Site Assessment of the Bloomington Business Park - Block 2 Properties, Bloomington, San Bernardino County, California

RG Bloomington LLC  
c/o Rockefeller Group Development Corporation

Project Number: 60620647

June 2021

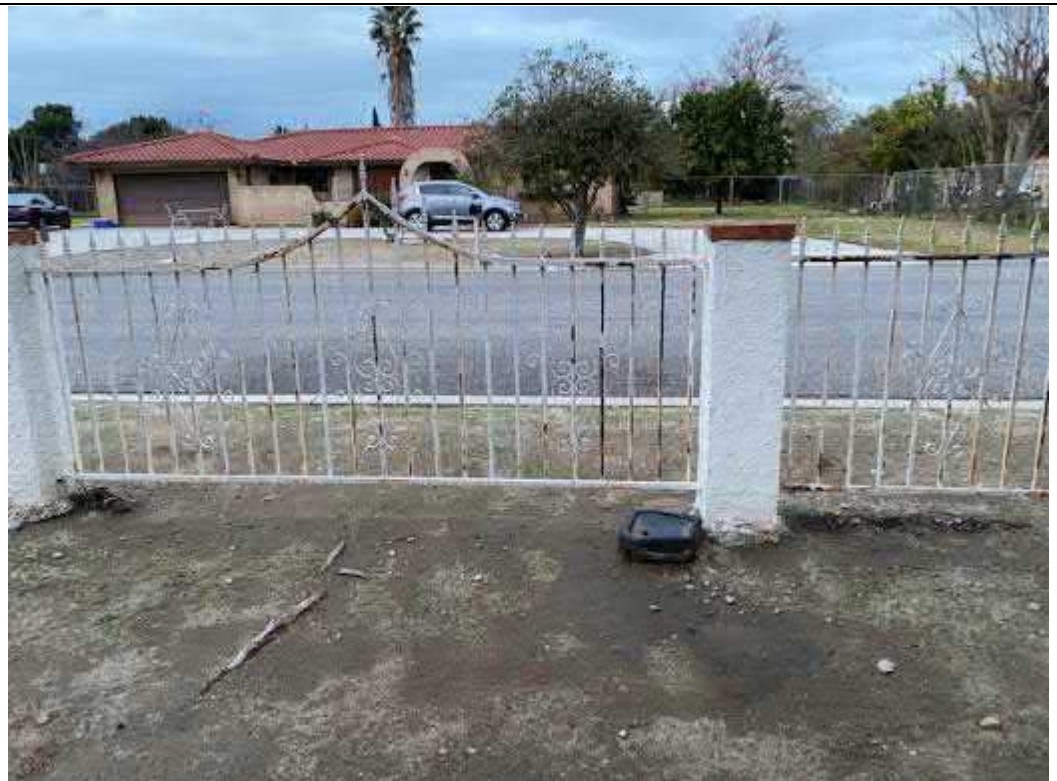
**Photo No.**  
**14**

View of a one-gallon oil container and de minimis oily staining (approximately 2 feet by 2 feet) on the bare ground surface located along the northern boundary of Site No. 15.

- A one-gallon oil container and de minimis oily-type staining (approximately 2 feet by 2 feet) on bare ground surface were observed along the northern boundary of Site No. 15 (18143 Rose Ave).

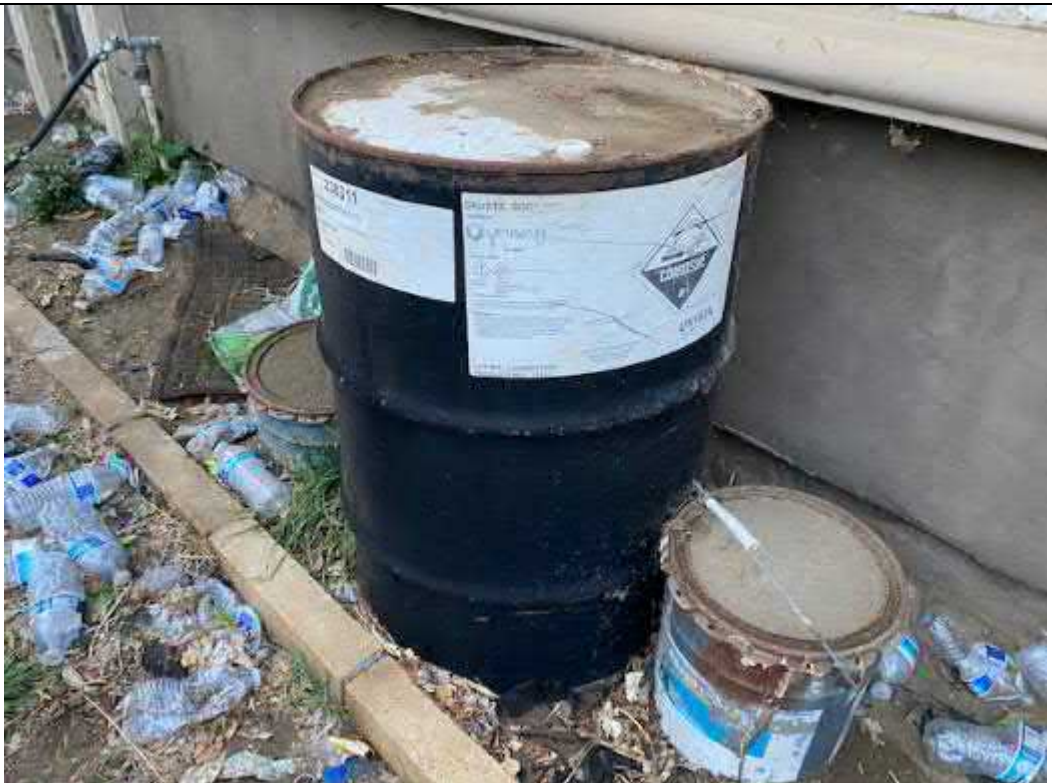
**Photo No.**  
**16**

View of a 55-gallon drum of caustic soda and small-quantity (5 gallons or less) containers of paint stored on bare ground surface behind the residence at Site No. 16.

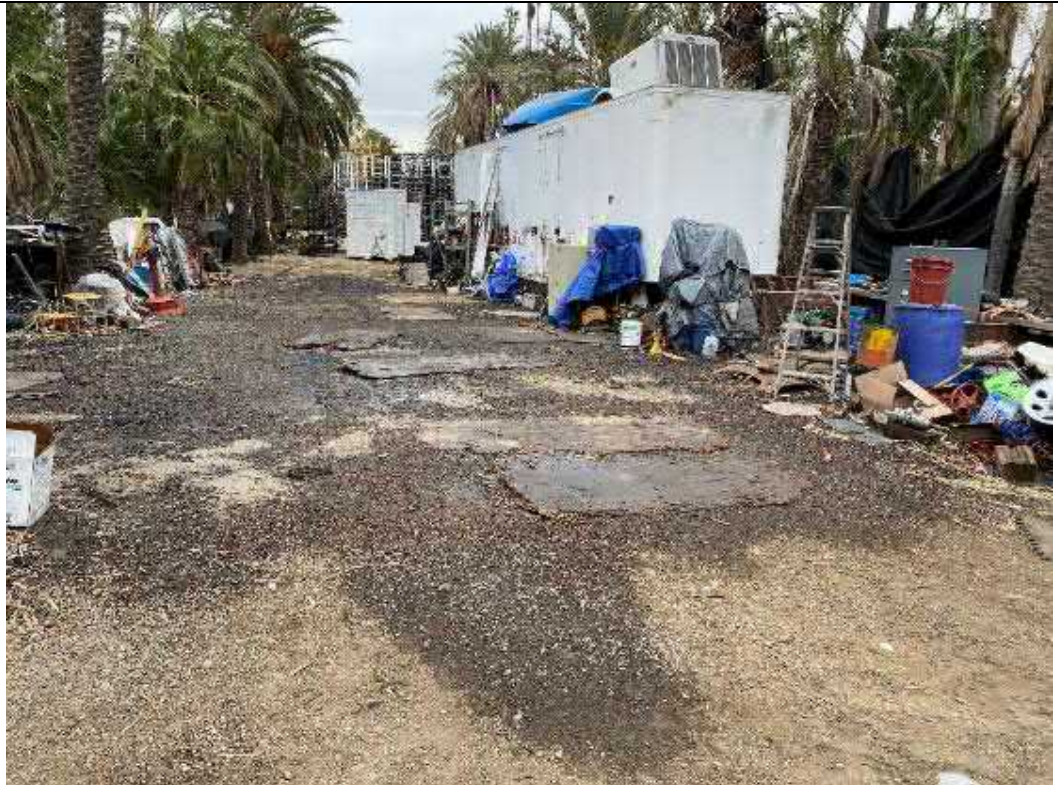
<b>Photo No.</b> <b>19</b>	<b>Date:</b> 3/3/21
<b>Direction Photo Taken:</b>  East	
<b>Description:</b>  View of the equipment/vehicle repair area (on bare ground) in the central portion of Site No. 18. The ground surface in the equipment/vehicle repair area appeared to have been covered with crushed asphalt and several pieces of oily-stained plywood were observed on the ground surface.

- Site No. 18: Palm tree farm/agricultural land has occupied the central portion of the subject property since at least the 1930s. An equipment/vehicle (i.e., field trucks, bucket/grapple saw trucks, tractors, trenchers, harvesters, forklifts, etc.) repair area (on bare ground) was observed in the central portion of the palm tree farm. The ground surface in the equipment/vehicle repair area appeared to have been covered with crushed asphalt and several pieces of oily-stained plywood were staged on the ground throughout, which restricted observations of the underlying bare ground surface. Miscellaneous equipment, solid wastes, buckets/containers of petroleum products, and other items were observed scattered throughout this area. A 1,600-gallon heavily rusted single-walled waste oil AST mounted to a trailer and a large debris pile were also observed in the north-central portion of the palm tree farm. The AST had visible spillage along the sides of the tank from the fill port and a strong oily odor was noted in the vicinity of the AST. The large debris pile contained numerous abandoned and empty 55-gallon plastic/metal drums, polyethylene (poly) totes, and 5-gallon buckets which previously contained motor oil as well as drip pans and used oil filters. In addition, a television set, wood pallets, plant debris, and miscellaneous other solid wastes were also observed in the debris pile. Several used oil filters were observed on the bare ground surface in the vicinity of the AST and debris pile.

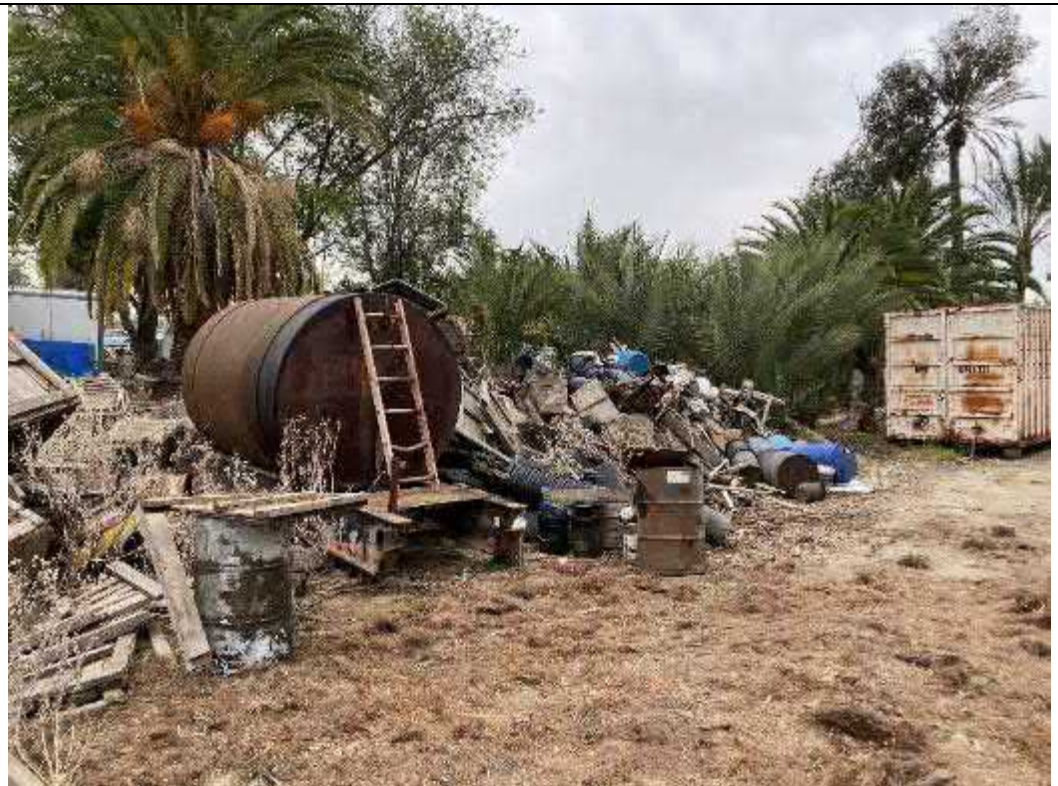
<b>Photo No.</b> <b>20</b>	<b>Date:</b> 3/3/21
<b>Direction Photo Taken:</b>  Northeast	
<b>Description:</b>  View of a waste oil AST and debris pile containing 55-gallon plastic/metal drums that previously contained motor oil, 5-gallon containers that previously contained motor oil, used oil filters, and miscellaneous solid waste in the north-central portion of Site No. 18 observed at the time of the initial site visit.

The areas of the identified REC at the palm tree were investigated during a limited Phase II subsurface investigation conducted by AECOM (prepared under a separate cover) which included the collection and analysis of shallow soil samples. During the limited subsurface investigation, impacts to shallow soils from petroleum hydrocarbons were detected in the equipment/vehicle repair area. Based on the results of the limited subsurface investigation, the area of impacted soil includes an area approximately 70 feet by 20 feet to a depth of 1.5 feet. It is AECOM's opinion that that area of impacted soil can be addressed prior to redevelopment of the subject property and during future grading activities as part of the redevelopment.

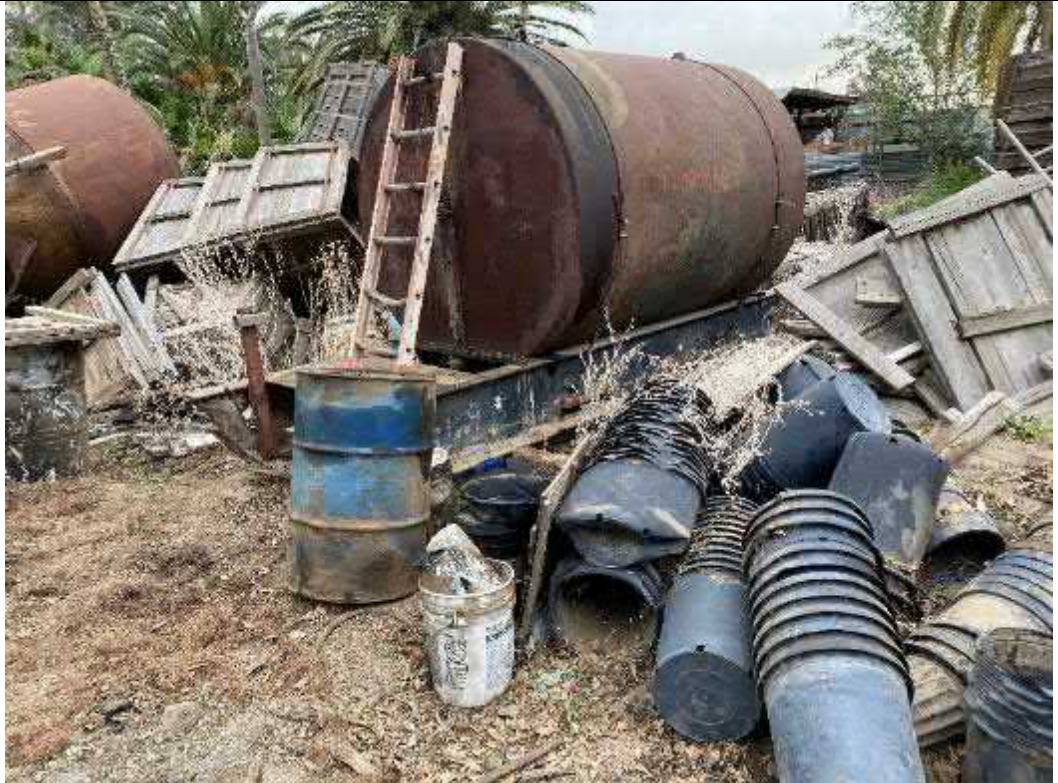
Alternative view of the waste oil AST at the time of the initial site visit. The AST was observed to be single-walled, heavily rusted, and spillage was observed on the sides of the tank from the fill port.

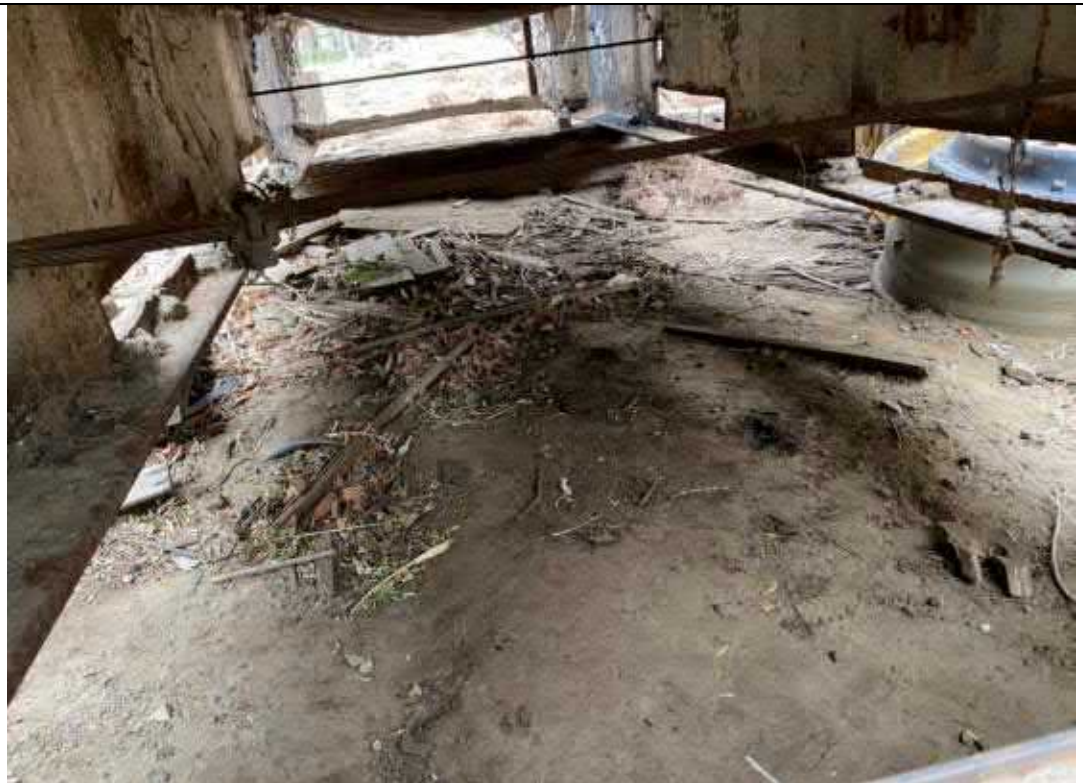
**Photo No.**  
**22**

View of bare ground surface beneath the waste oil AST with apparent de minimis oily-type staining on Site No. 18 at the time of the initial site visit.

- De minimis oily-type staining (approximately 1 foot by 1 foot) was observed on the bare ground surface beneath the AST trailer on Site No. 18 (11146 Maple Ave) at the time of the site visit, which was not readily visible at the time of the follow-up site visit. In addition, several used oil filters were observed on the bare ground surface in the vicinity of the AST. De minimis oily-staining (approximately one foot by one foot) was observed in the area of the used oil filters.

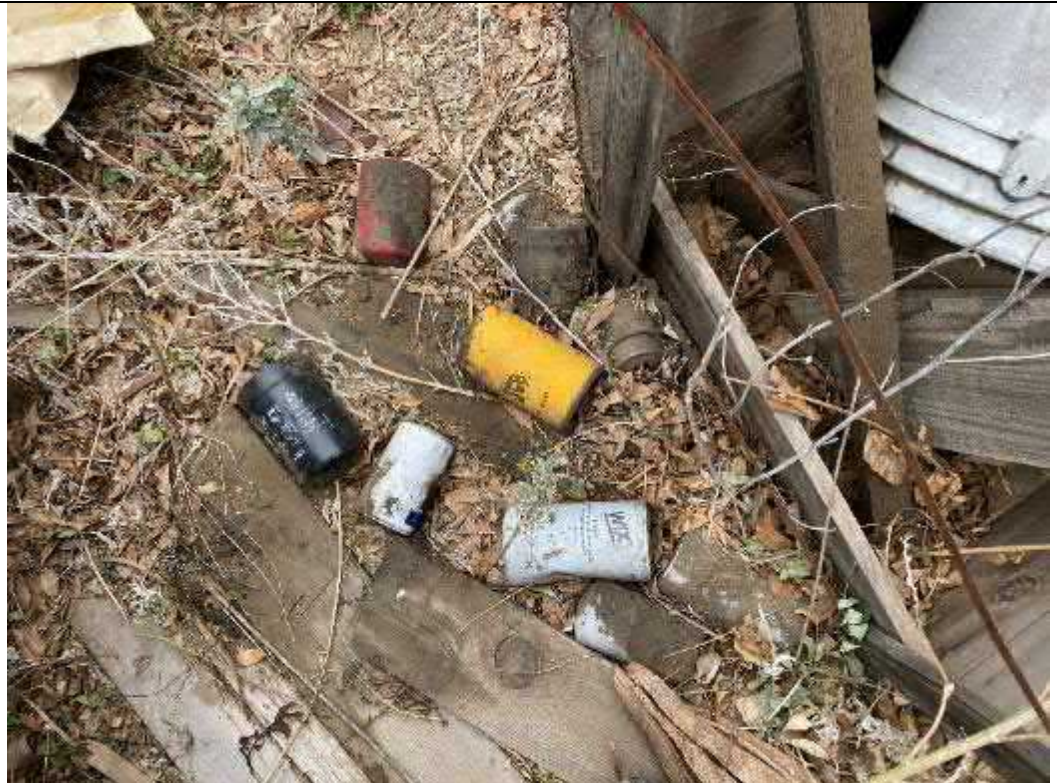
Representative view of  
used oil filters observed  
on the bare ground in the  
vicinity of the AST on Site  
No. 18 at the time of the  
initial site visit.

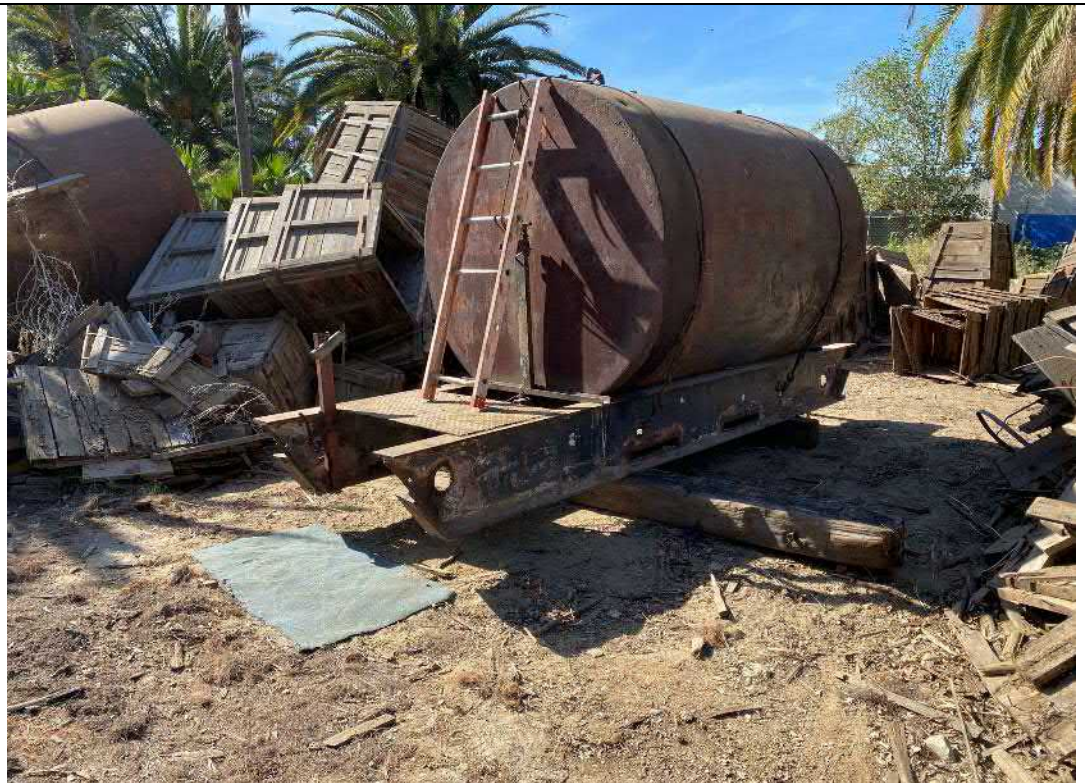
**Photo No.**  
**24**

View of the AST area at  
the time of the follow-up  
site visit.

During the follow-up site visit, it appeared that numerous oil containers had been removed from the debris pile (although some still remained in the debris pile) and placed inside an adjacent roll-off dumpster. Apparent oil spillage was visible in the roll-off dumpster. Due to the size of the debris pile, it is unknown what other (if any) unidentified wastes/materials (i.e., petroleum products, hazardous materials and/or wastes) are present. The bare ground surface beneath the debris pile was not visible. Based on poor housekeeping observed and limited observation of the bare ground surface in the area of the debris pile and the equipment/vehicle repair area, this site (palm tree farm) is considered to represent a REC to the subject property, in AECOM's opinion, and as such a potential vapor encroachment condition (VEC) at the subject property cannot be ruled out.

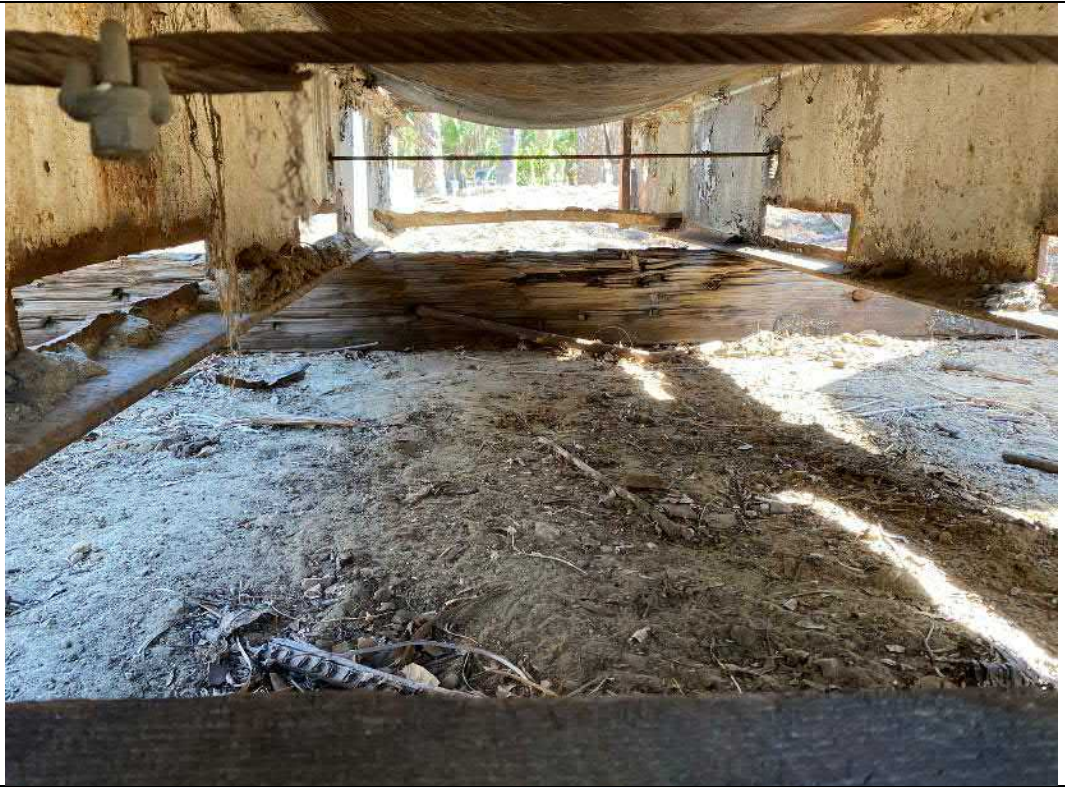
<b>Photo No.</b> <b>25</b>	<b>Date:</b> 4/29/21
<b>Direction Photo Taken:</b>  South	
<b>Description:</b>  View of the bare ground beneath the AST, on which staining was not observed during the follow-up site visit.

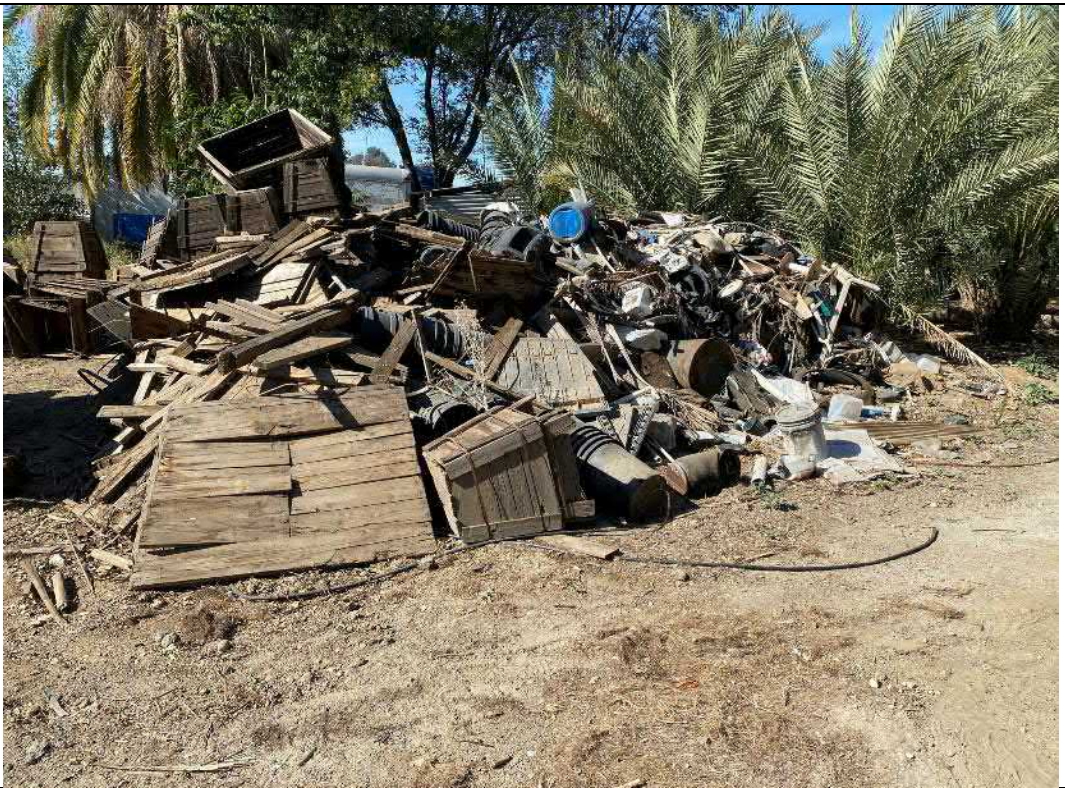
<b>Photo No.</b> <b>26</b>	<b>Date:</b> 4/29/21
<b>Direction Photo Taken:</b>  West	
<b>Description:</b>  View of the debris pile on Site No. 18 at the time of the follow-up site visit. Note: Several of the 55-gallon drums and 5-gallon oil containers had been removed from the pile; however, several remaining oil containers were observed in this area during the follow-up site visit.

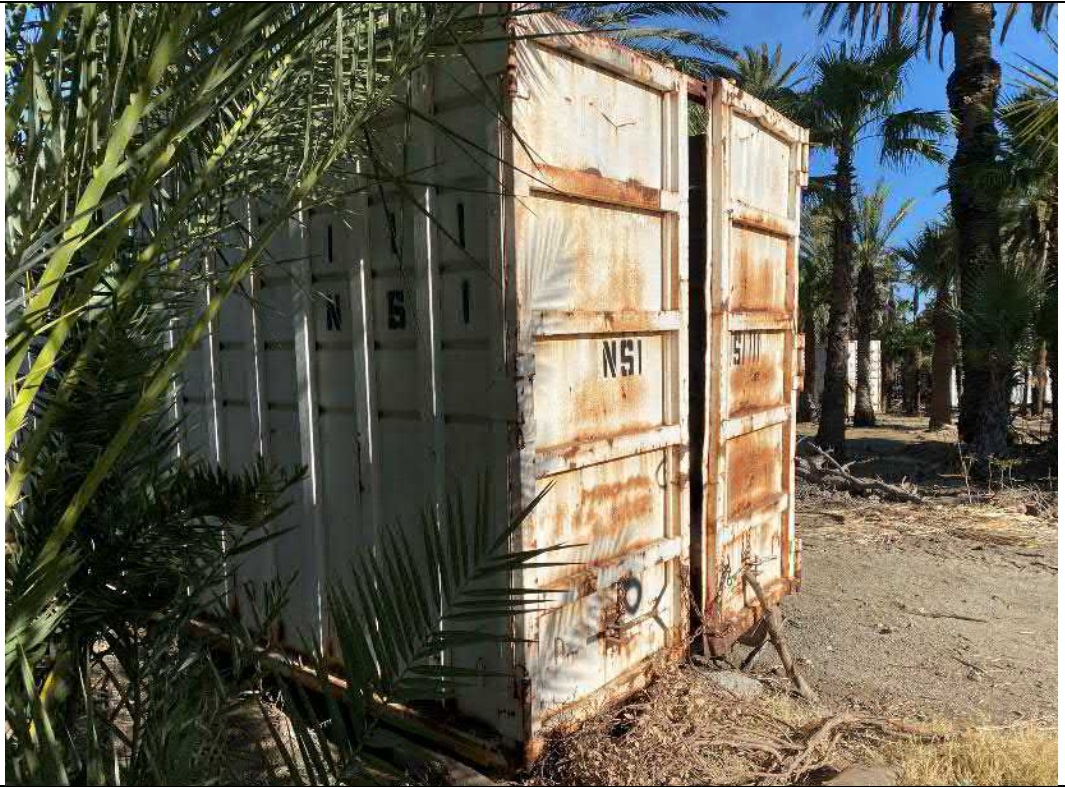
<b>Photo No.</b> <b>27</b>	<b>Date:</b> 4/29/21
<b>Direction Photo Taken:</b>  Southeast	
<b>Description:</b>  View of a roll-off dumpster observed to the east of the AST and debris pile at the time of the follow-up site visit, in which some of the oil containers that had been removed from the debris pile had been placed. Note: The side doors to the roll-off were observed to be cracked open during the follow-up site visit.

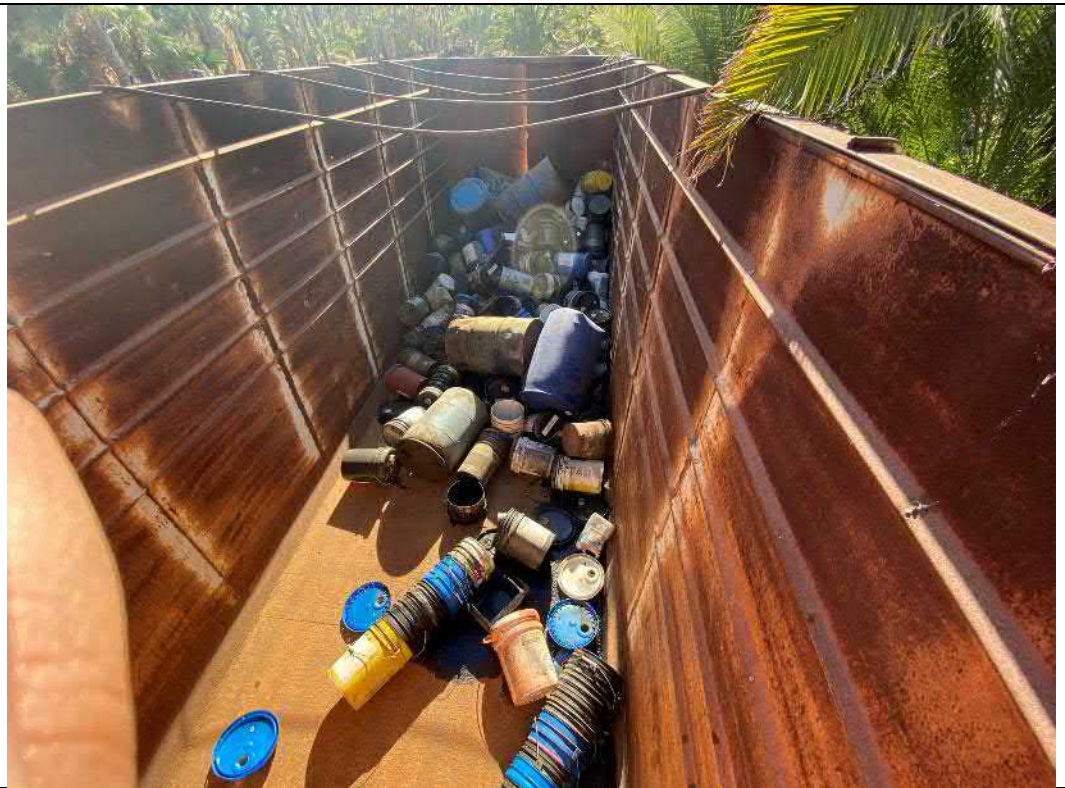
<b>Photo No.</b> <b>28</b>	<b>Date:</b> 4/29/21
<b>Direction Photo Taken:</b>  West	
<b>Description:</b>  Interior view of the roll-off dumpster to the east of the AST and debris pile, which was observed to contain various oil drums and containers that had been removed from the debris pile since the initial site visit.

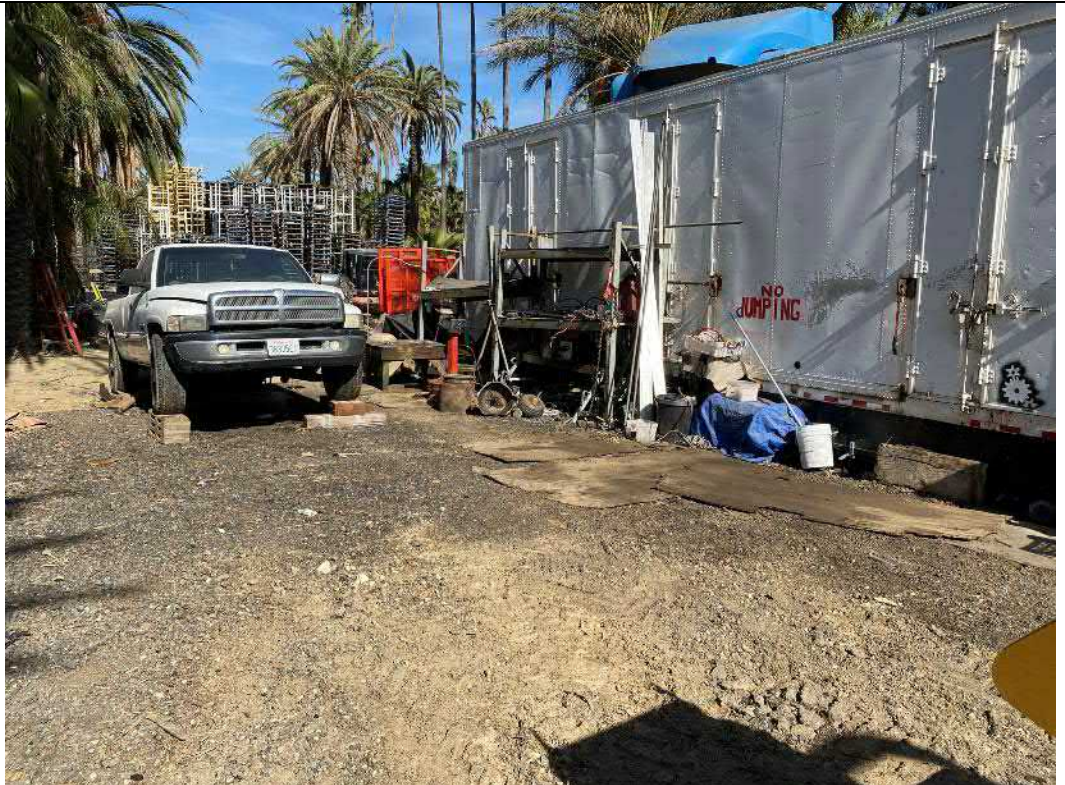
<b>Photo No.</b> <b>29</b>	<b>Date:</b> 4/29/21
<b>Direction Photo Taken:</b>  Southeast	
<b>Description:</b>  View of the equipment/vehicle repair area (on bare ground) located in the central portion of Site No. 18 during the follow-up site visit (dry weather conditions). The ground surface in the equipment/vehicle repair area appeared to be covered with crushed asphalt and several pieces of stained plywood were observed on the ground surface.

- Site No. 18: An equipment/vehicle repair area (on bare ground) was observed in the central portion of the palm tree farm and a large debris pile was also observed in the north-central portion of the palm tree farm. The ground surface in the equipment/vehicle repair area appeared to have recently been covered with a darker type soil/dirt and several pieces of plywood were staged on the ground throughout, which restricted observations of the bare ground surface. Due to the size of the debris pile, it is unknown what other (if any) unidentified wastes/materials (i.e., petroleum products, hazardous materials and/or wastes) are present. The bare ground surface beneath the debris pile was not visible. Based on poor housekeeping observed and limited observation of the bare ground surface in the area of the debris pile and the equipment/vehicle repair area, this site (palm tree farm) is considered to represent a REC to the subject property, in AECOM's opinion, and as such a potential VEC to the subject property cannot be ruled out.

The areas of the identified REC at the palm tree were investigated during a limited Phase II subsurface investigation conducted by AECOM (prepared under a separate cover) which included the collection and analysis of shallow soil samples. During the limited subsurface investigation, impacts to shallow soils from petroleum hydrocarbons were detected in the equipment/vehicle repair area. Based on the results of the limited subsurface investigation, the area of impacted soil includes an area approximately 70 feet by 20 feet to a depth of 1.5 feet. It is AECOM's opinion that that area of impacted soil can be addressed prior to redevelopment of the subject property and during future grading activities as part of the redevelopment.

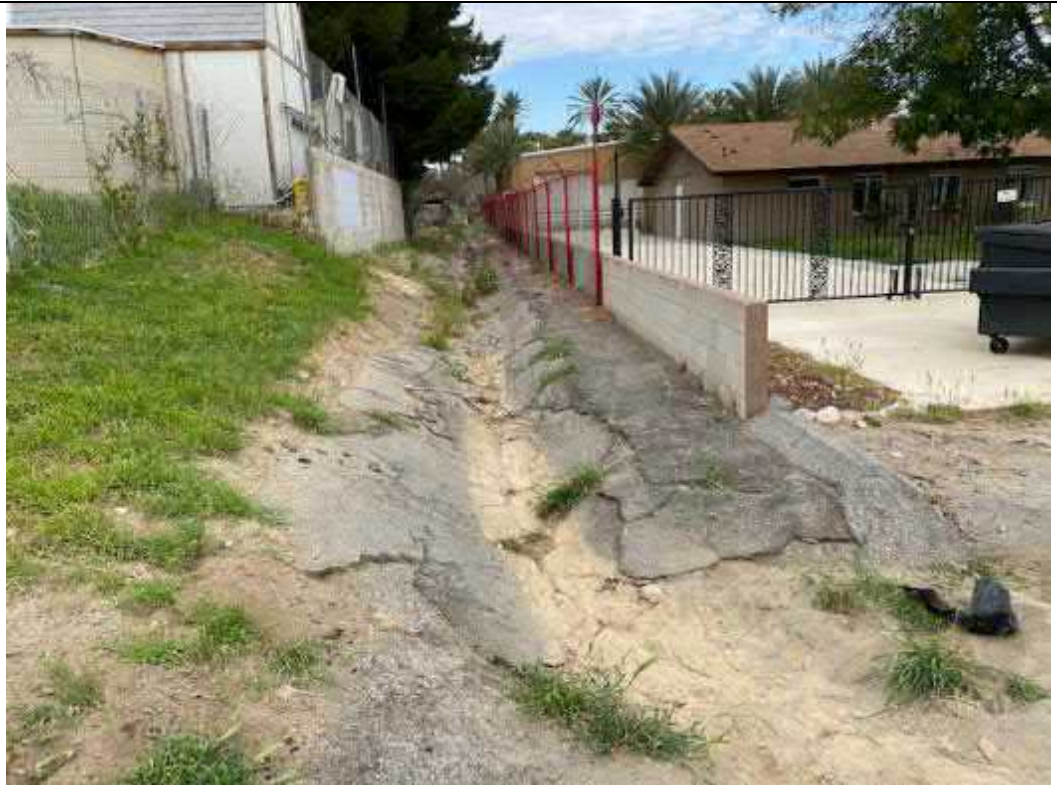
<b>Photo No.</b> <b>31</b>	<b>Date:</b> 3/3/21
<b>Direction Photo Taken:</b>  North	
<b>Description:</b>  View of an asphalt-paved stormwater drainage channel located in the southwestern portion of the subject property between the western boundary of Site No. 19 (right side of photograph) and the eastern boundaries of Site Nos. 24, 25, 41, 42, and 43. The drainage channel appears to direct stormwater towards Jurupa Avenue.

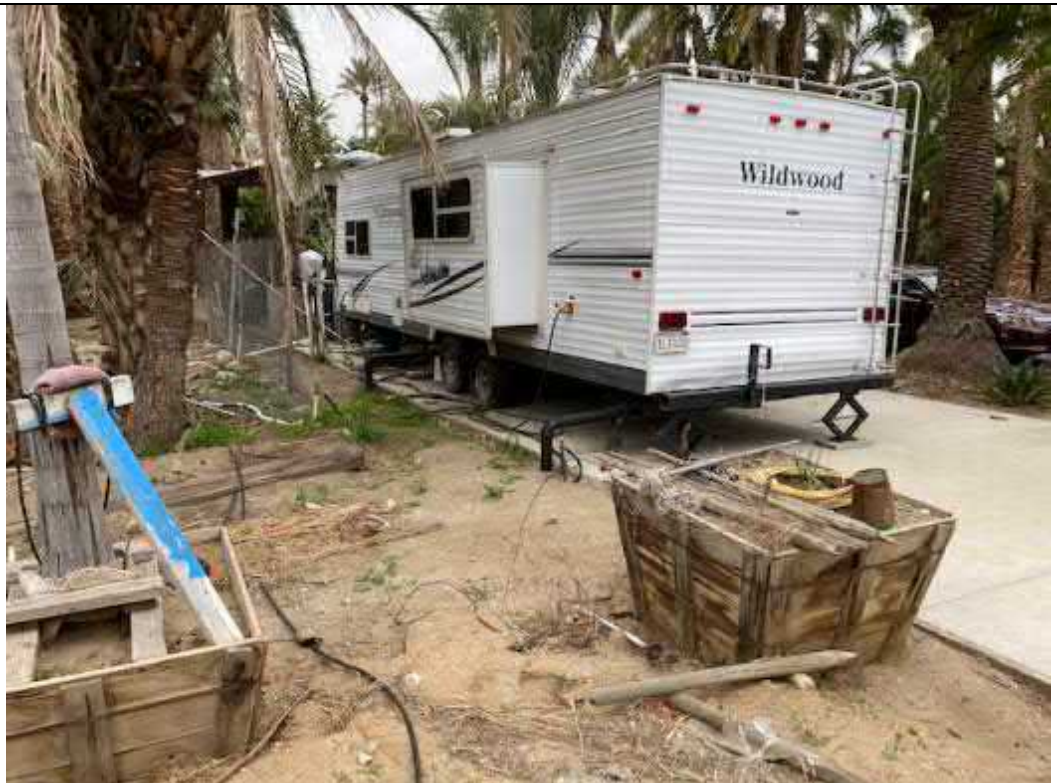
<b>Photo No.</b> <b>32</b>	<b>Date:</b> 3/3/21
<b>Direction Photo Taken:</b>  Northwest	
<b>Description:</b>  View of Site No. 20 (11250 Maple Avenue) located in the southeastern portion of the subject property, which is occupied by a palm tree farm with a mobile home equipped with a low-profile septic tank in the southeastern portion of the parcel.

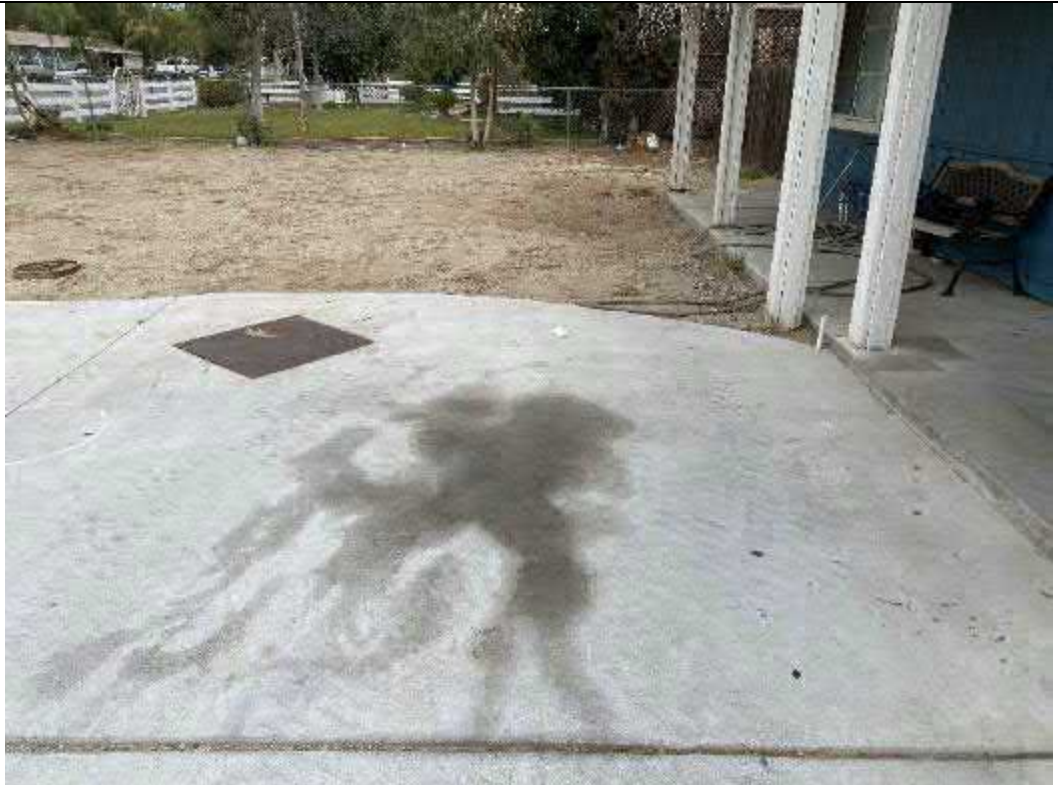
<b>Photo No.</b> <b>35</b>	<b>Date:</b> 3/3/21
<b>Direction Photo Taken:</b>  North	
<b>Description:</b>  View of de minimis oily staining (approximately 5 feet by 3 feet) observed on the intact concrete driveway at Site No. 22.

- Two areas of de minimis oily-type staining (approximately 5 feet by 3 feet each) were observed on the intact concrete driveway of Site No. 22 (11215 Locust Ave).

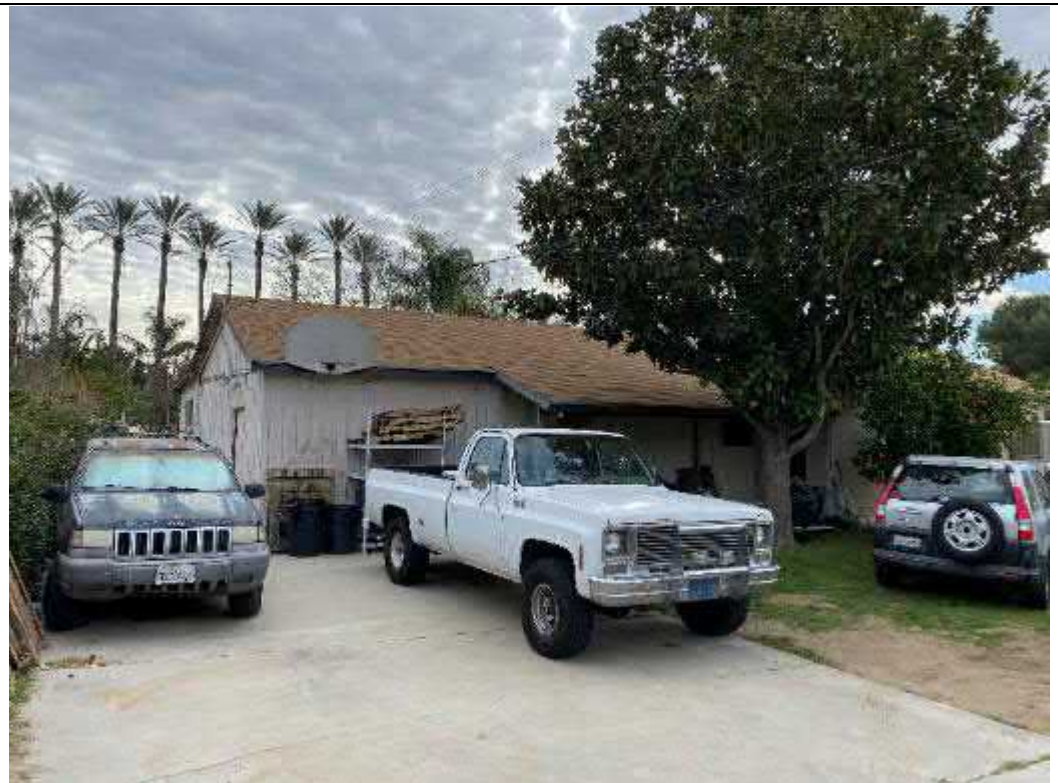
<b>Photo No.</b> <b>36</b>	<b>Date:</b> 3/3/21
<b>Direction Photo Taken:</b>  Southeast	
<b>Description:</b>  View of the residence at Site No. 23 (11227 Locust Avenue) located in the southwestern portion of the subject property.  Note: de minimis oily-type staining (approximately 2 feet by 2 feet) was observed on the concrete driveway of this parcel.

- De minimis oily-type staining (approximately 2 feet by 2 feet) was observed on the intact concrete driveway of Site No. 23 (11227 Locust Ave).
- De minimis oily-type staining (ranging from approximately 1 foot by 1 foot to 2 feet by 2 feet) was observed on the intact concrete of the outdoor repair area of Site No. 36 (18212 Jurupa Ave).

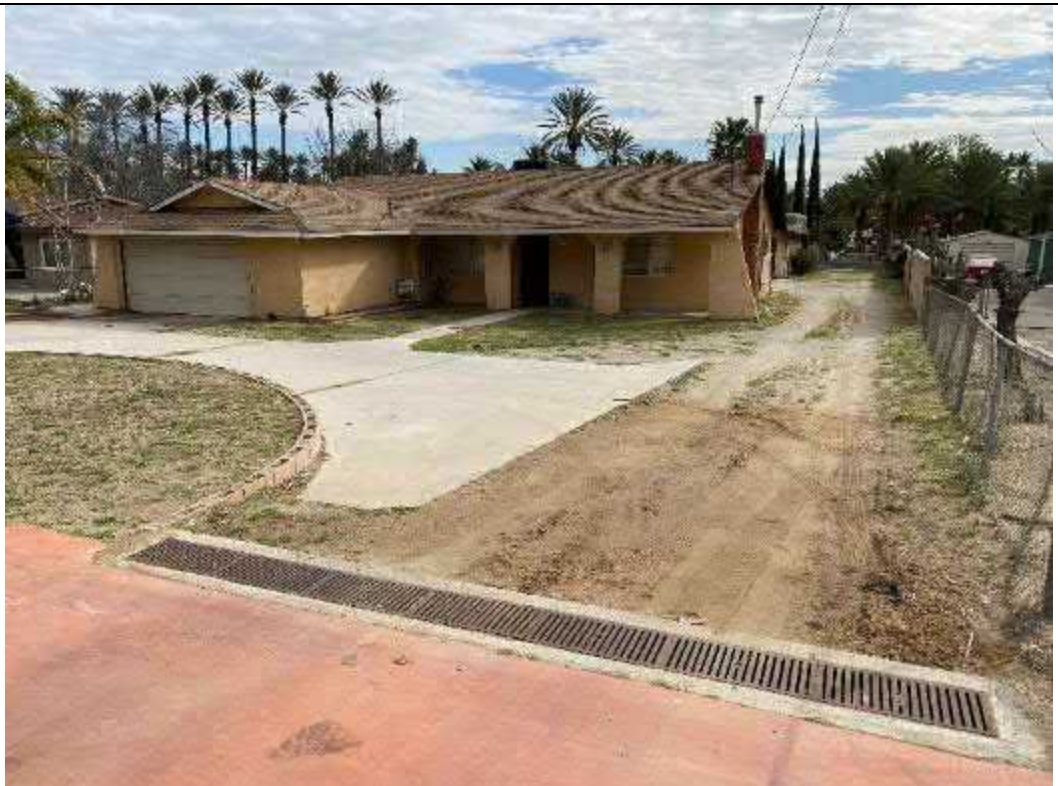
<b>Photo No.</b> <b>38</b>	<b>Date:</b> 3/3/21
<b>Direction Photo Taken:</b>  Northeast	
<b>Description:</b>  View of the residence at Site No. 25 (11255 Locust Avenue) located in the southwestern portion of the subject property.  Note: Stormwater trench drains were observed at both driveway entrances and in front of the garage door at this property.

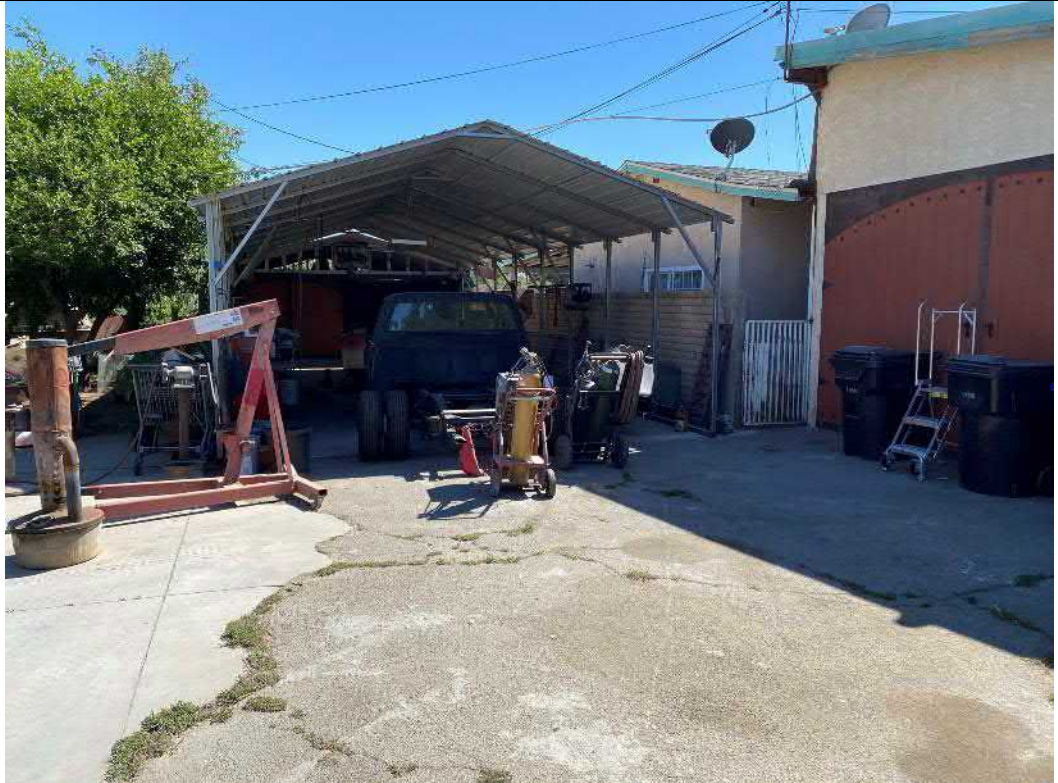
View of a personal vehicle repair area located beneath a metal canopy in between the residences in the eastern portion of Site No. 31.

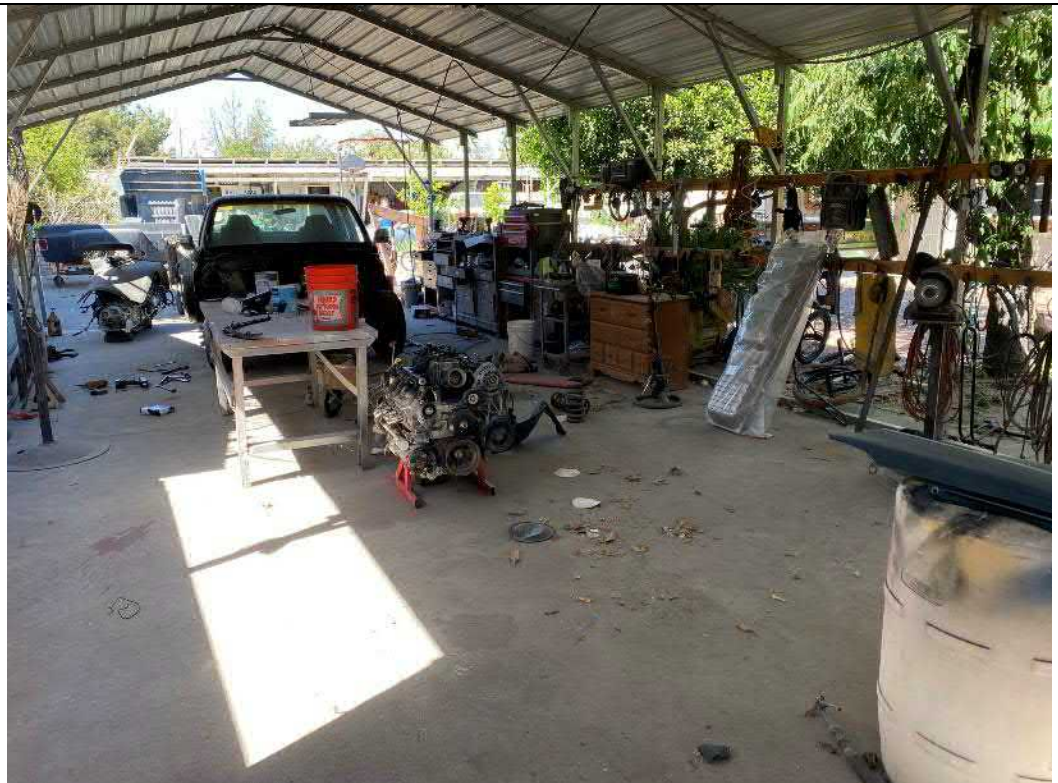
Alternative view of the vehicle repair area in the eastern portion of Site No. 31.

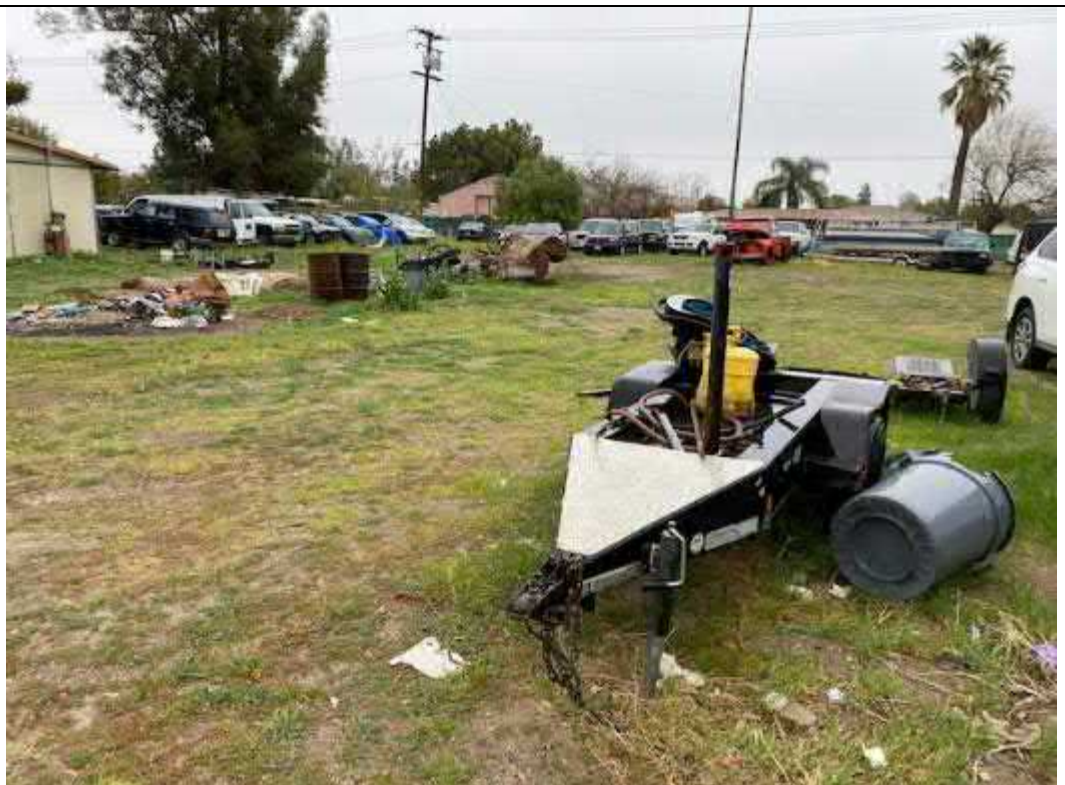
<b>Photo No.</b> <b>50</b>	<b>Date:</b> 3/3/21
<b>Direction Photo Taken:</b>  Northeast	
<b>Description:</b>  View of an automotive salvage yard located in the eastern portion of Site No. 33. Two 55-gallon drums of motor oil and hydraulic oil were also observed in this area.

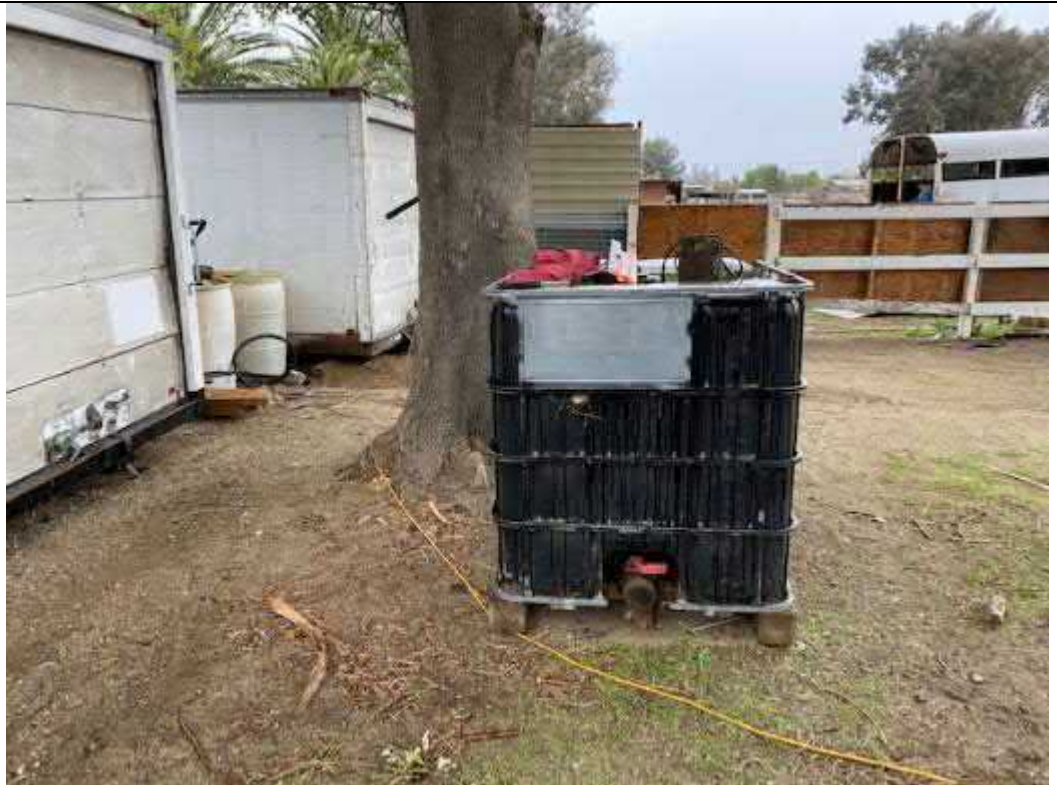
View of an unlabeled empty 330-gallon polyethylene (poly) tote and two unlabeled 55-gallon white poly drums located in the western portion of Site No. 34.

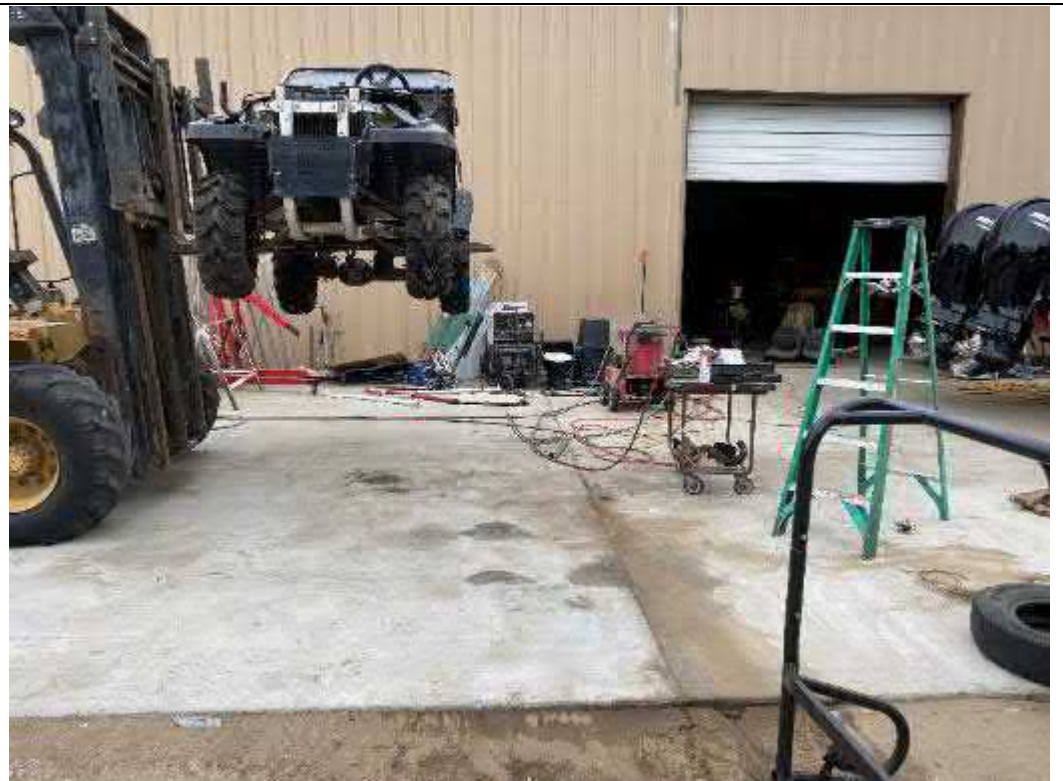
View of de minimis oily-type staining and concrete-paved outdoor repair area located at Site No. 36.

- De minimis oily-type staining (approximately 2 feet by 2 feet) was observed on the intact concrete driveway of Site No. 23 (11227 Locust Ave).
- De minimis oily-type staining (ranging from approximately 1 foot by 1 foot to 2 feet by 2 feet) was observed on the intact concrete of the outdoor repair area of Site No. 36 (18212 Jurupa Ave).
