# Phase I Environmental Site Assessment of the Bloomington Business Park - Block 2 Properties, Bloomington, San Bernardino County, California

RG Bloomington LLC  
c/o Rockefeller Group Development Corporation

Project Number: 60620647

June 2021

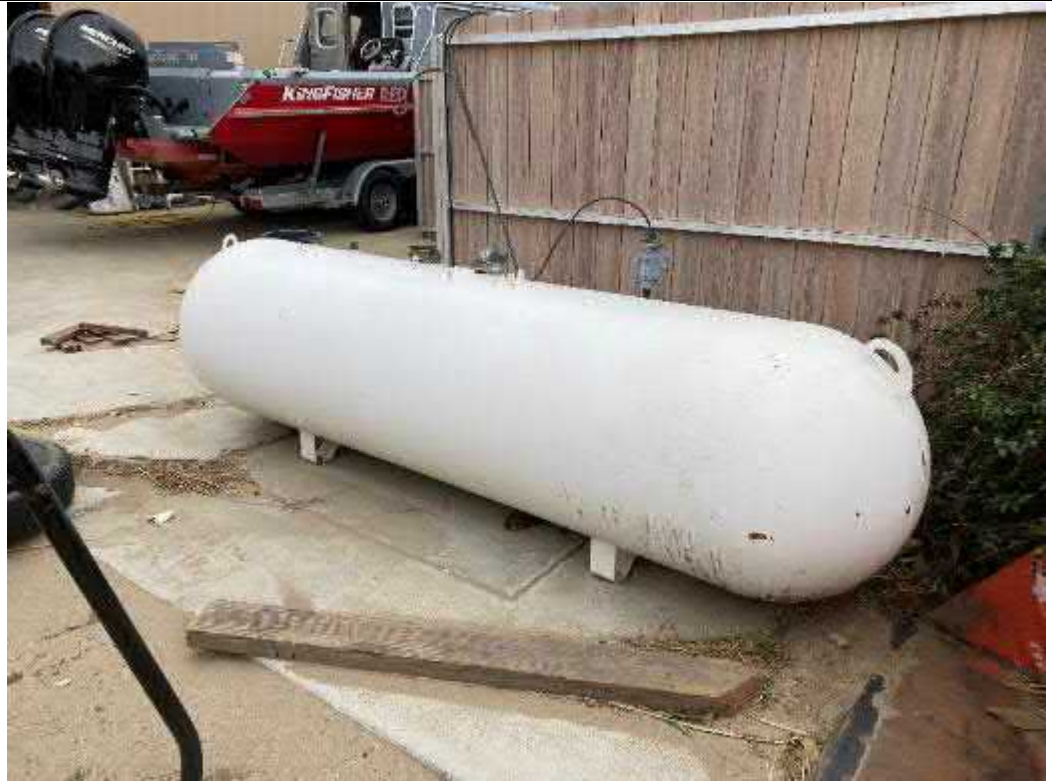
View of an approximately  
1,000-gallon propane AST  
located at Site No. 36.

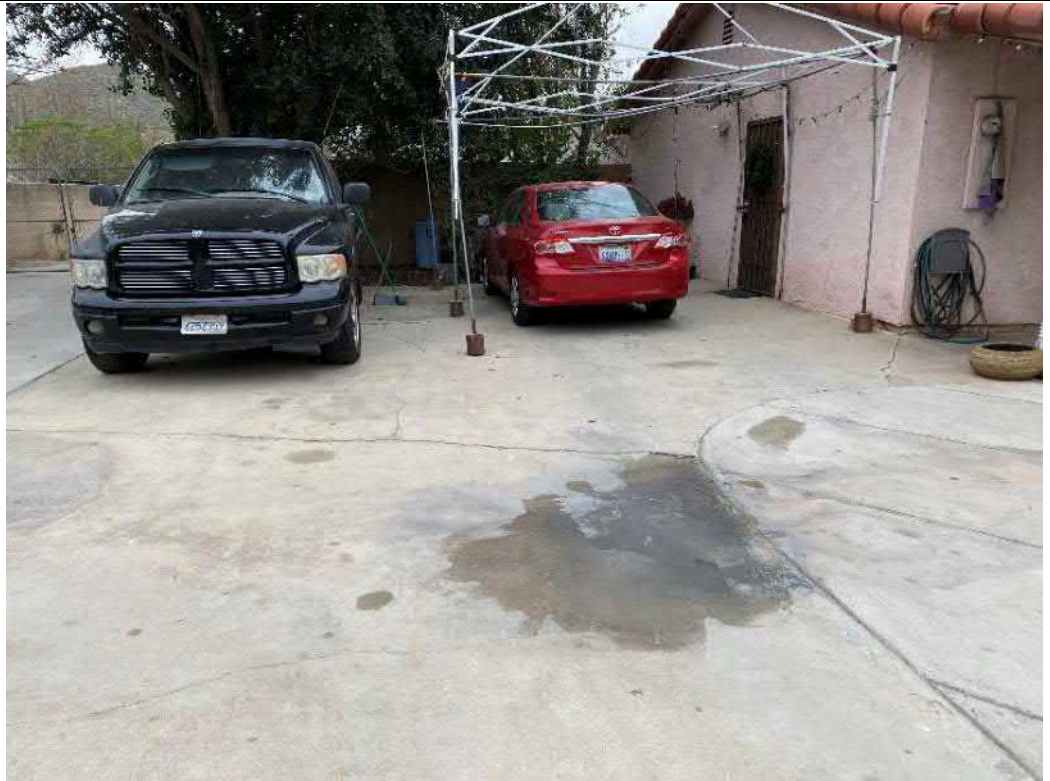
View of de minimis oily staining (approximately 3 feet by 3 feet) observed on the intact concrete driveway of Site No. 39.

- De minimis oily staining (approximately 3 feet by 3 feet) was observed on the intact concrete driveway of Site No. 39 (11266 Maple Avenue).
- De minimis oily-type staining (areas of approximately 1 foot by 1 foot) was observed on the asphalt-paved driveway along northern boundary of Site No. 41 (11279 Locust Ave).

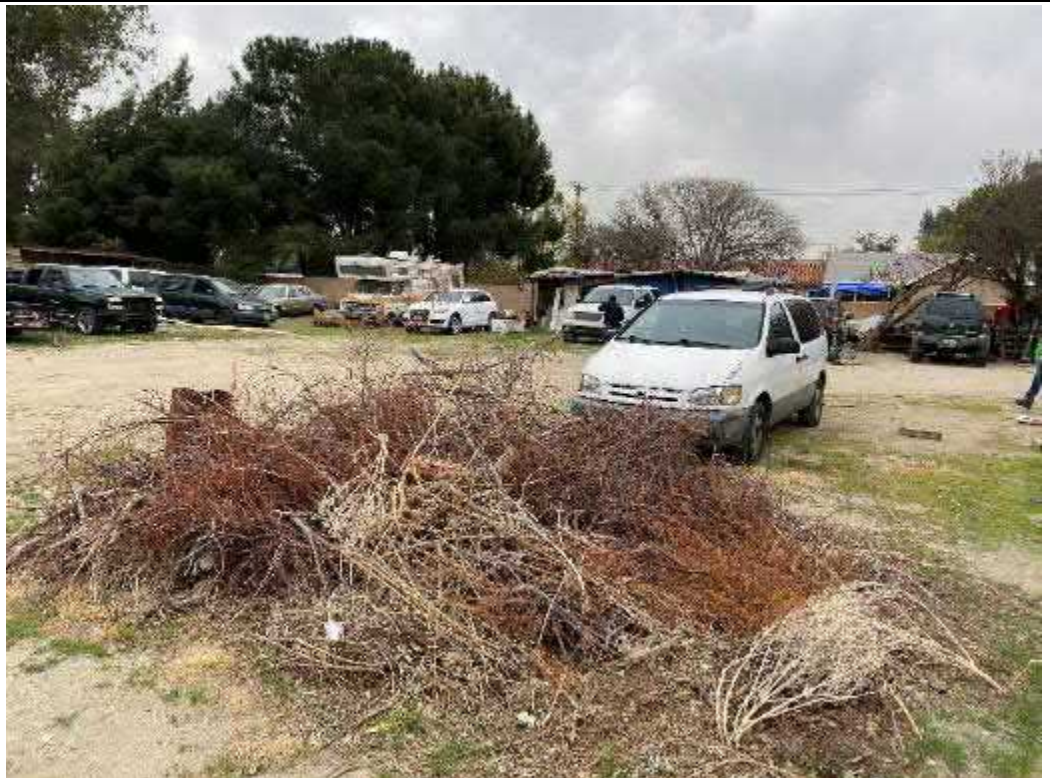
View of an automotive salvage yard located in backyard area of Site No. 39.

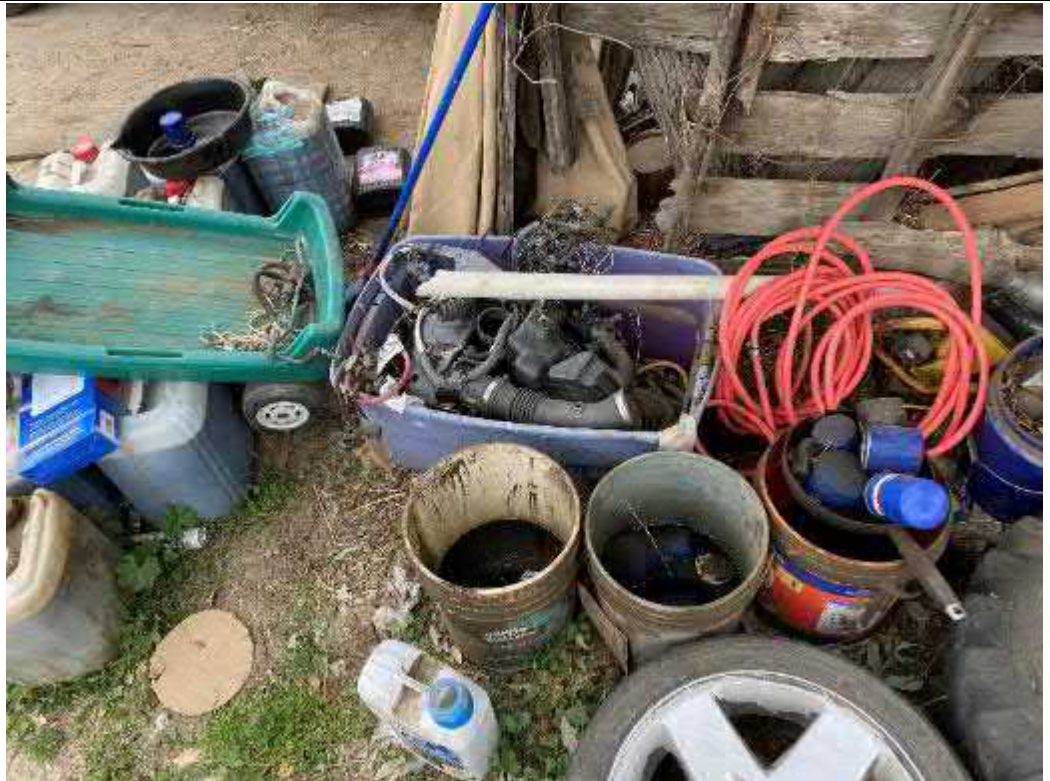
<b>Photo No.</b> <b>67</b>	<b>Date:</b> 3/3/21
<b>Direction Photo Taken:</b>  N/A	
<b>Description:</b>  View of used oil containers (several uncovered), used oil filters, and miscellaneous automotive parts observed at Site No. 39.

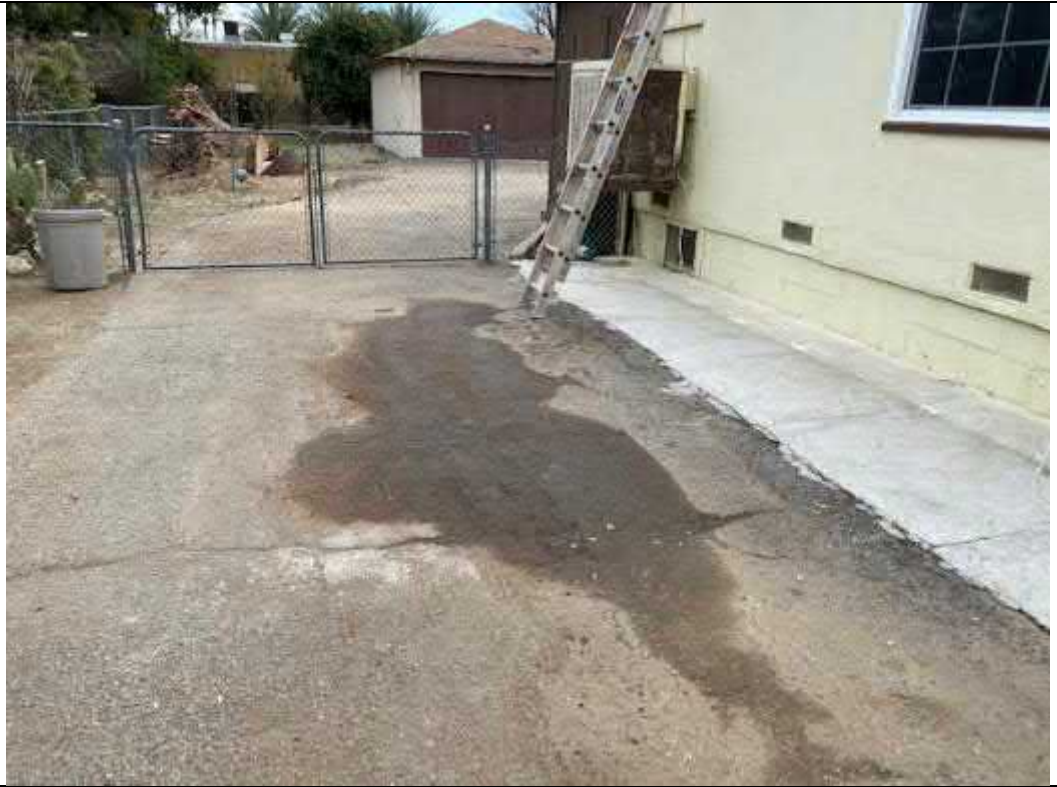
<b>Photo No.</b> <b>73</b>	<b>Date:</b> 3/3/21
<b>Direction Photo Taken:</b>  East	
<b>Description:</b>  View of de minimis oily-type staining (approximately 8 feet by 3 feet) on asphalt-paved driveway area located along the northern boundary of Site No. 42.

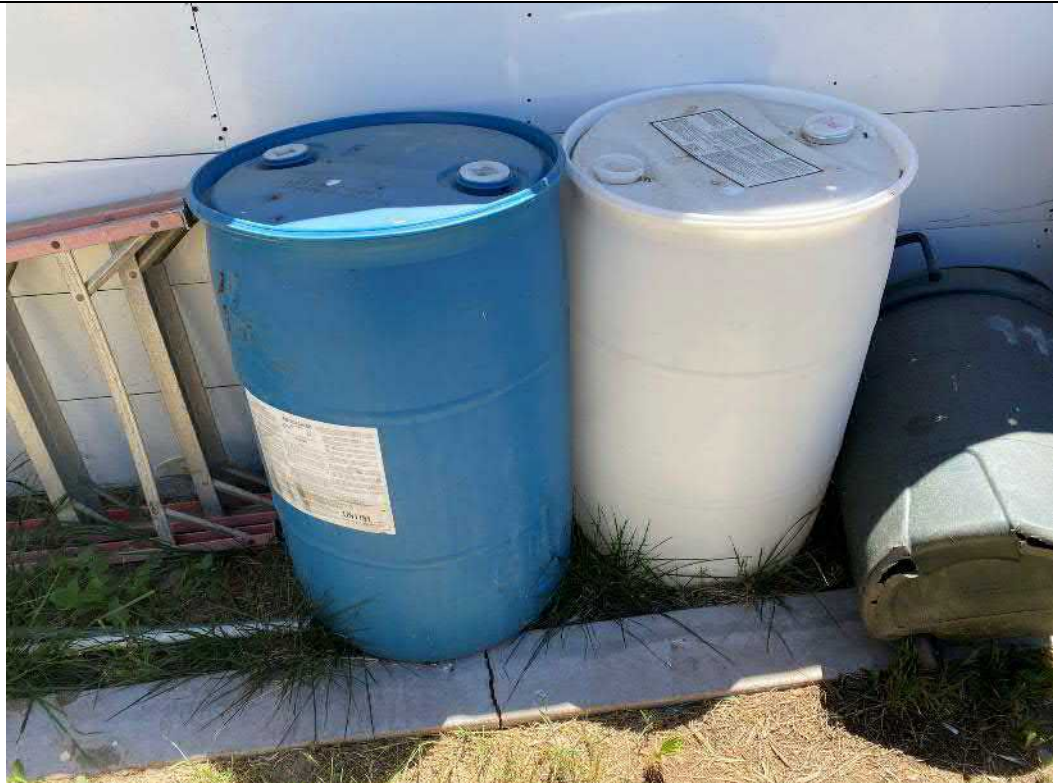
View of two 55-gallon plastic drums observed on Site No. 43 during the follow-up site visit, which were observed to be empty.

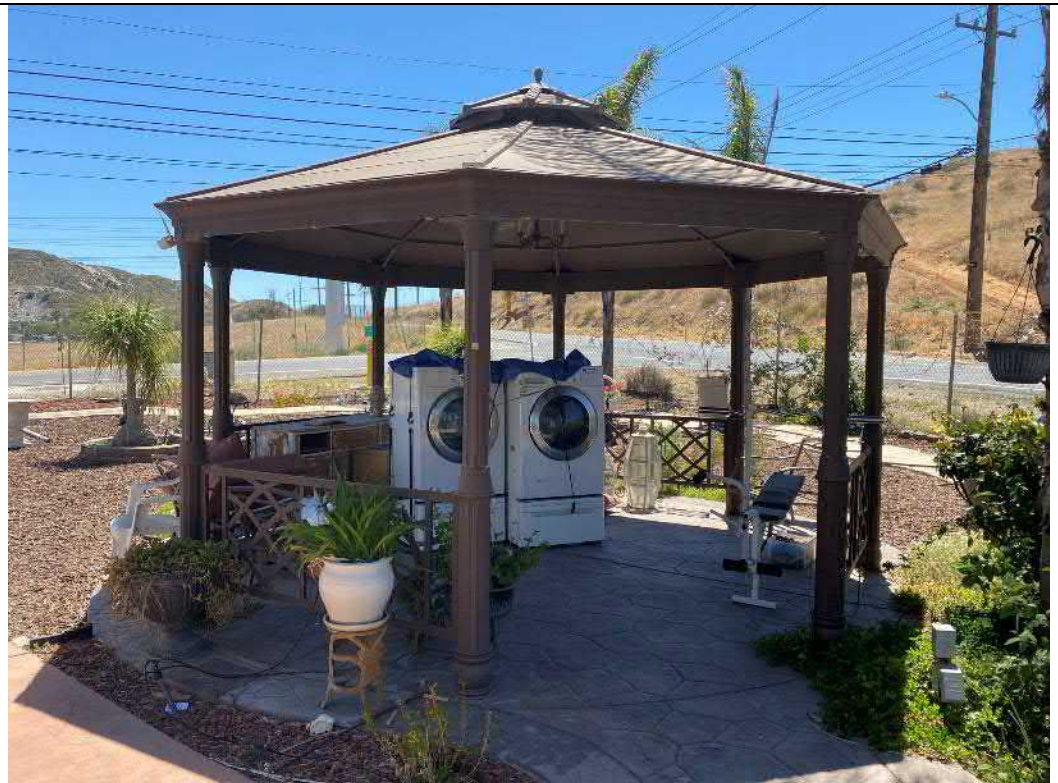
**Photo No.**  
**76**

View of an outdoor wash area observed on Site No 43 during the follow-up site visit.
