# MEMORANDUM

**PROJECT NUMBER:** 0551-5CUSH

**SUBJECT:** Cushenbury Mine South Pit Expansion Project, Located in the Community of Lucerne Valley, San Bernardino County, California: CDFW Jurisdictional Delineation Impact Analysis and Supplement to 2012 Report.

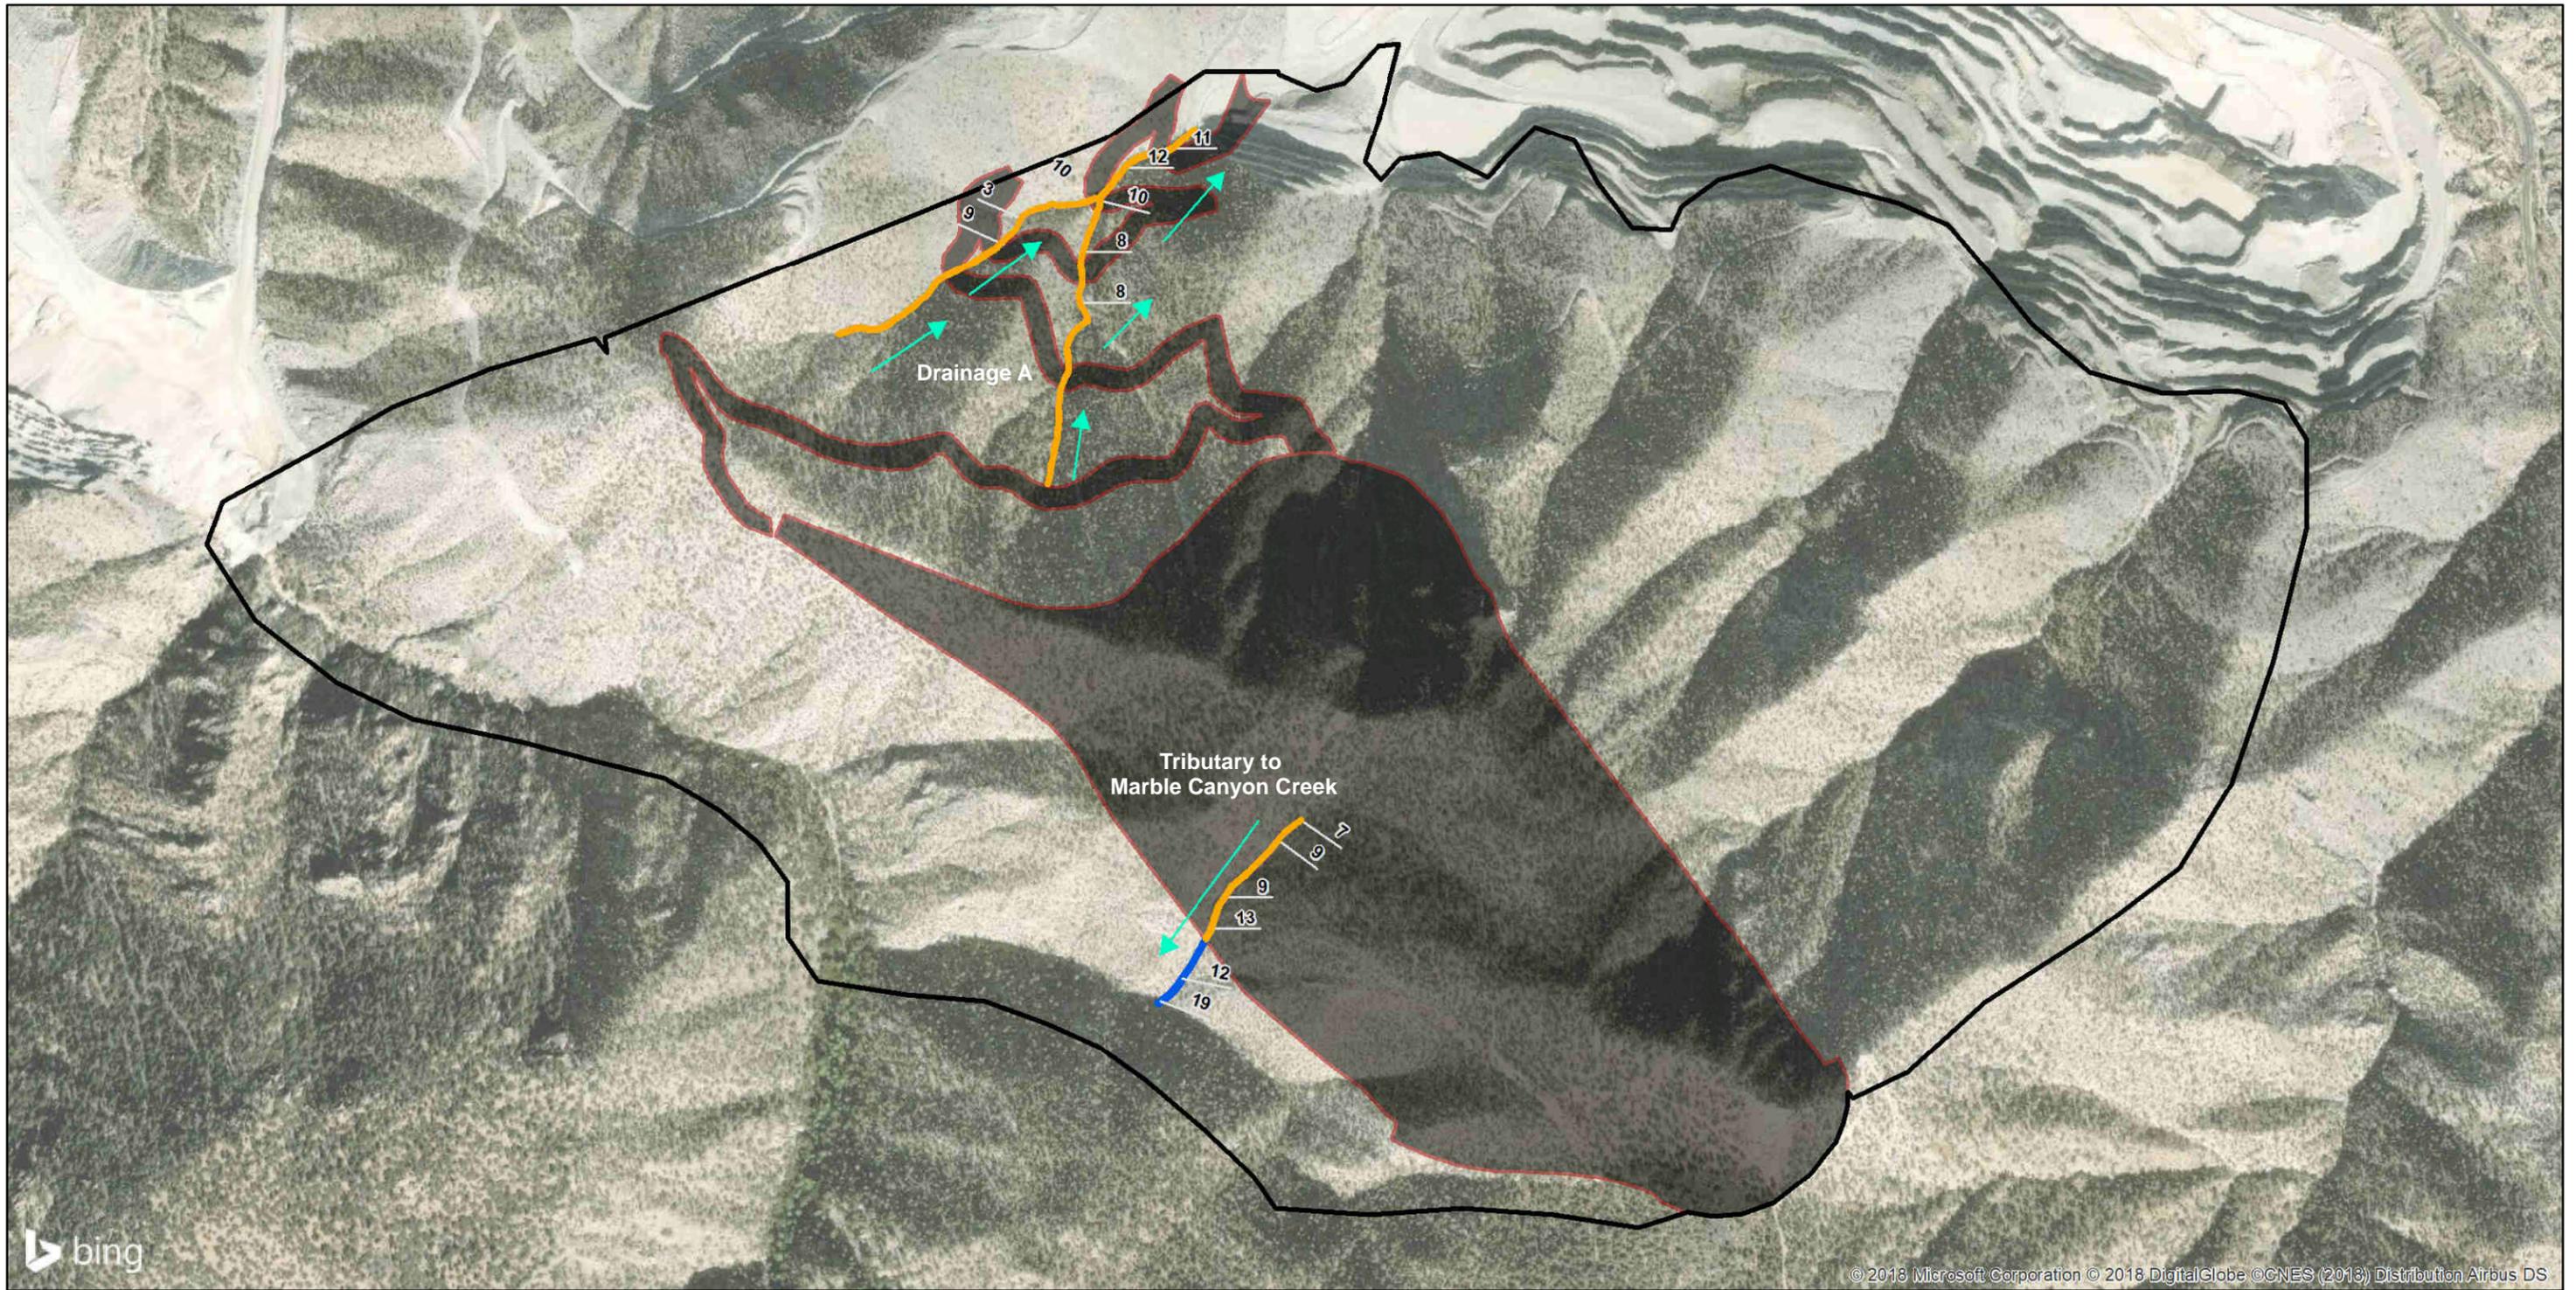
November 2018 CDFW Jurisdictional Delineation/Impact Map

CDFW jurisdiction associated with the Project totals 0.74 acre, none of which consists of vegetated riparian habitat. A total of 3,622 linear feet of streambed is present. The Project, as proposed, would permanently impact up to 0.74 acre and 3,622 linear feet of non-riparian streambed. No temporary impacts are associated with the Project.

The Project contains a total of 0.74 acre and 3,622 linear feet of non-riparian CDFW jurisdiction, all of which will be permanently impacted by Project development. No temporary impacts are associated with the Project<sup>3</sup>. Table Two below depicts impacts to CDFW jurisdiction, followed by a description of each drainage. A graphic depicting the Project's impacts to CDFW jurisdiction is provided as Exhibit 3 and site photographs are provided as Exhibits 4a and 4b.

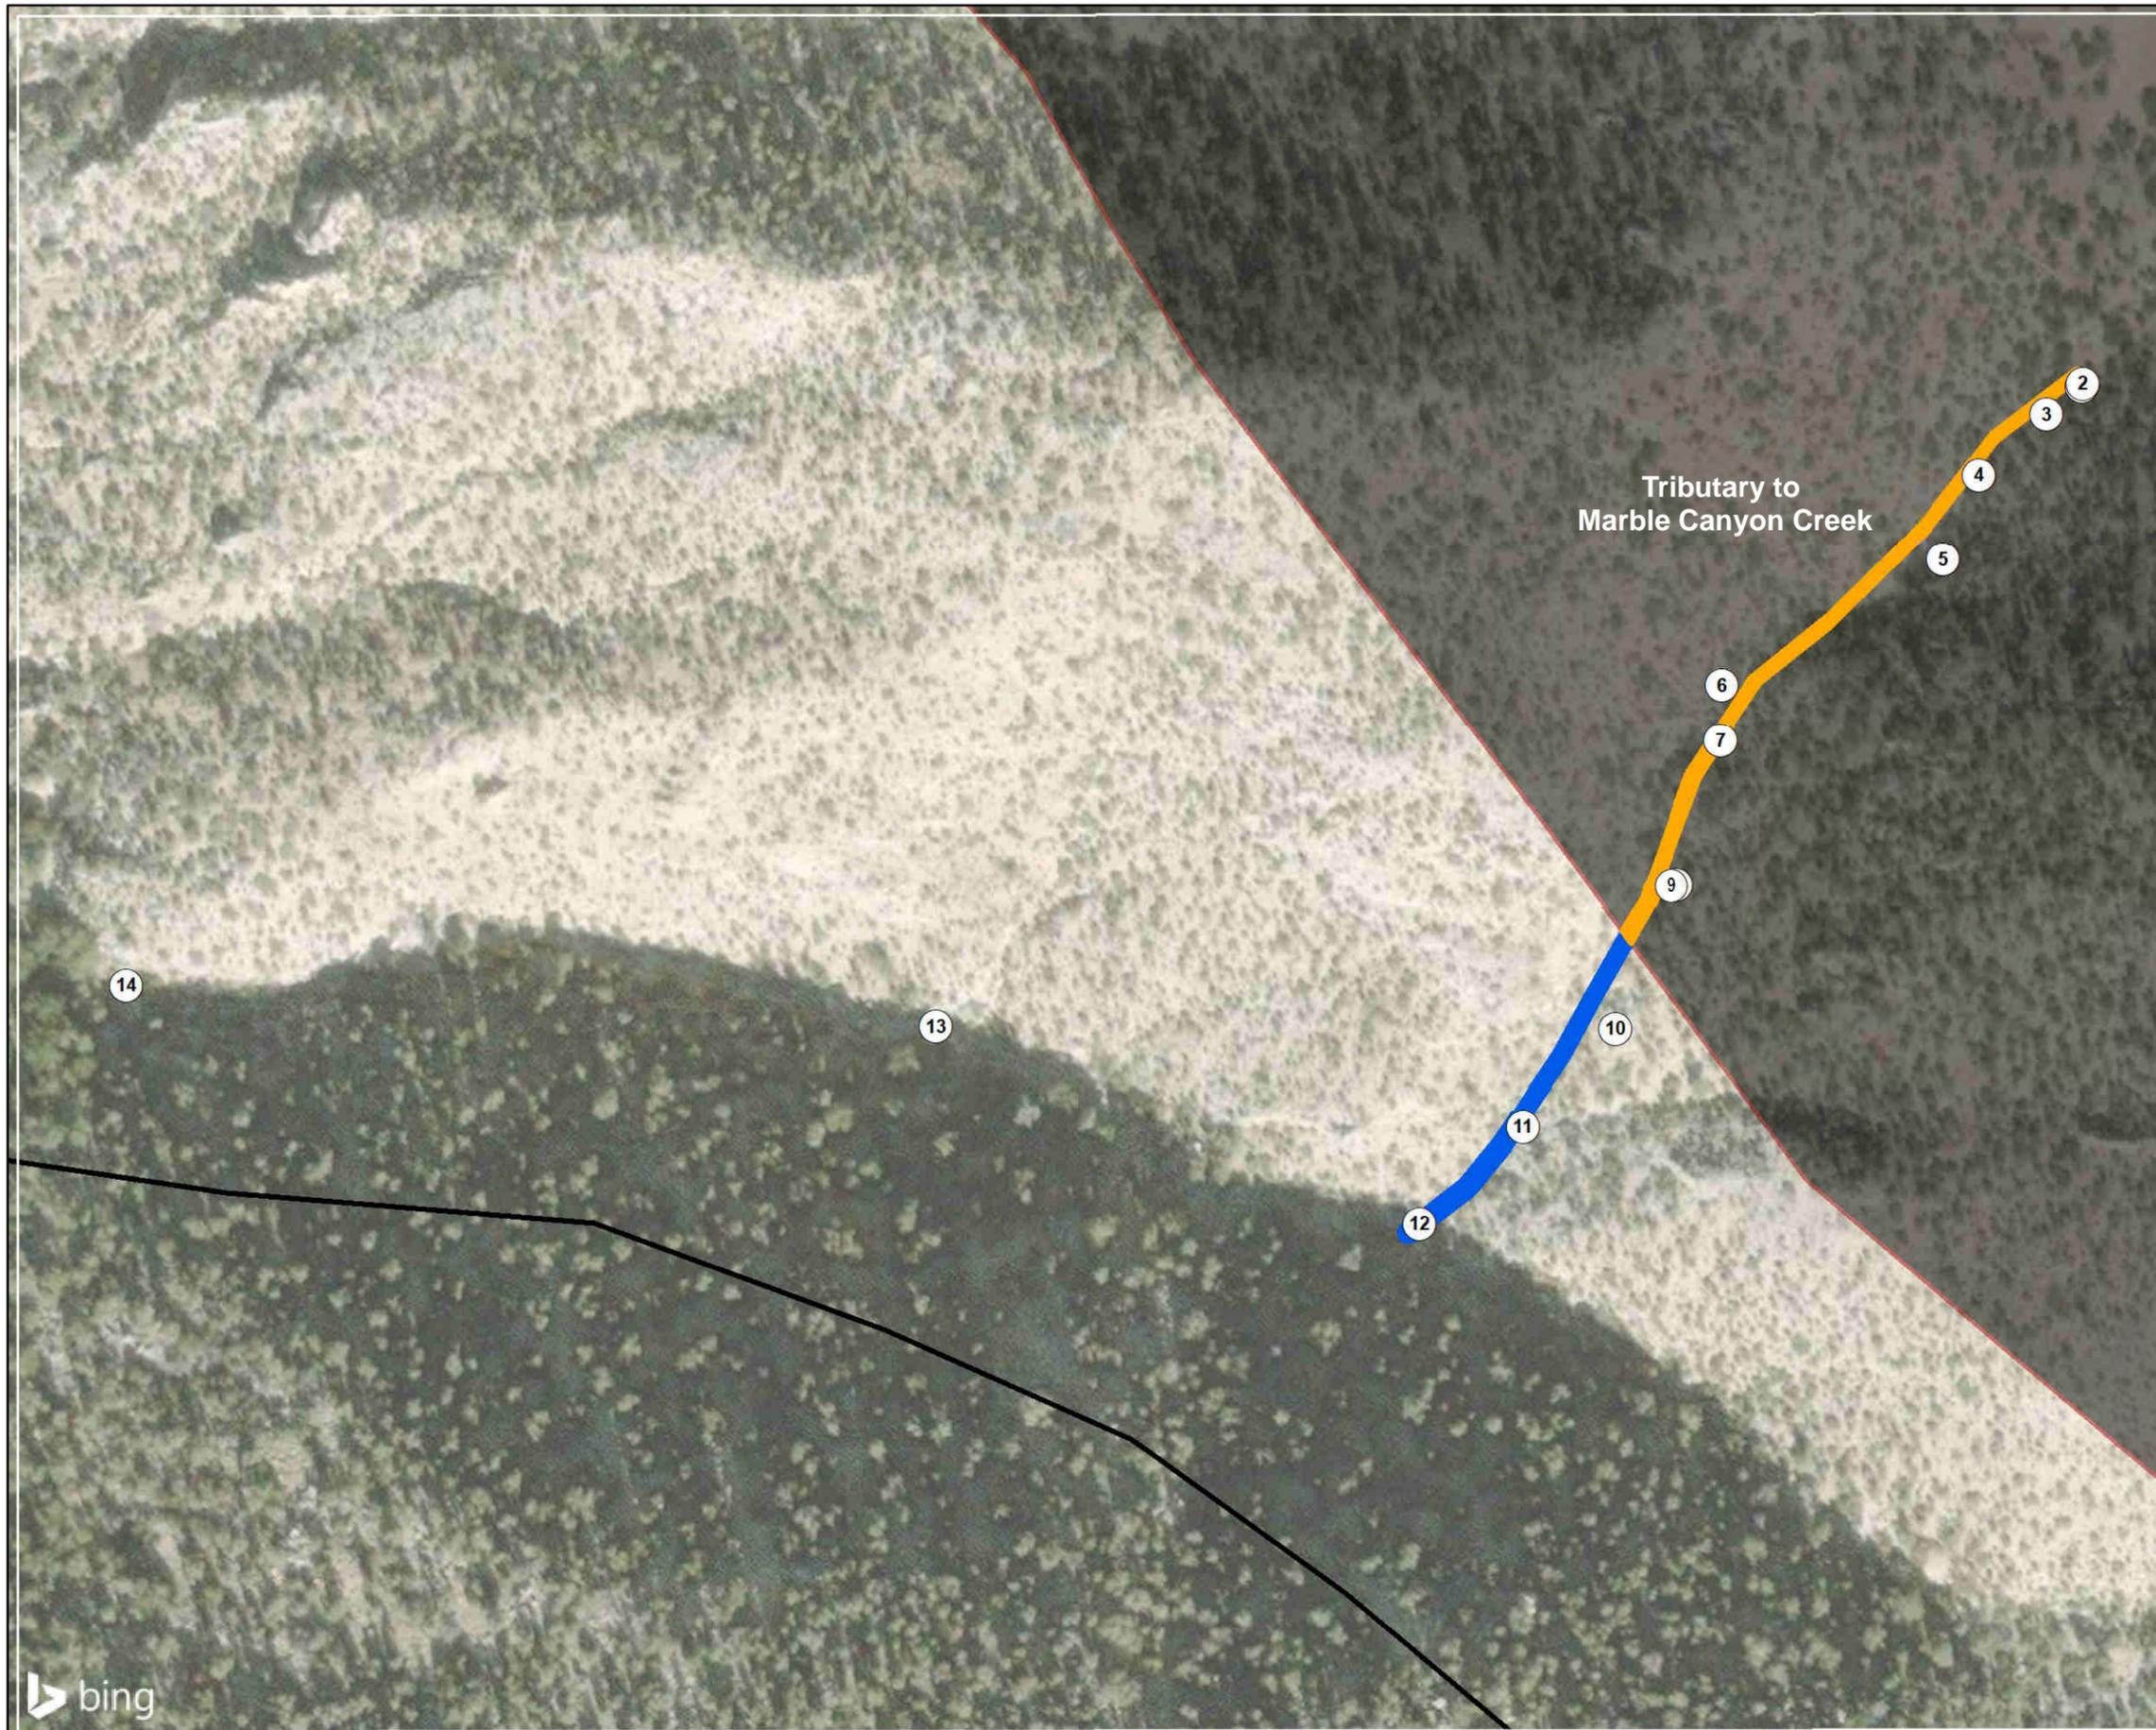
PHOTO	LATITUDE	LONGITUDE
1	34.337918	-116.858864
2	34.337926	-116.858862
3	34.337853	-116.858968
4	34.337712	-116.859164
5	34.337512	-116.859271
6	34.337219	-116.859910
7	34.337087	-116.859916
8	34.336747	-116.860049
9	34.336745	-116.860062
10	34.336407	-116.860229
11	34.336176	-116.860497
12	34.335948	-116.860799
13	34.336430	-116.862185
14	34.336550	-116.864512

**CUSHENBURY MINE  
SOUTH PIT EXPANSION PROJECT**  
Photo Location Map

Enclosed is a 650-scale map [Exhibit 3] that depicts the areas of CDFW jurisdiction. A photograph location map and site photographs documenting the topography, vegetative communities, and general widths of each of the waters are provided as Exhibits 4a and 4b, respectively.

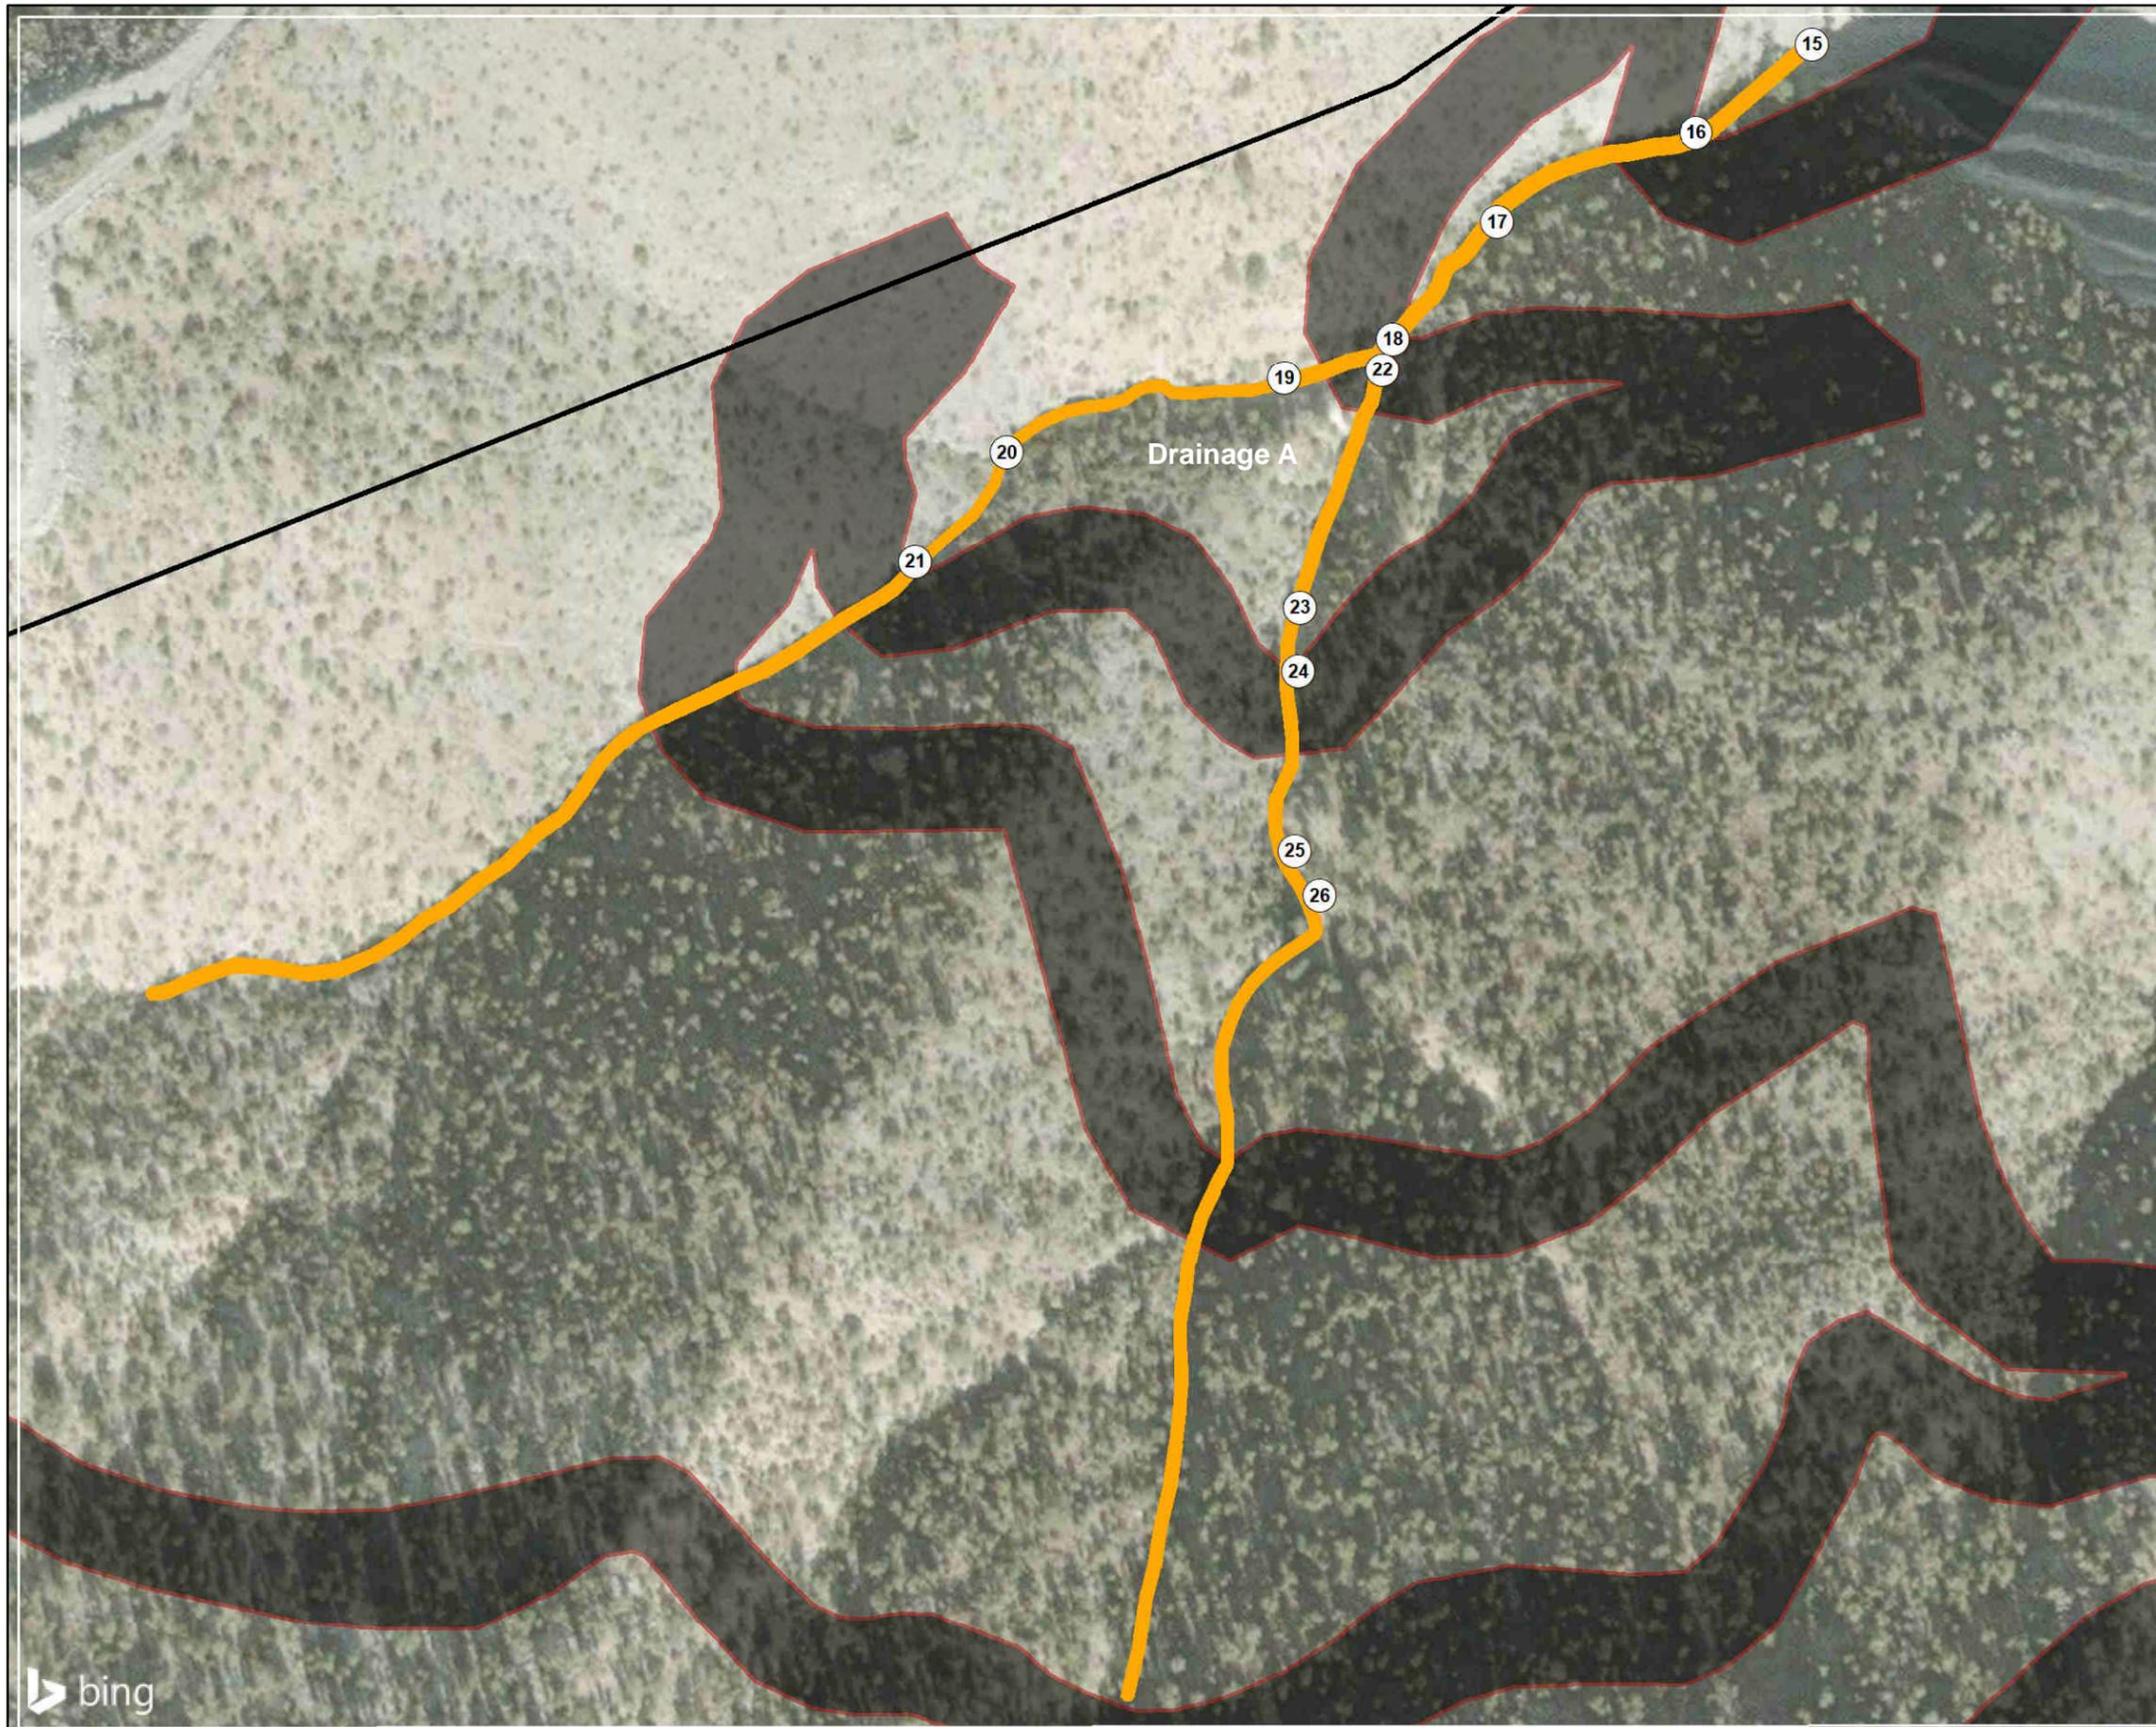
PHOTO	LATITUDE	LONGITUDE
15	34.345638	-116.860217
16	34.345431	-116.860555
17	34.345223	-116.861132
18	34.344946	-116.861436
19	34.344856	-116.861751
20	34.344686	-116.862553
21	34.344428	-116.862822
22	34.344873	-116.861467
23	34.344308	-116.861714
24	34.344157	-116.861719
25	34.343729	-116.861737
26	34.343622	-116.861665

Photo Location Map

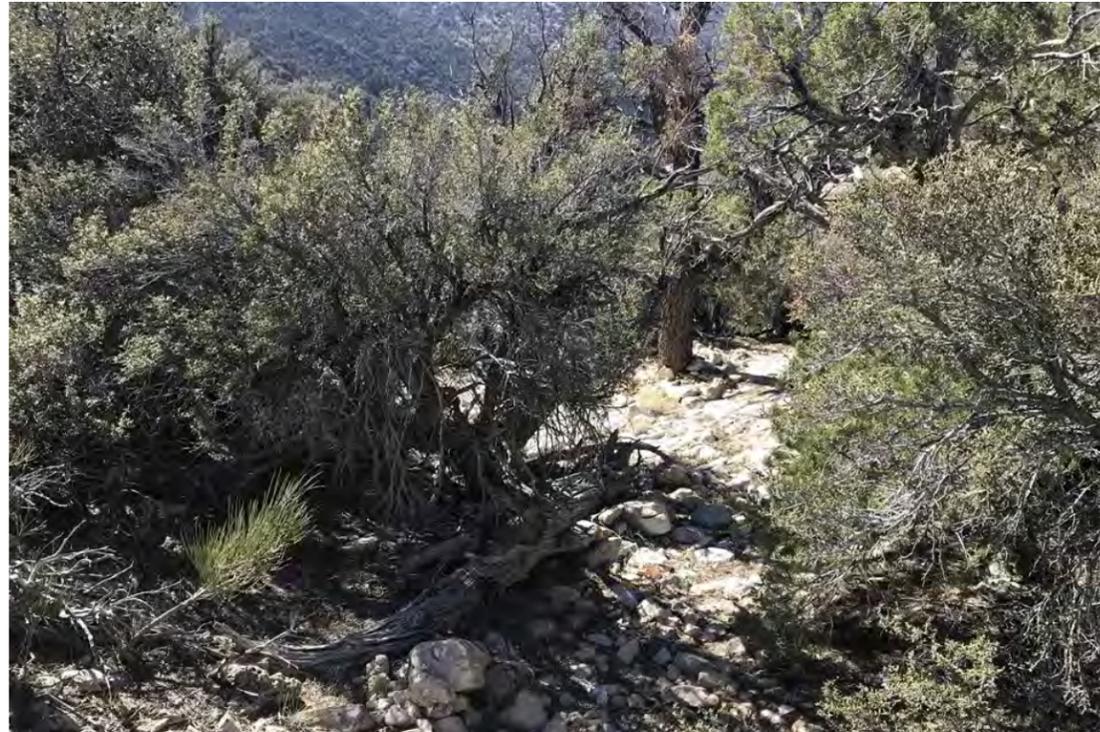
Photograph 1: View of uplands adjacent to start of Tributary to Marble Canyon Creek looking downslope. Photograph taken on 11/05/2018.

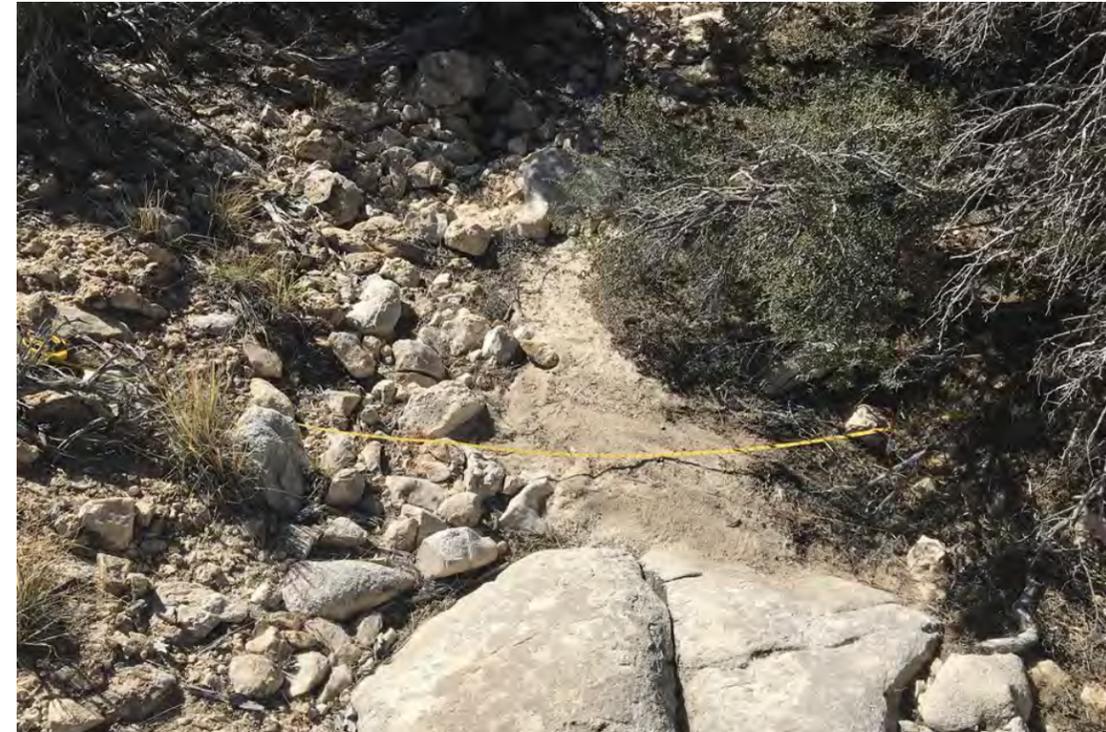
Photograph 2: Tributary to Marble Canyon Creek looking downstream at start of flow sign. Drainage width averages seven (7) feet in width. Photograph taken on 11/05/2018.

The substrate of the Tributary to Marble Canyon Creek is predominantly unvegetated and consists of boulders, rocks, cobbles, and gravel due to the velocity of ephemeral water flow and extreme gradient of the drainage feature. The tributary exhibits a bed, bank, and channel ranging from seven (7) to 13 feet in width as evidenced by changes in sediment deposition, the presence of scour, and terracing. The downstream off-site portion of the tributary extends beyond 19 feet in width prior to its confluence with the main stem drainage. In areas lacking a well-defined bed, bank, and channel, the lateral extent of CDFW jurisdiction was expanded to the point in which fluvial processes were no longer distinguishable from the terrestrial landscape. In these cases, jurisdiction was generally expanded to include the canyon bottom.

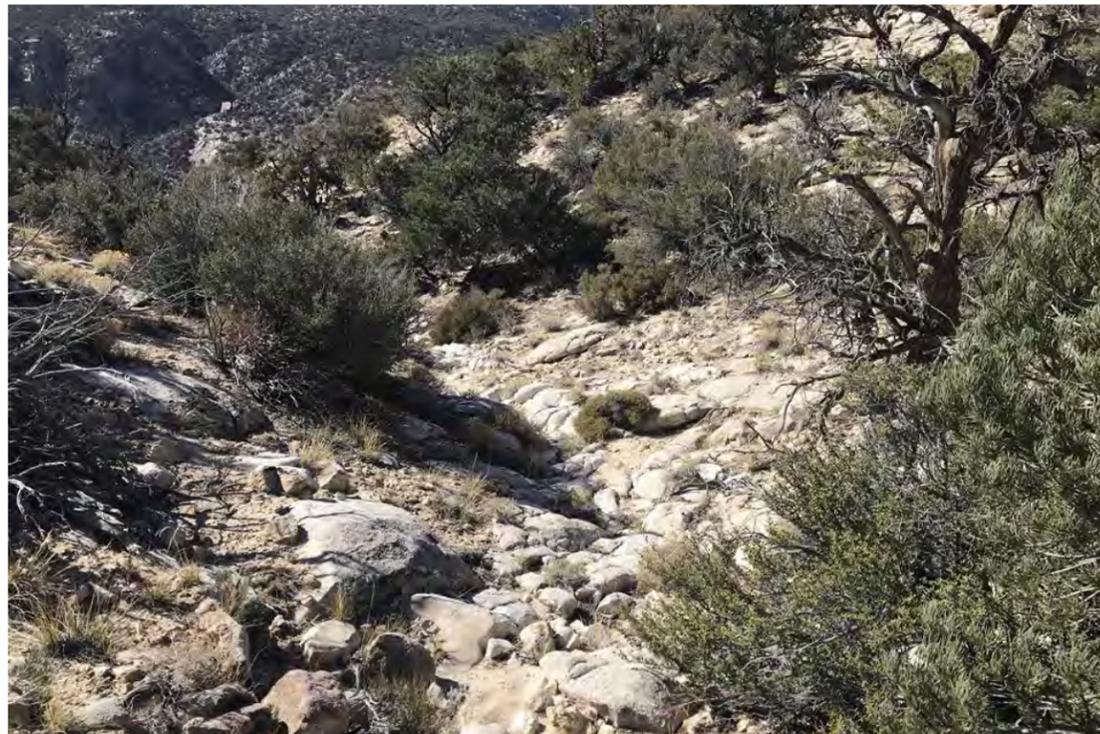
Photograph 3: Upstream reach of Tributary to Marble Canyon Creek looking downstream. Photograph taken on 11/05/2018.

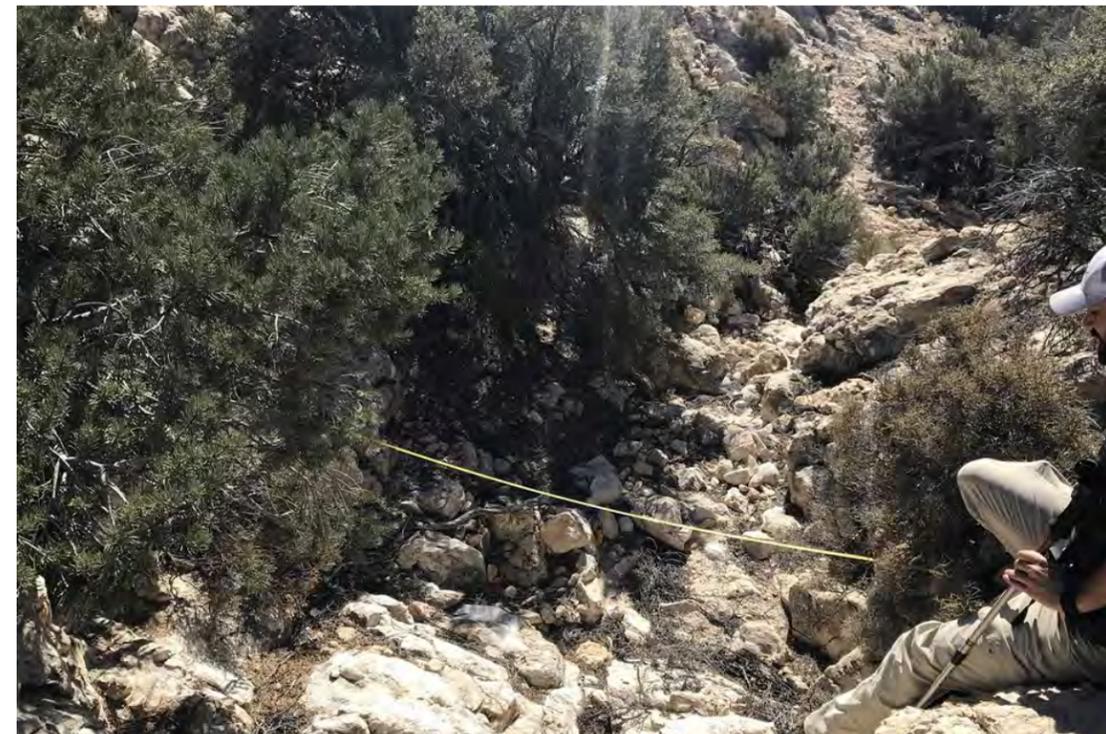
Photograph 4: Tributary to Marble Canyon Creek looking downstream. Drainage width averages nine (9) feet in width. Photograph taken on 11/05/2018.

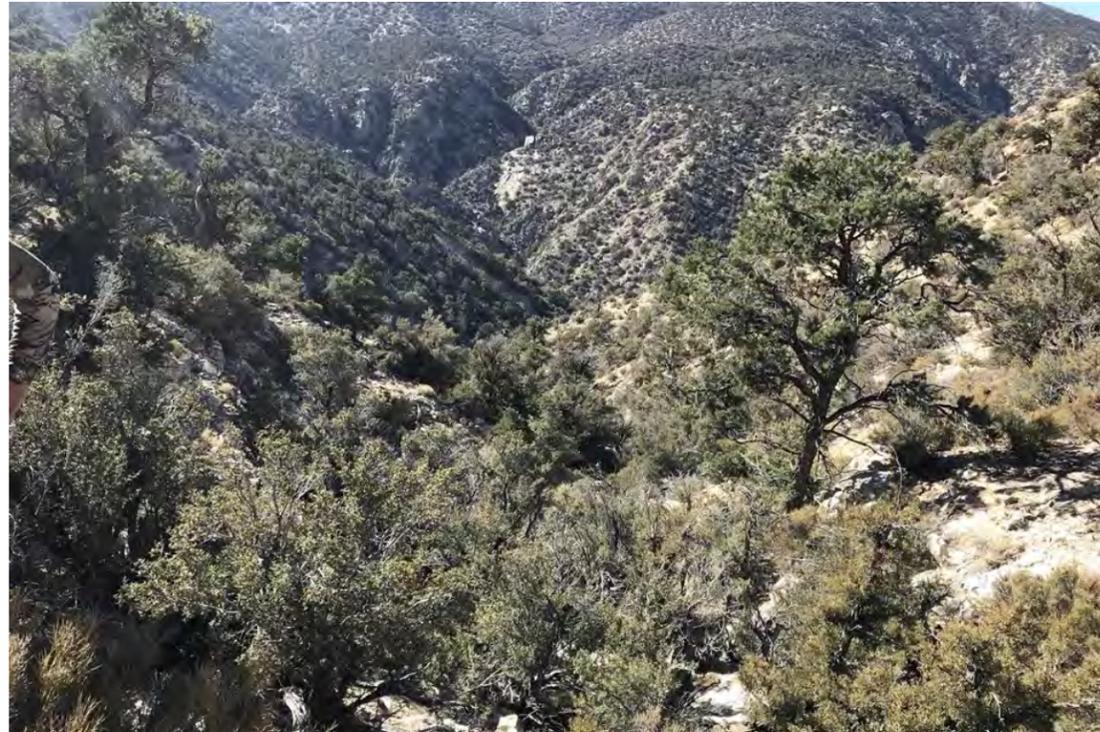
Photograph 5: Representative landscape view of Tributary to Marble Canyon Creek and adjacent upland areas looking downstream. Note the consistency of vegetation cover in the vicinity. Photograph taken on 11/05/2018.

live oak (*Quercus chrysolepis*), antelope bitterbrush (*Pursia tridentata*), California juniper (*Juniperus californica*), singleleaf pinyon (*Pinus monophylla*), ephedra (*Ephedra* sp.), ceanothus (*Ceanothus* sp.), and rubber rabbitbrush (*Chrysothamnus nauseosus*). These species extend far up the canyon slopes and occur throughout the adjacent uplands in a pattern that is consistent throughout much of the site.

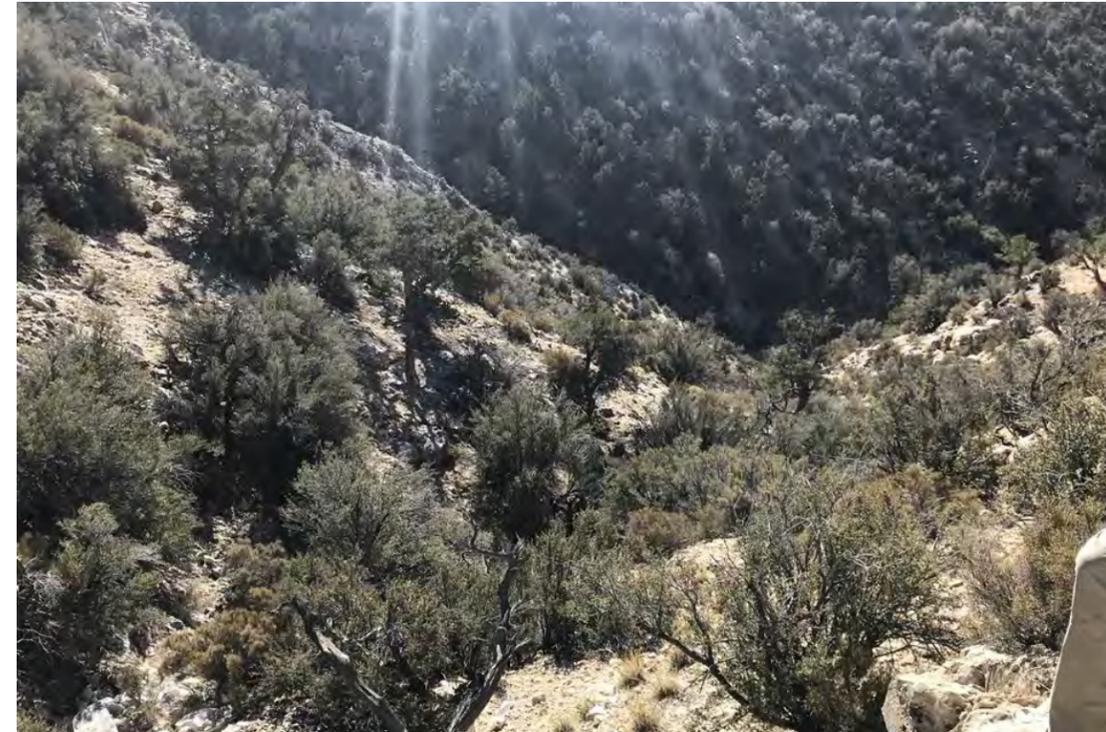
Photograph 6: Tributary to Marble Canyon Creek middle reach looking downstream. Photograph taken on 11/05/2018 from upland slope.

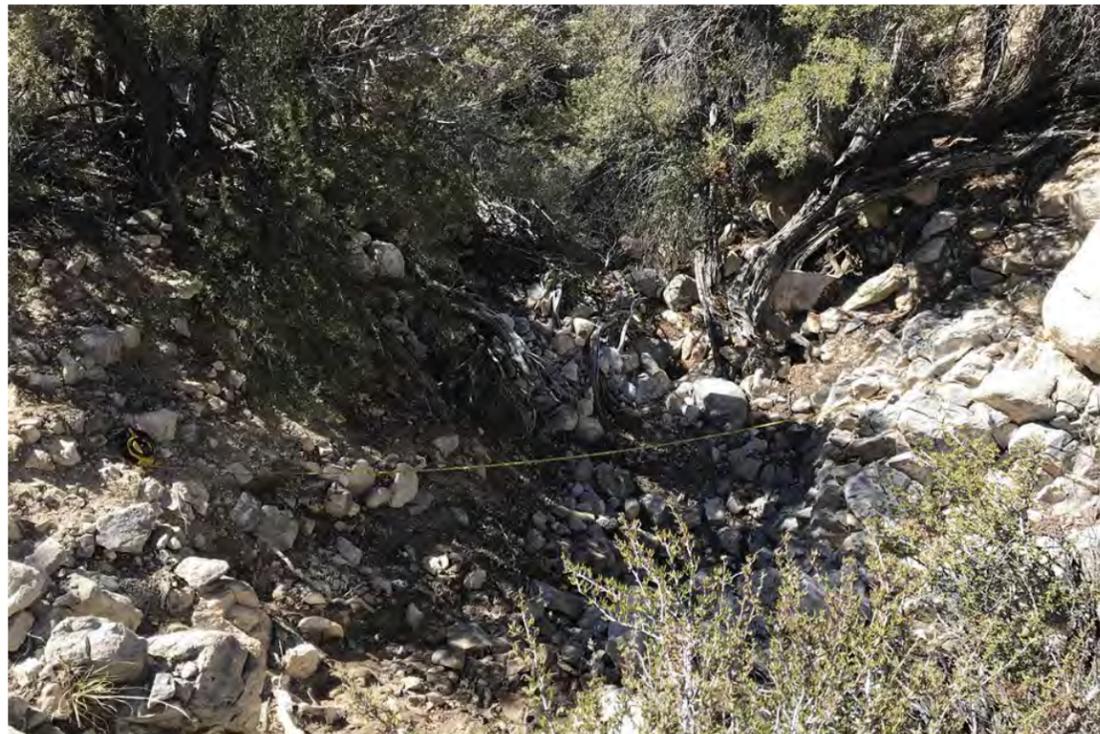
Photograph 7: Tributary to Marble Canyon Creek middle reach looking downstream. Drainage averages nine (9) feet in width. Photograph taken on 11/05/2018.

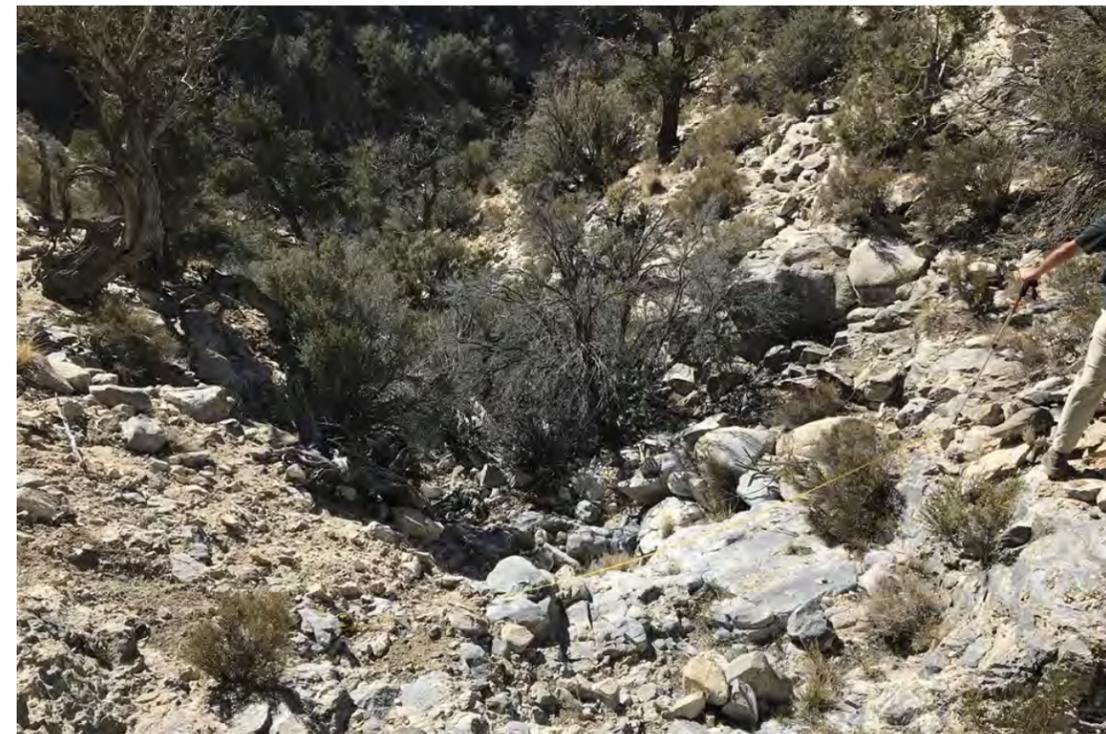
Photograph 8: Tributary to Marble Canyon Creek looking downstream. Drainage averages 13 feet in width. Photograph taken on 11/05/2018.

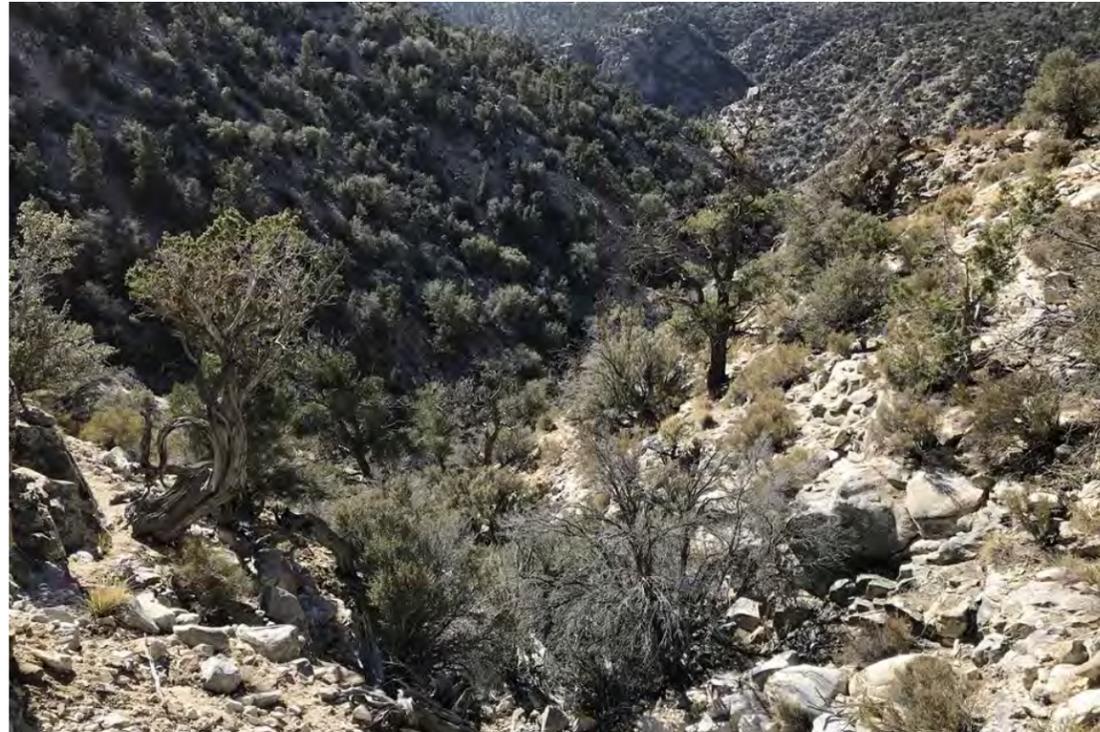
Photograph 9: Additional view of Tributary to Marble Canyon Creek middle reach and adjacent canyon side slopes looking downstream. Drainage averages 13 feet in width. Photograph taken on 11/05/2018.

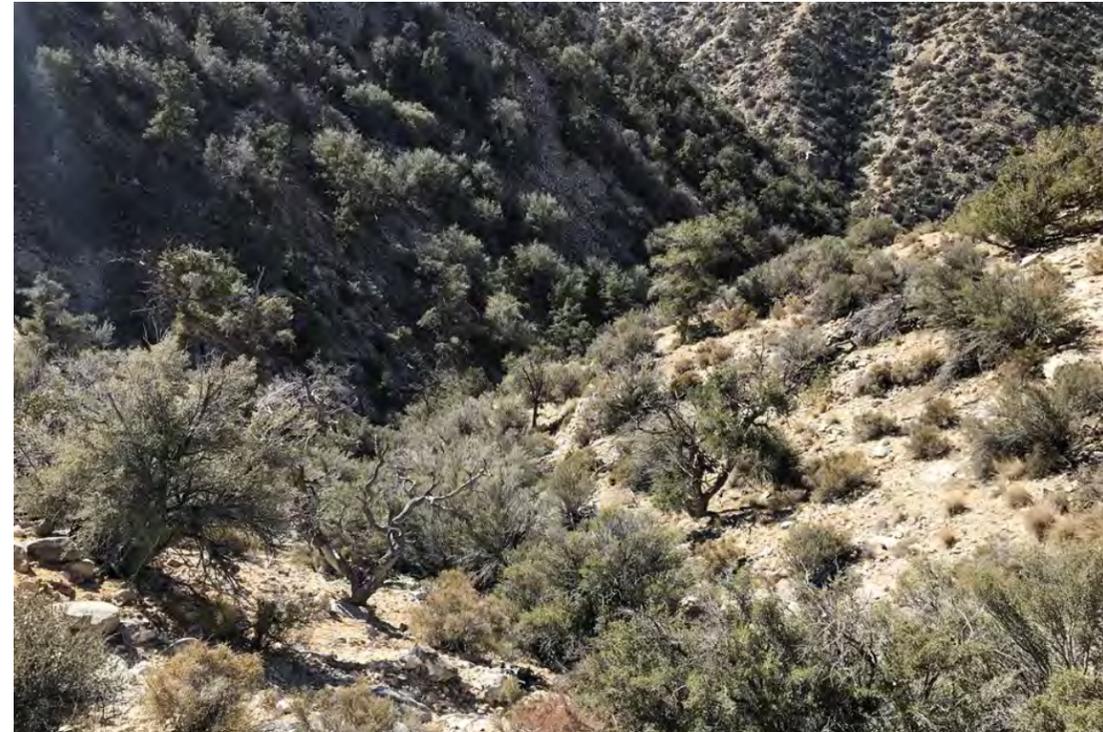
Photograph 10: Offsite portion of Tributary to Marble Canyon Creek and adjacent canyon side slopes looking downstream. Photograph taken on 11/05/2018.

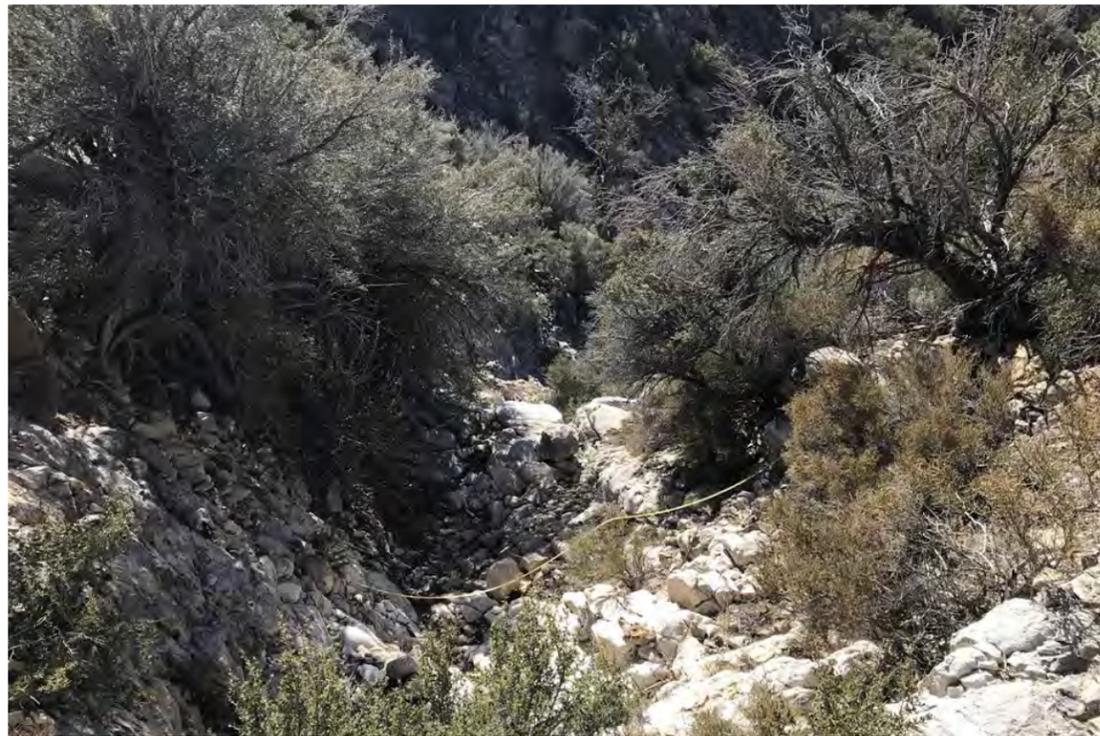
Photograph 11: Offsite portion of Tributary to Marble Canyon Creek looking downstream. Drainage averages 12 feet in width. Photograph taken on 11/05/2018.

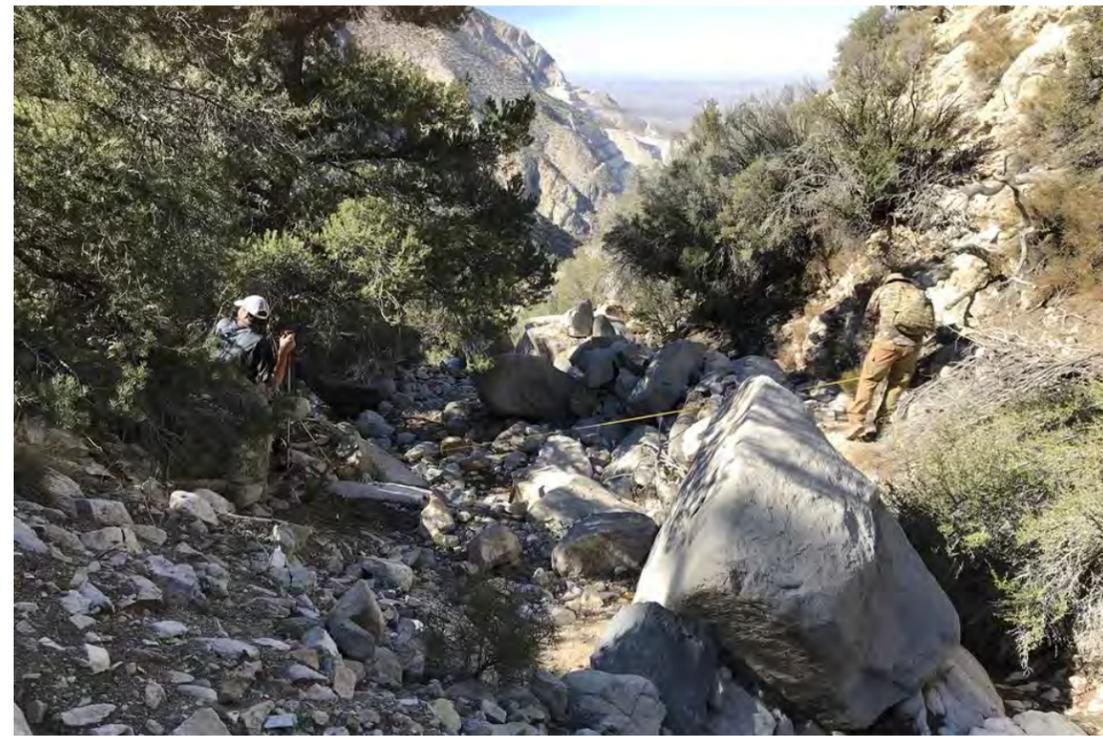
Photograph 12: Offsite portion of Tributary to Marble Canyon Creek looking downstream. Drainage averages 19 feet in width. Photograph taken on 11/05/2018.

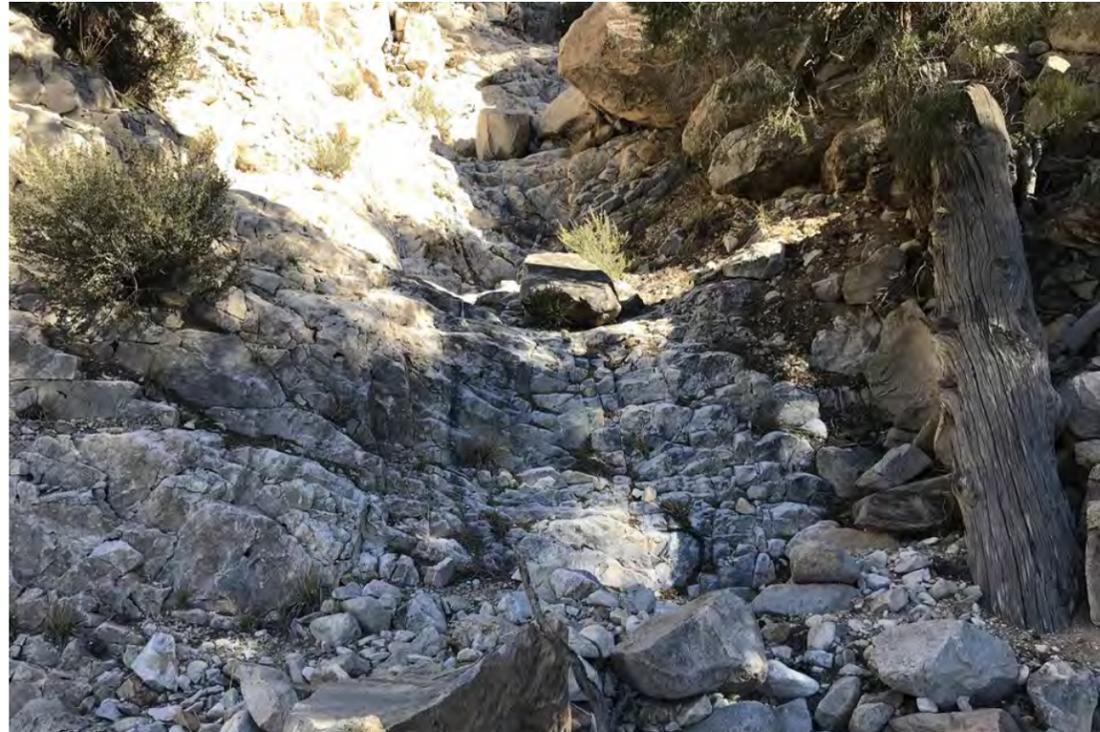
Photograph 13: Offsite unmapped portion of Tributary to Marble Canyon Creek looking upstream towards steep rock outcrop. Photograph taken on 11/05/2018.
