# MEMORANDUM

**PROJECT NUMBER:** 0551-5CUSH

**SUBJECT:** Cushenbury Mine South Pit Expansion Project, Located in the Community of Lucerne Valley, San Bernardino County, California: CDFW Jurisdictional Delineation Impact Analysis and Supplement to 2012 Report.

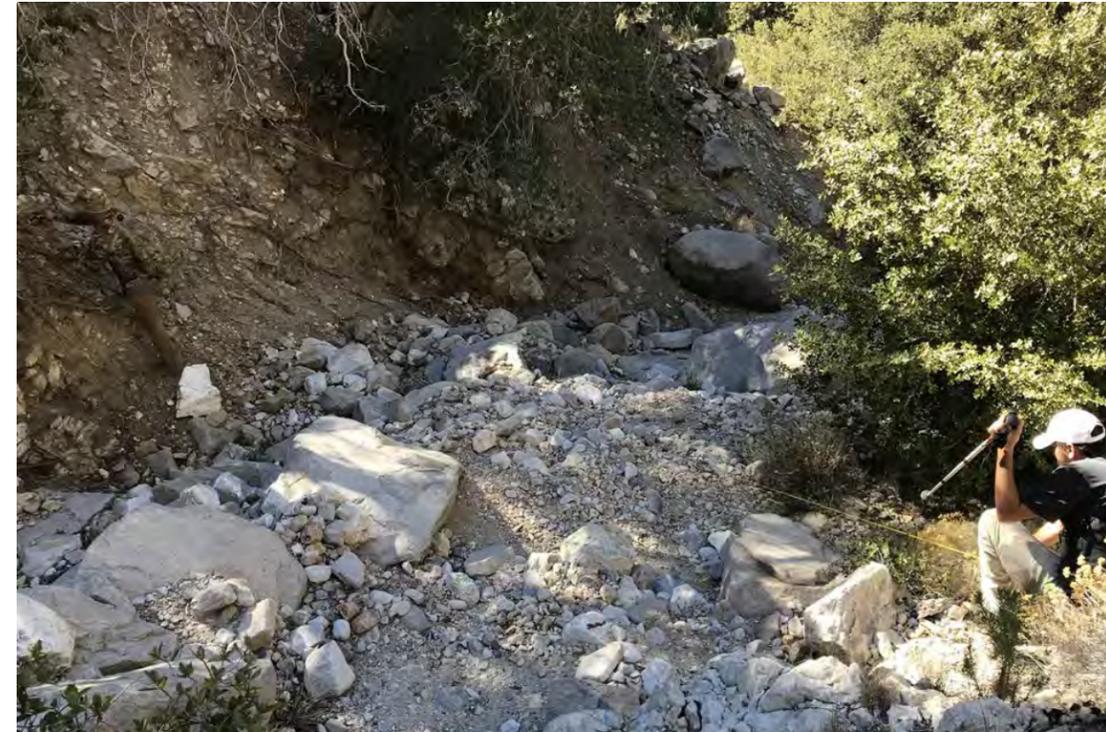
Photograph 14: Offsite unmapped portion of Tributary to Marble Canyon Creek looking downstream. Drainage averages 27 feet in width. Photograph taken on 11/05/2018.

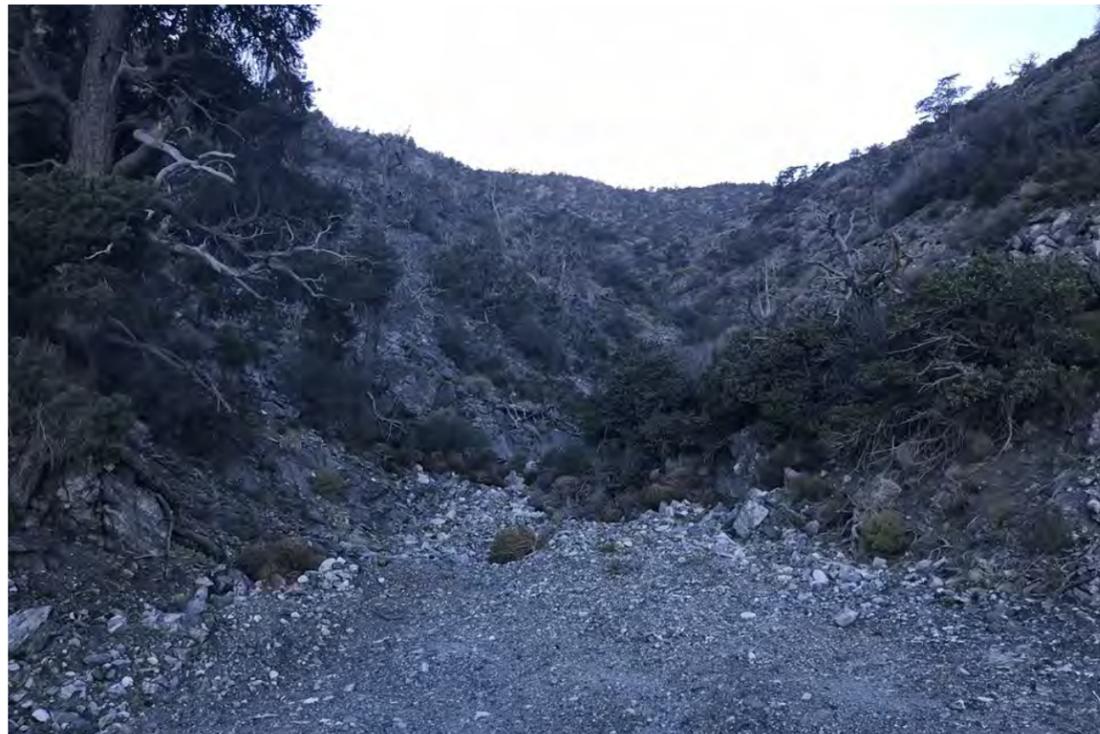
Photograph 15: View looking towards start of Drainage A looking upstream. Photograph taken on 11/05/2018.

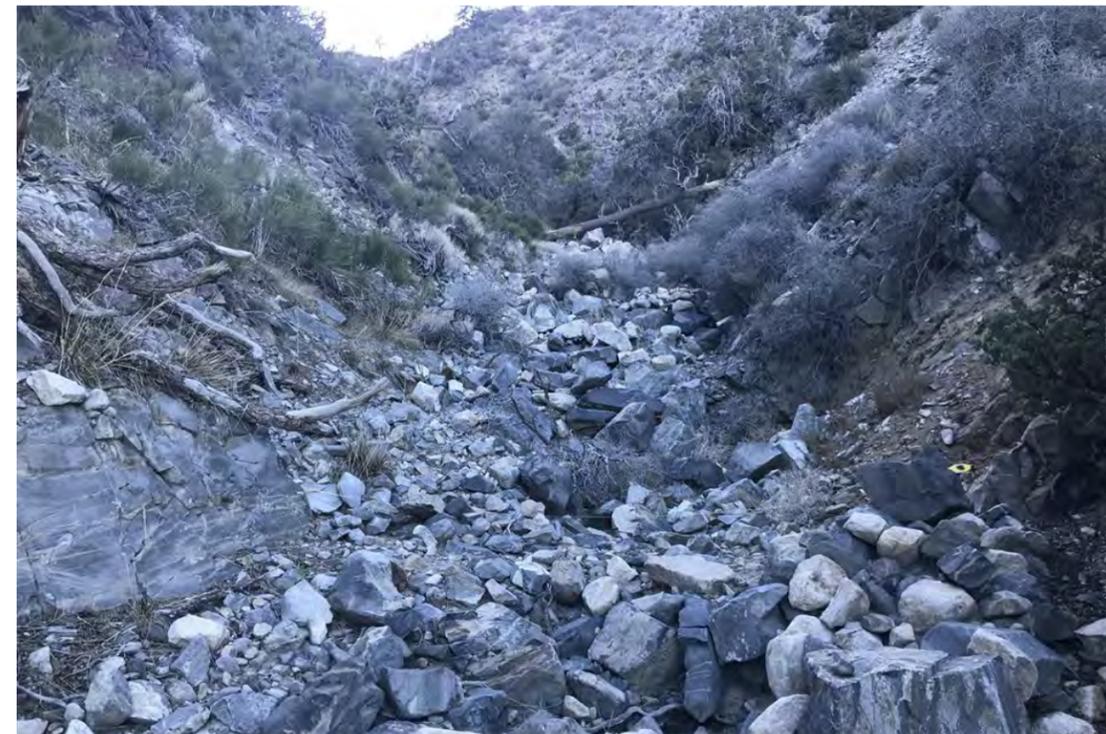
Photograph 16: Drainage A looking upstream. Drainage averages 11 feet in width. Photograph taken on 11/05/2018.

The substrate of Drainage A is predominantly unvegetated and consists of boulders, rocks, cobbles, and gravel due to the velocity of the water flow and extreme gradient of the drainage feature. Drainage A exhibits a bed, bank, and channel ranging from three (3) to 12 feet in width as evidenced by changes in sediment deposition, the presence of scour, and terracing. In areas lacking a well-defined bed, bank, and channel, the lateral extent of CDFW jurisdiction was expanded to the point in which fluvial processes were no longer distinguishable from the terrestrial landscape. In these cases, jurisdiction was generally expanded to include the canyon bottom.

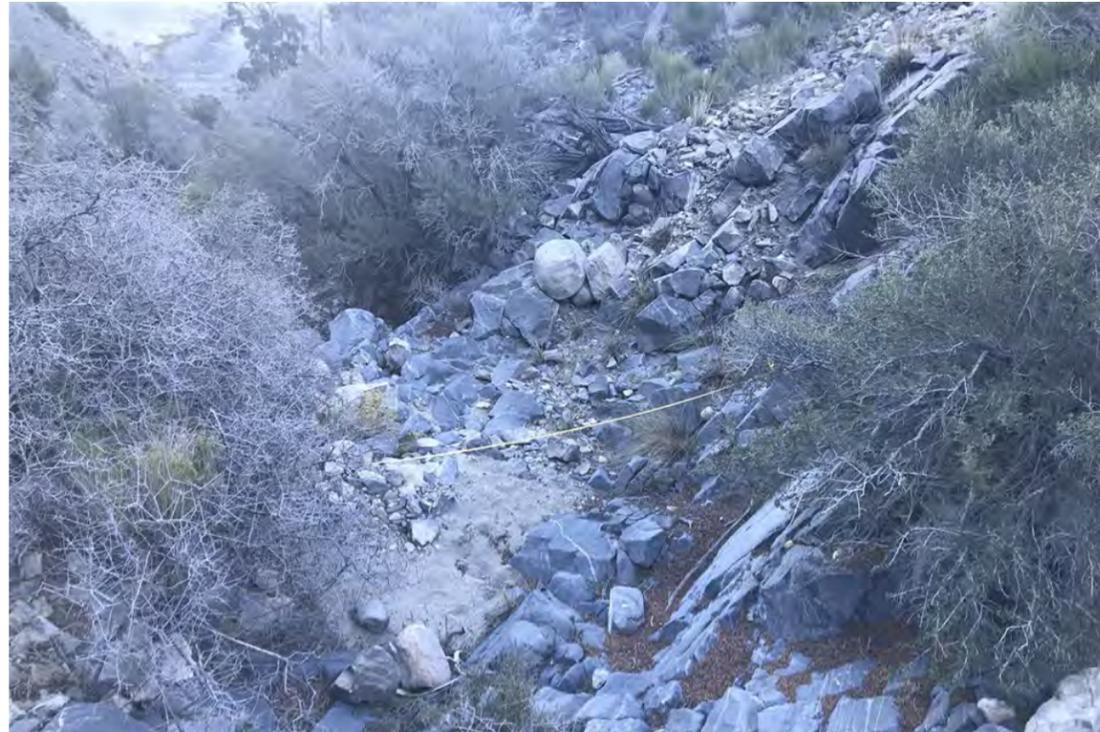
Photograph 17: Drainage A looking upstream. Drainage averages 12 feet in width. Photograph taken on 11/05/2018 from side terrace.

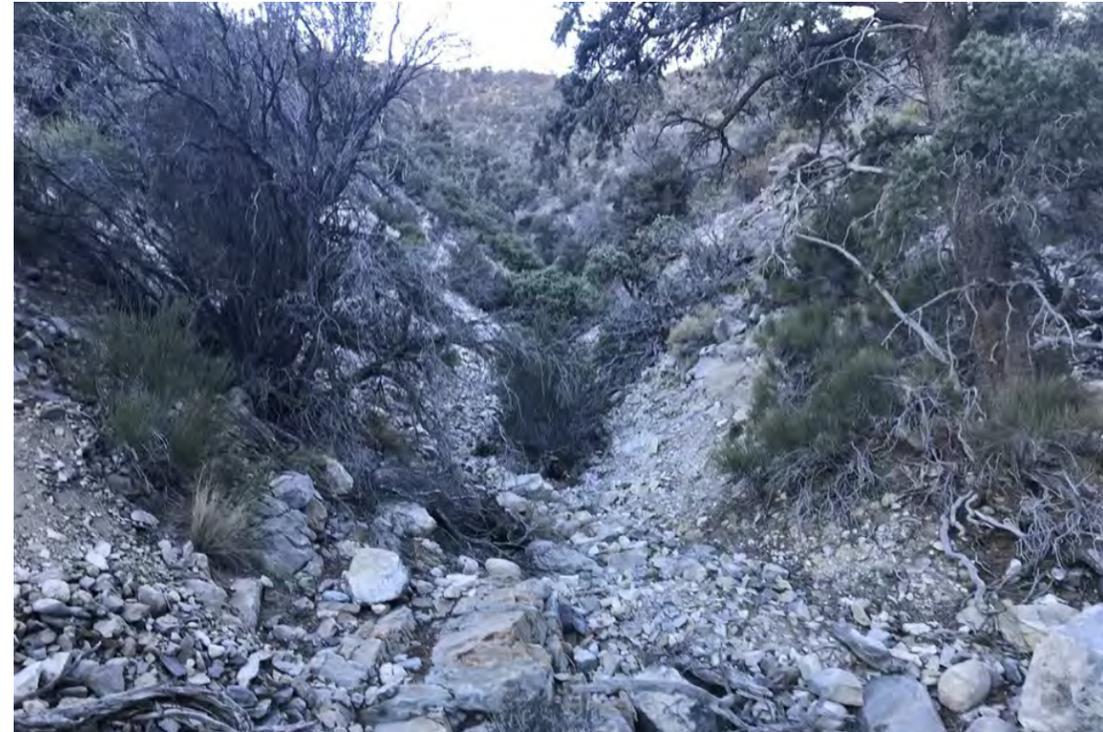
Photograph 18: Drainage A looking upstream towards eastern branch. Photograph taken on 11/05/2018.

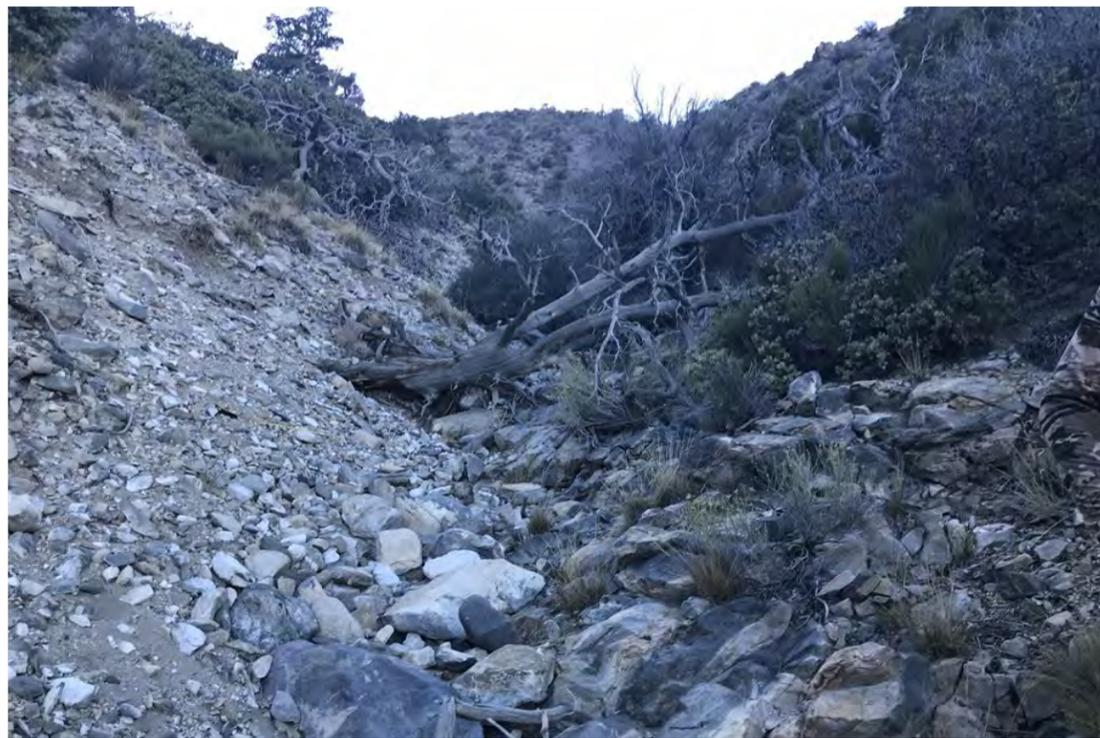
Photograph 19: Western branch of Drainage A looking upstream. Drainage averages 10 feet in width. Photograph taken on 11/05/2018.

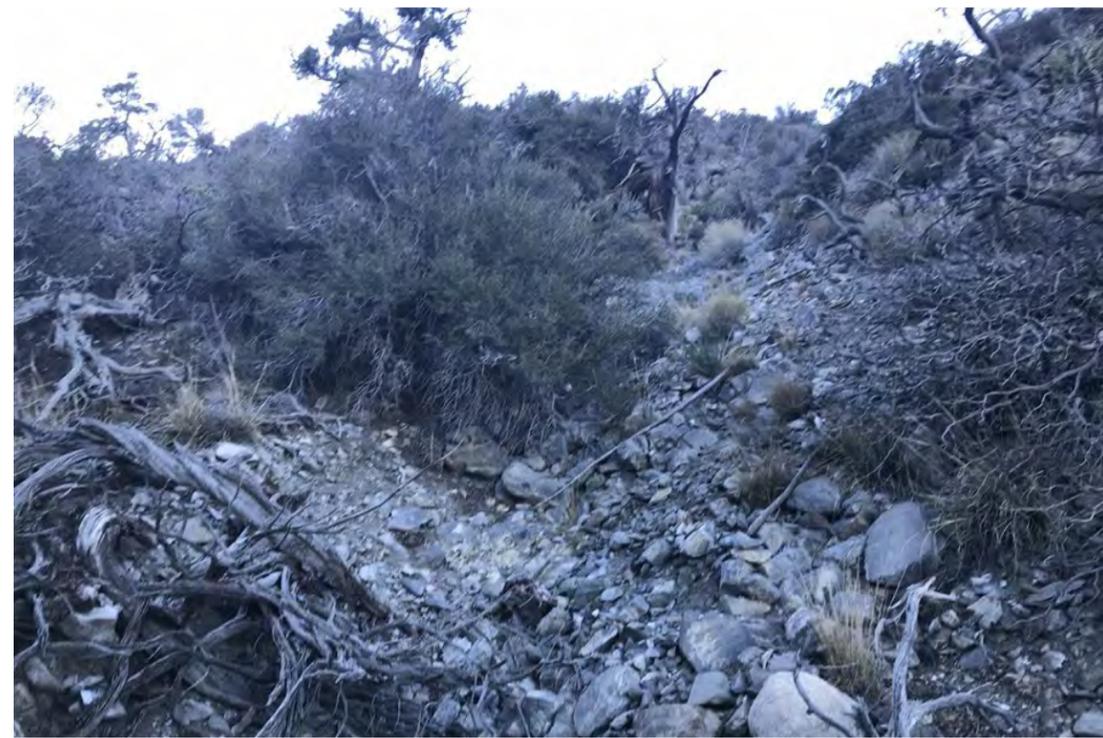
Photograph 20: Western branch of Drainage A looking upstream. Photograph taken on 11/05/2018.

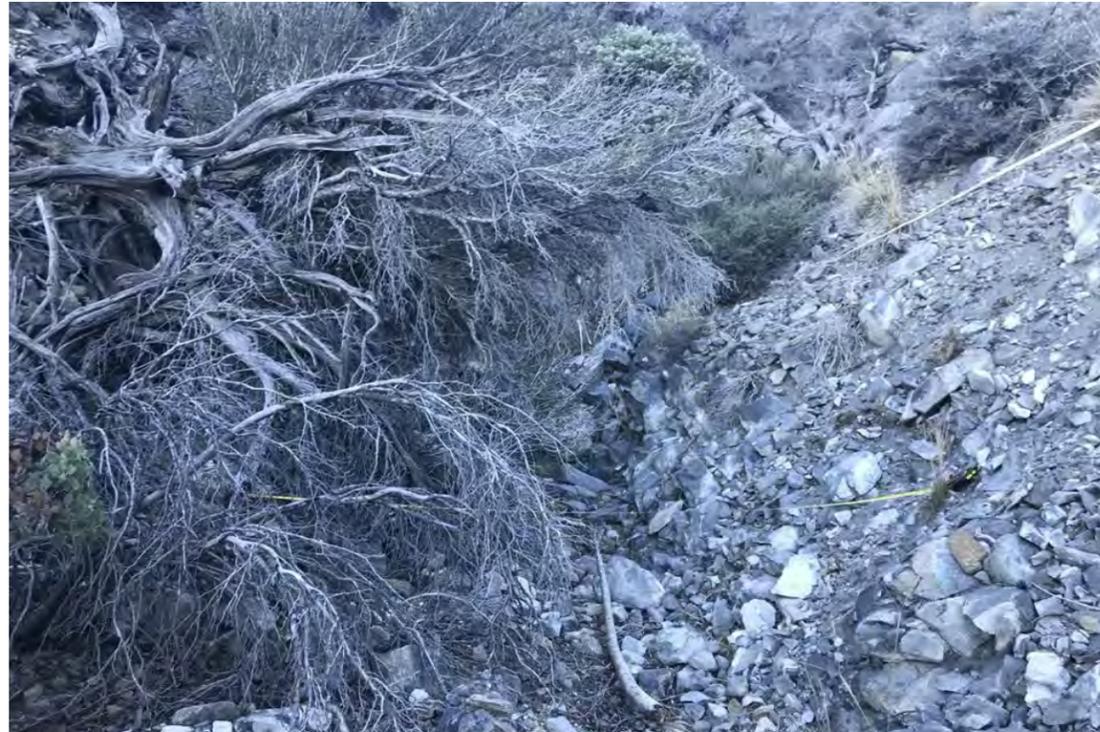
Photograph 21: Western branch of Drainage A looking upstream. Photograph taken on 11/05/2018 from adjacent uplands.

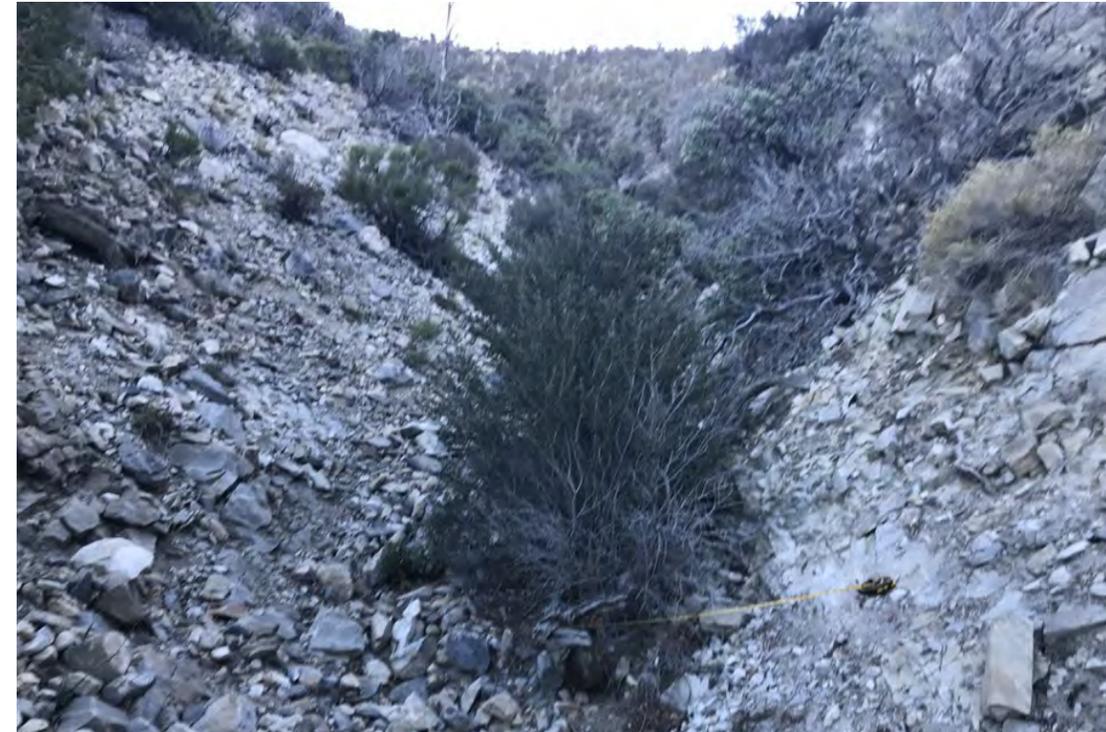
Photograph 22: Eastern branch of Drainage A looking upstream. Photograph taken on 11/05/2018.

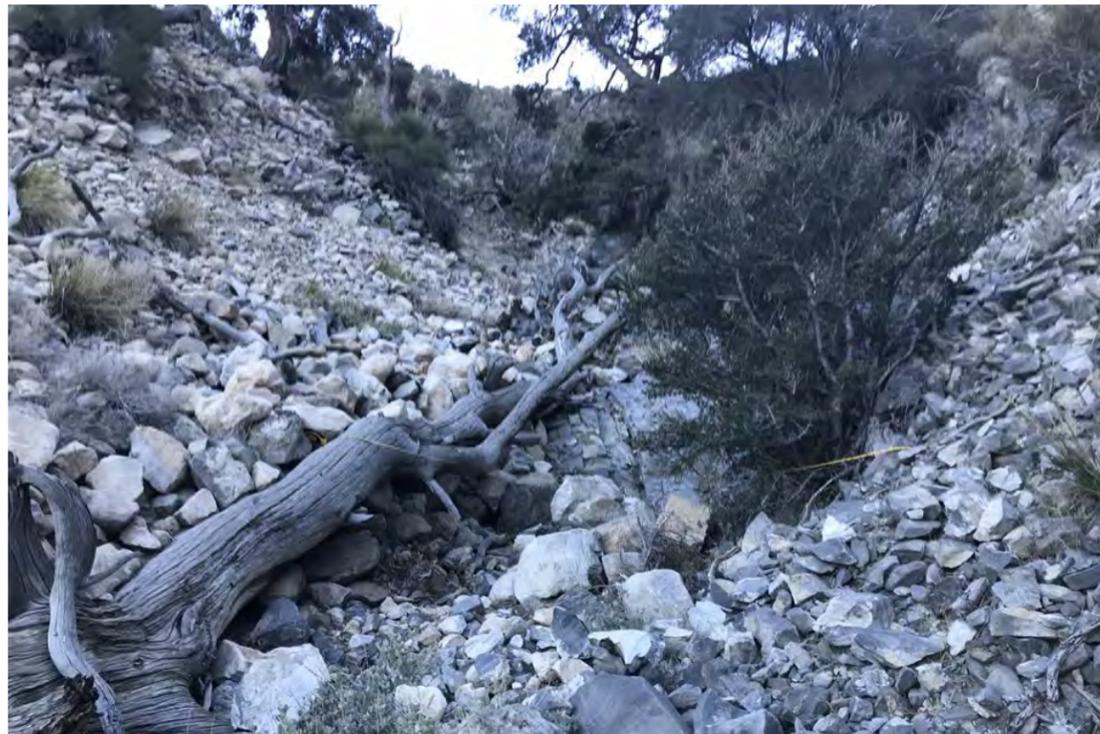
Photograph 23: Eastern branch of Drainage A looking upstream. Photograph taken on 11/05/2018.

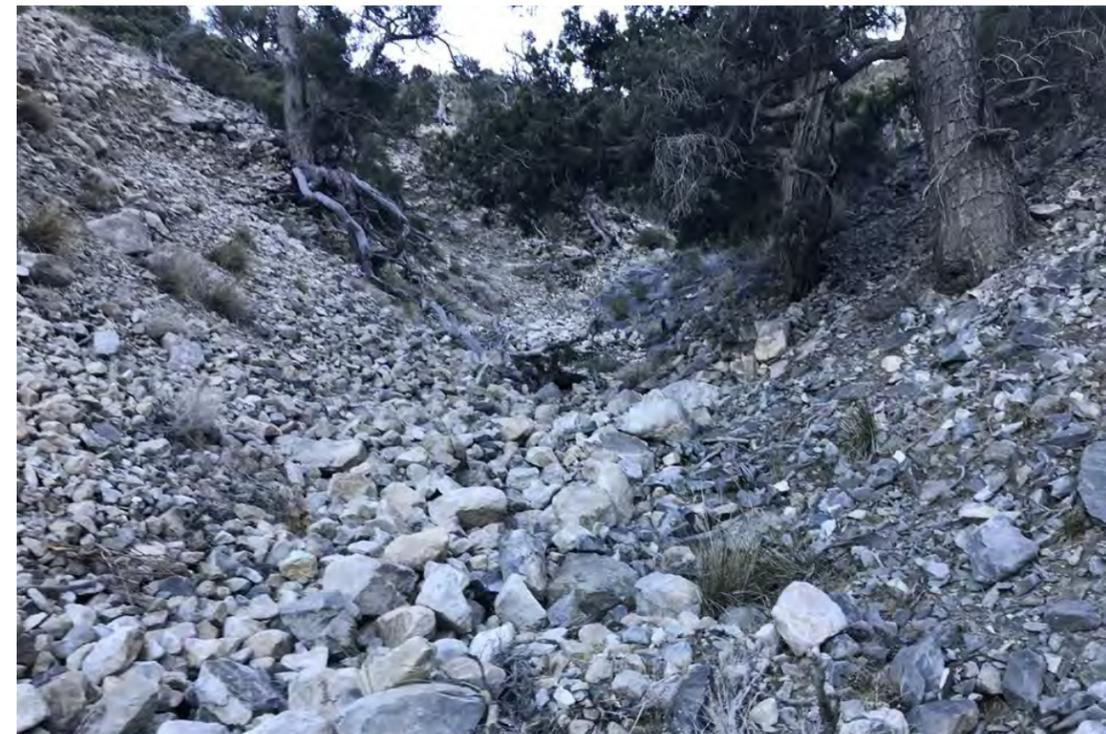
Photograph 24: Eastern branch of Drainage A looking upstream. Photograph taken on 11/05/2018.

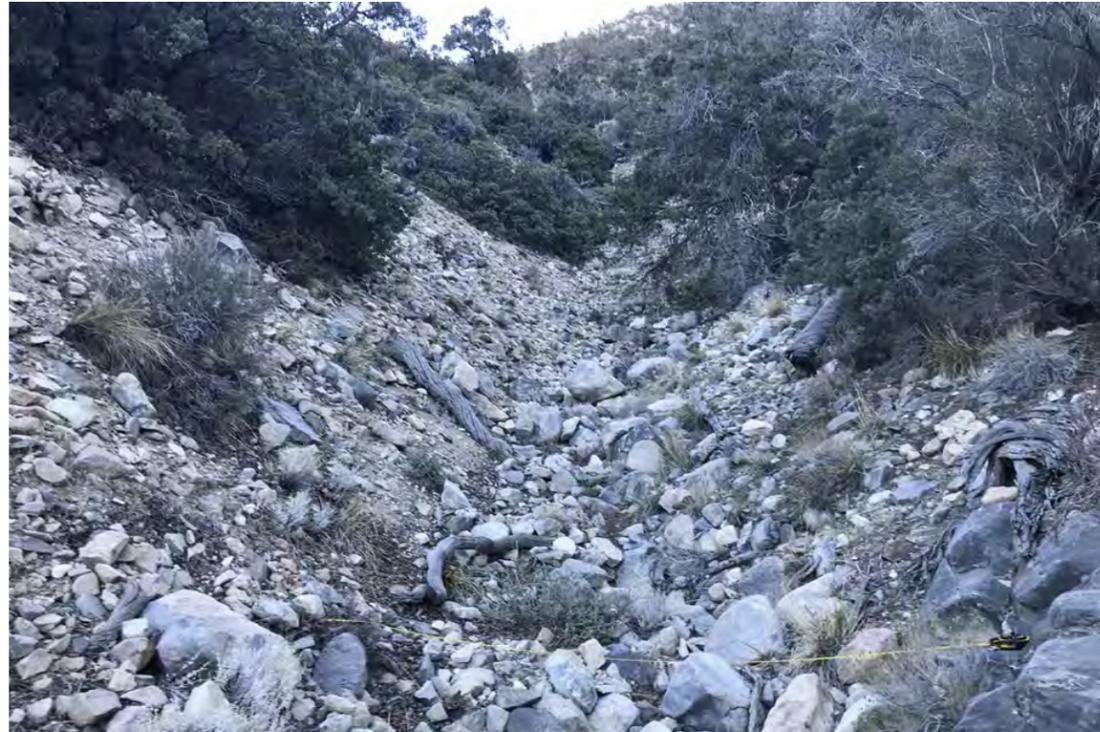
Photograph 25: Eastern branch of Drainage A looking upstream. Drainage mapped at eight (8) feet in width. Photograph taken on 11/05/2018.

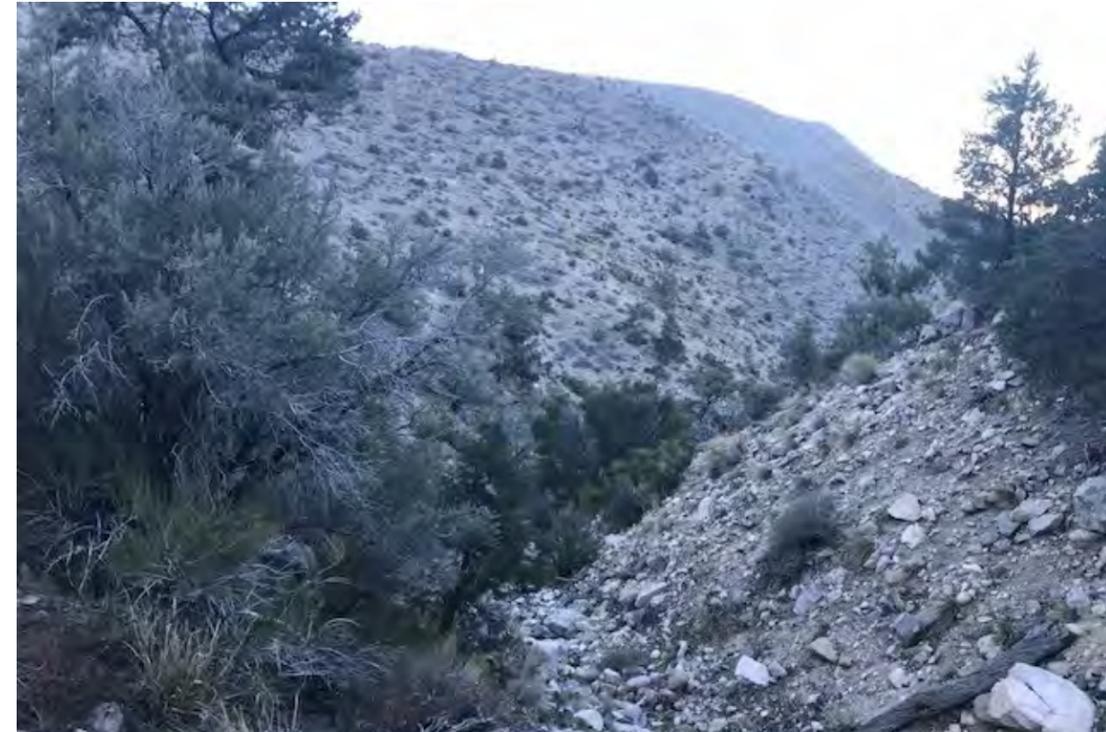
Photograph 26: Eastern branch of Drainage A looking downstream. Photograph taken on 11/05/2018.

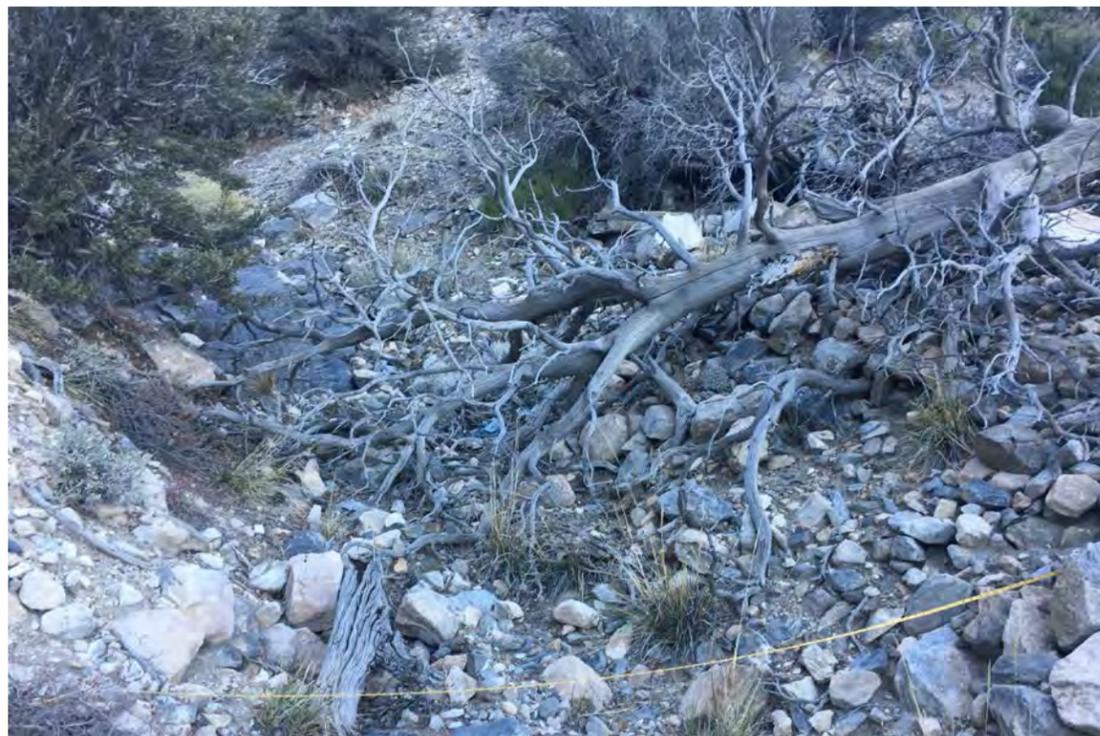
Photograph 27 (unmapped): Eastern branch of Drainage A looking upstream towards headwaters. Drainage mapped at eight (8) feet in width. Photograph taken on 11/05/2018.

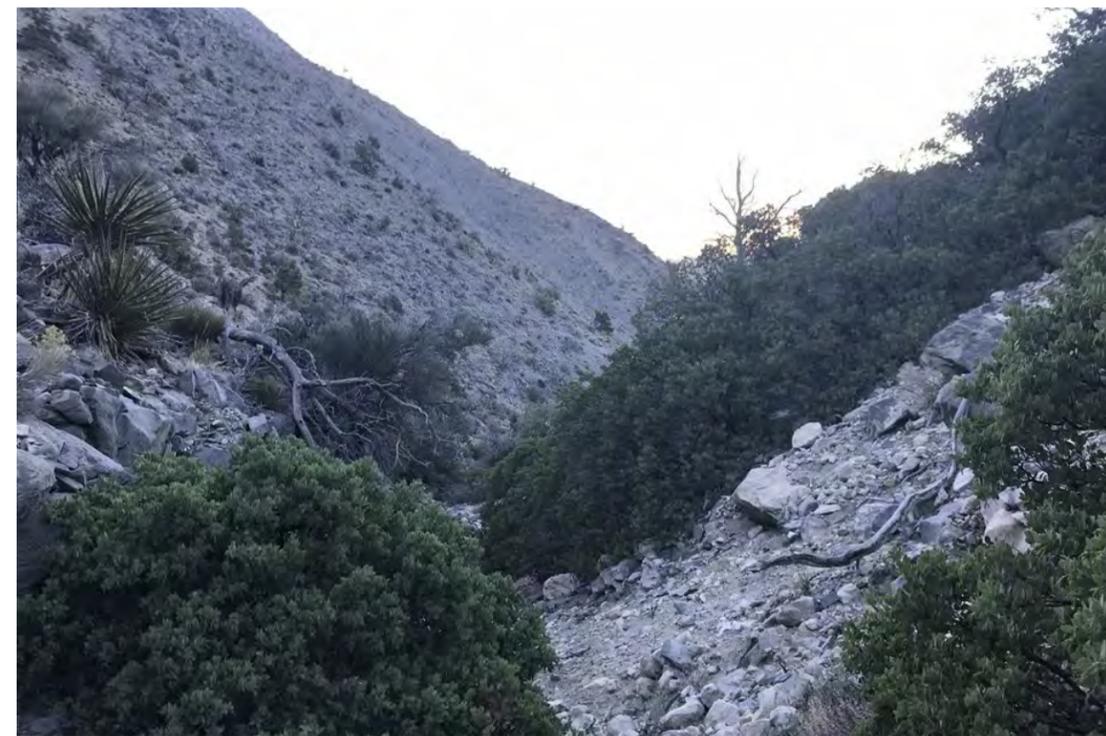
Photograph 28 (unmapped): Representative view of canyon slopes adjacent to Drainage A. Photograph taken on 11/05/2018.

Vegetation within and adjacent to Drainage A includes limited areas of upland species consisting of manzanita (*Arctostaphylos* sp.), antelope bitterbrush (*Pursia tridentata*), California juniper (*Juniperus californica*), Mojave yucca (*Yucca schidigera*), rubber rabbitbrush (*Chrysothamnus nauseosus*), Joshua tree (*Yucca brevifolia*), singleleaf pinyon (*Pinus monophylla*), ephedra (*Ephedra* sp.), and ceanothus (*Ceanothus* sp.). These species extend far up the canyon slopes and occur throughout the adjacent uplands in a pattern that is consistent throughout much of the site.
