PHASE II SUBSURFACE INVESTIGATION REPORT

Molto Properties

Nevada Street and Palmetto Avenue
Redlands, California 92374

Partner Project Number: 22-356187.1

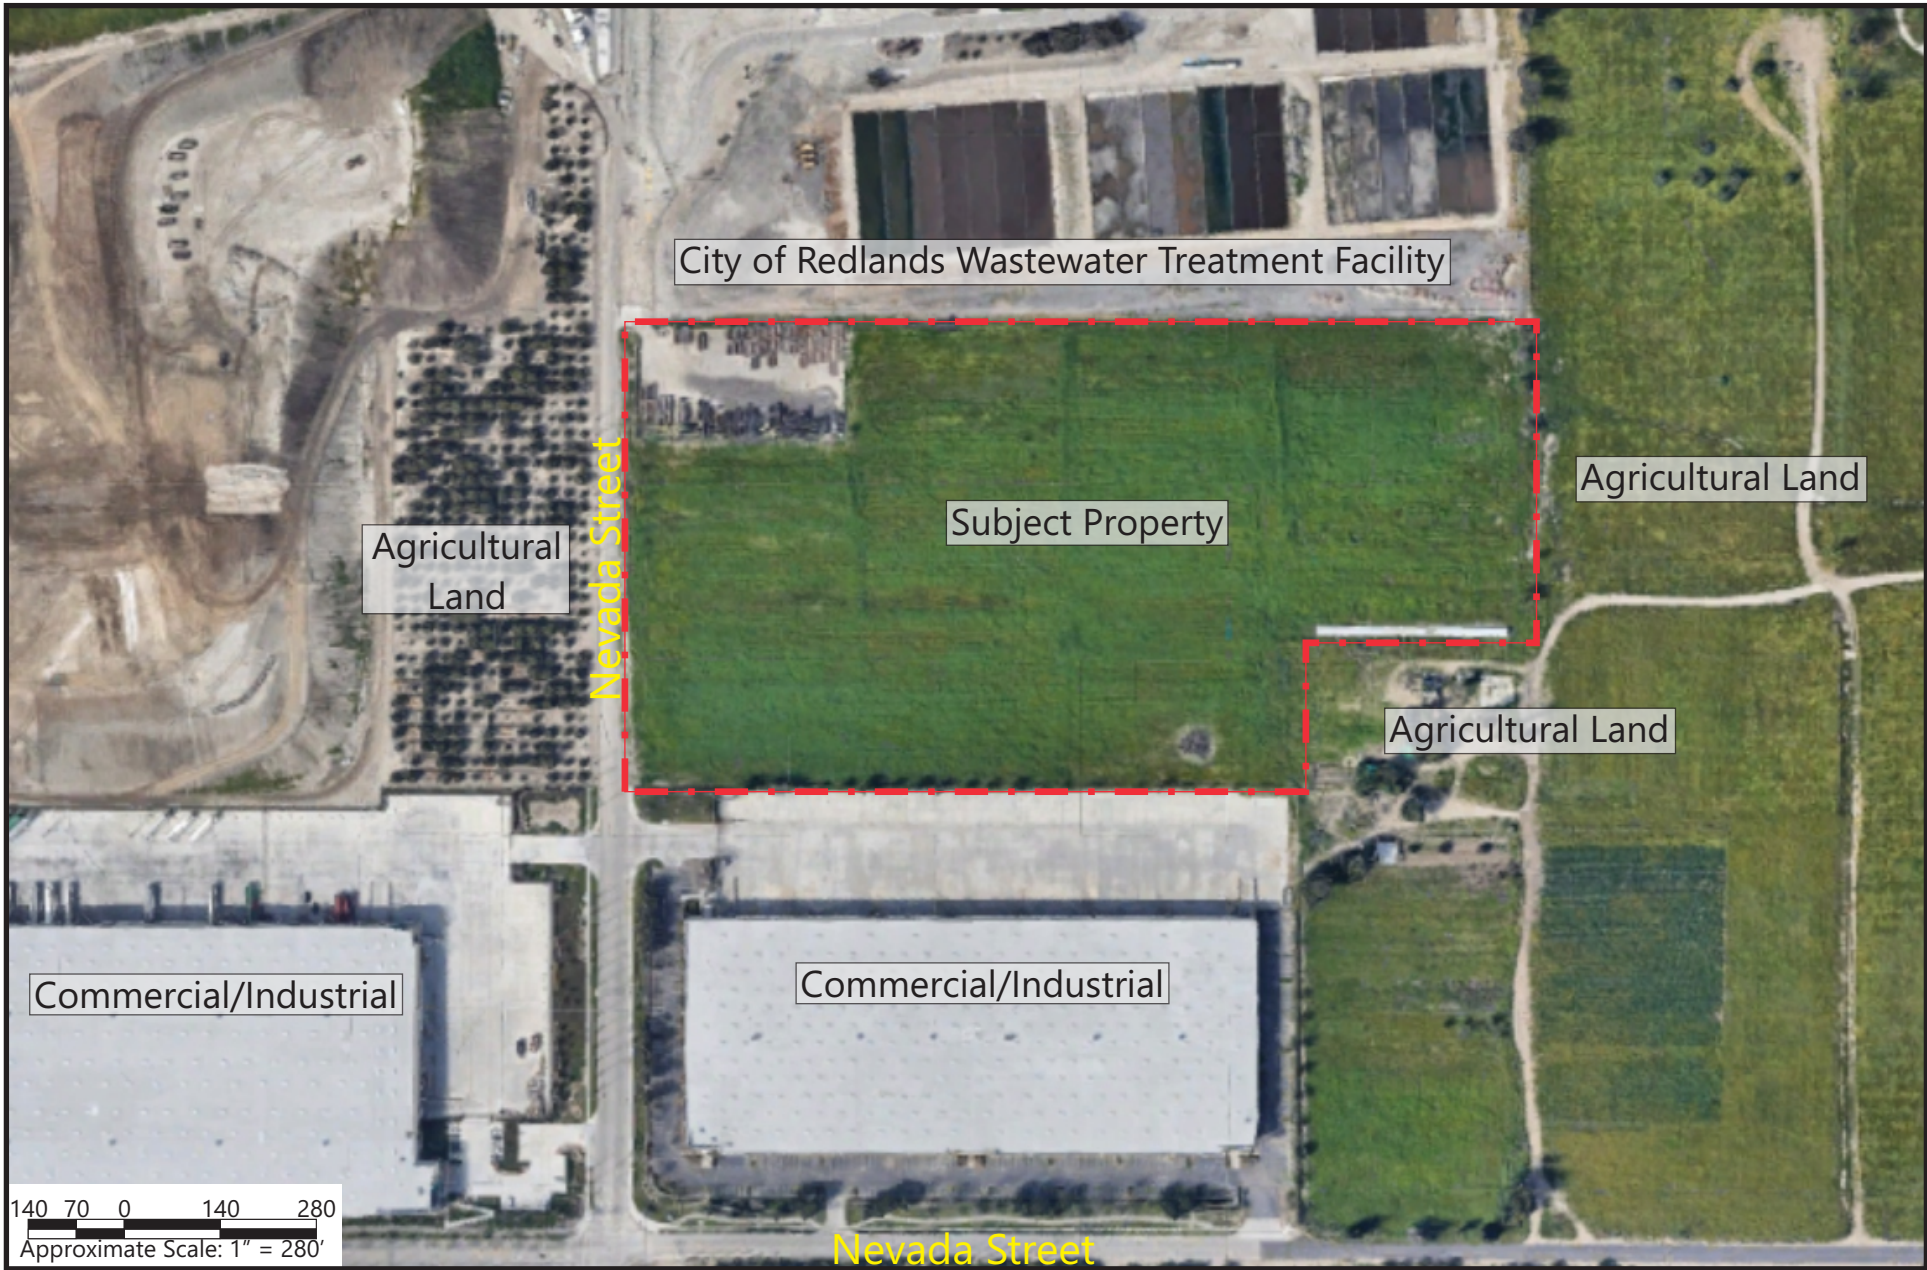
Site Vicinity Map		
Figure	Prepared By	Date
1	H. Gutierrez	February 2022
Nevada Street and Palmetto Avenue Redlands, California 92374

The Subject Property is bound by City of Redlands Wastewater Treatment Facility to the north, agricultural land to the east, agricultural land and commercial/industrial properties to the south, and agricultural land to the west across Nevada Street. Refer to **Figure 1** for a site vicinity map showing site features and surrounding properties.

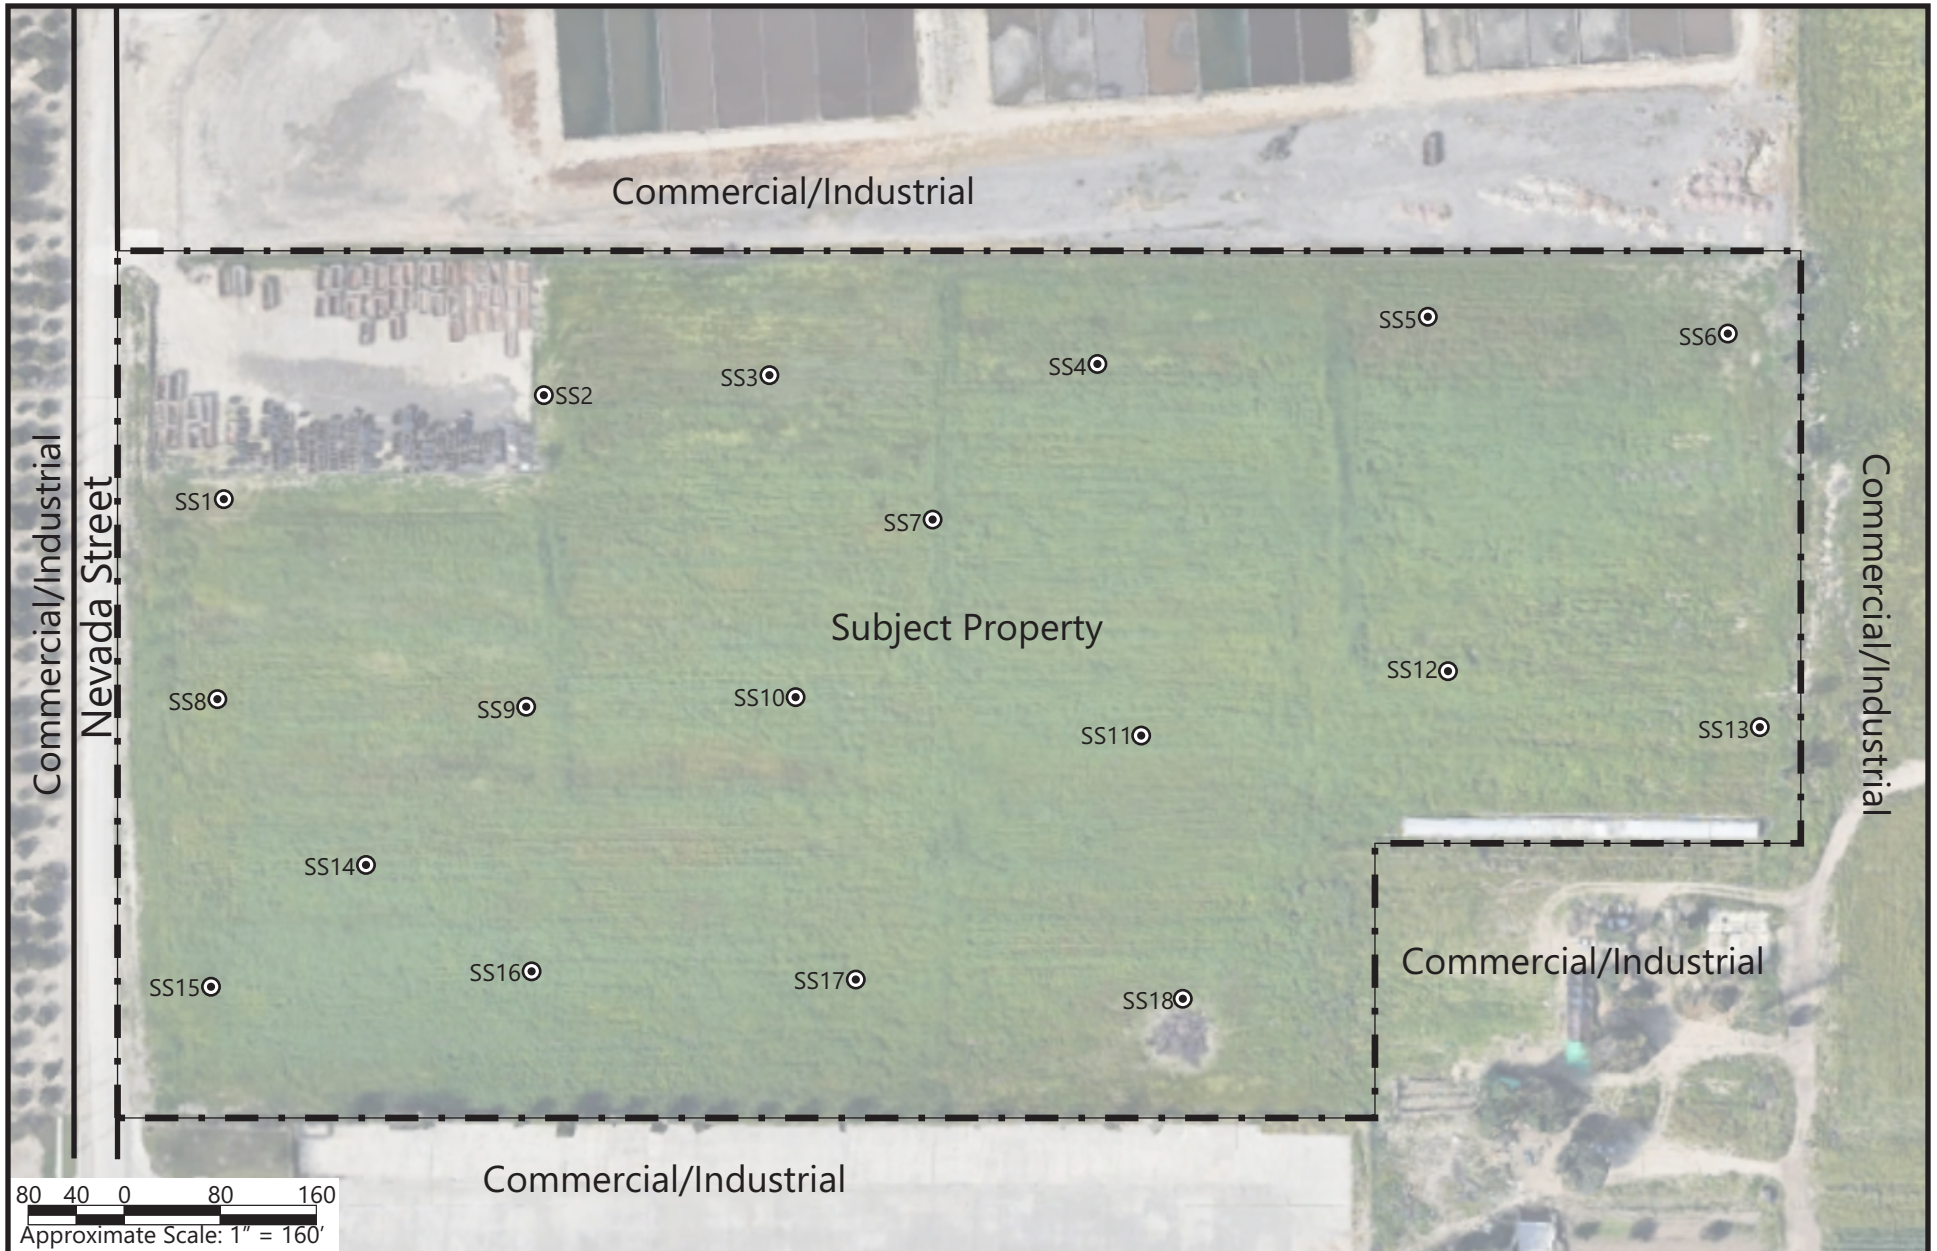
Figure	Prepared By	Date
3	H. Gutierrez	February 2022
Nevada Street and Palmetto Avenue Redlands, California 92374

Discrete samples SS1 through SS18 were collected on one-acre centers between rows of trees, to the extent practicable.

Refer to **Figure 3** for a map depicting sample locations.
