# **PHASE I**

## **ENVIRONMENTAL SITE ASSESSMENT**

**Calleja Road and Bellflower Street  
Assessor Parcel Numbers 0460-161-31, 32, and 33  
Adelanto, San Bernardino County, California**

**June 22, 2017**

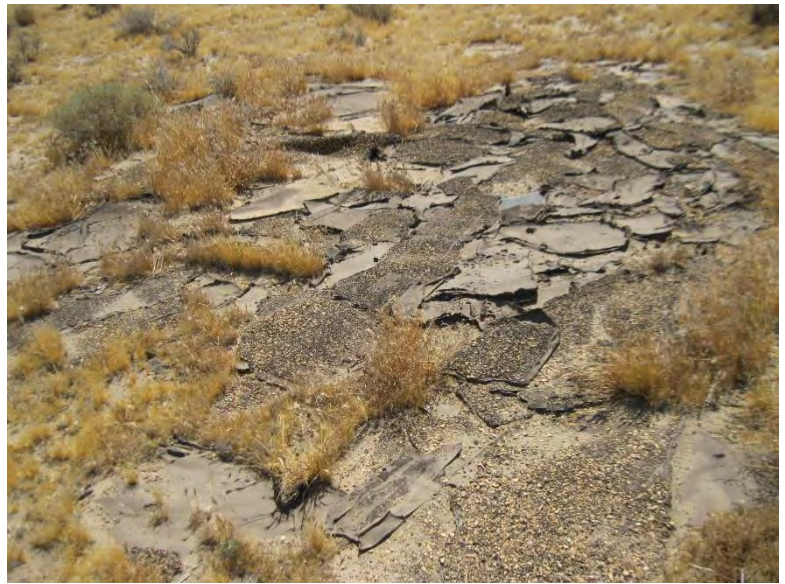
**Photograph 10**

Roofing material was noted on the southern portion of the Site. The roofing material appears to have been dumped onto the Site and its origin is not known. Approximately 1,000 square feet of the material was noted. The presence of the dumped roofing material is considered to be Business Environmental Risk.

View of the dumped roofing material on the southern portion of the Site.

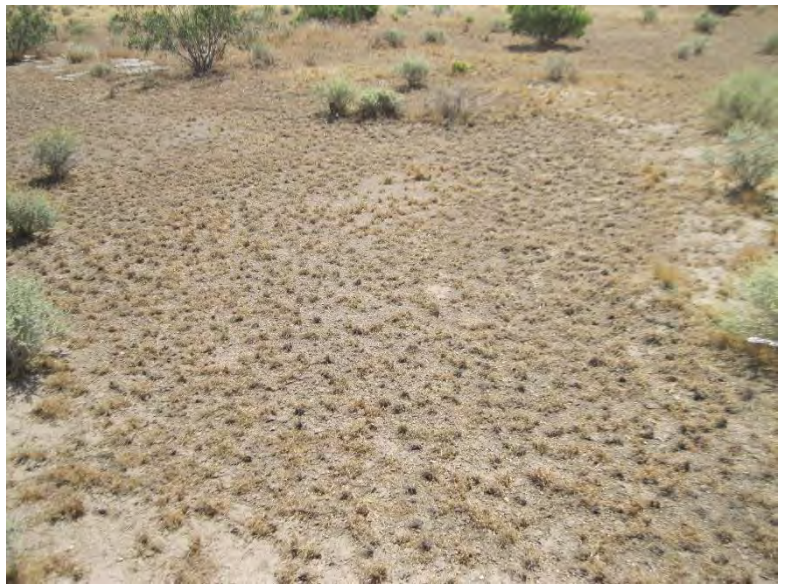
**Photograph 11**

An area of discolored soil appearing to be slightly darker in color than the surrounding native soils was noted along the southern Site boundary. The area of discoloration appears to be a low-lying area and encompasses approximately 25,000 square feet. The depth of the discoloration appears to be less than one inch. The discolored area was also apparent on the 2016 aerial photograph. Consideration the location of the discoloration, the source appears to be from stormwater runoff originating on the LKQ facility located immediately to the south and at a slightly higher elevation. Apex considers the discolored soil to be a *de minimis* condition.

View of discolored soil on the southern portion of the Site from the north.

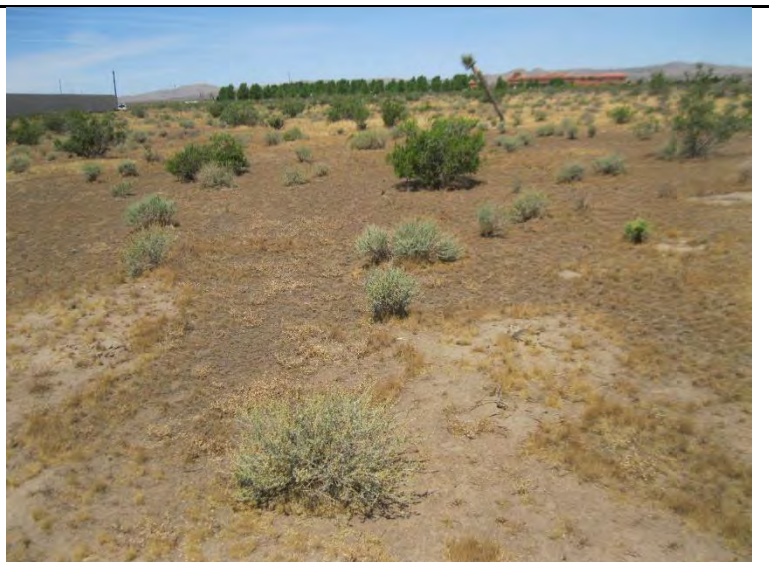
**Photograph 12**

View of the discolored soil on the southern portion of the Site from the east.

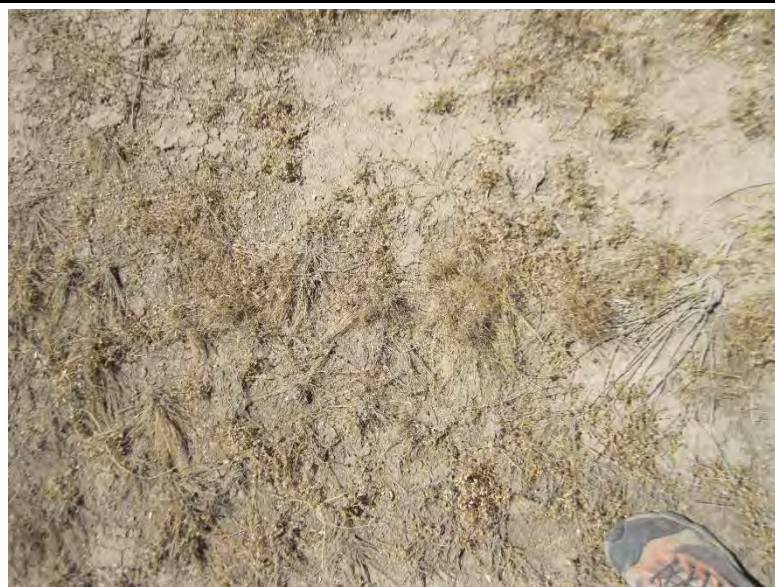
**Photograph 13**

Close up view of discolored soil on the lower portion of the photo and apparent native soil on the upper portion.

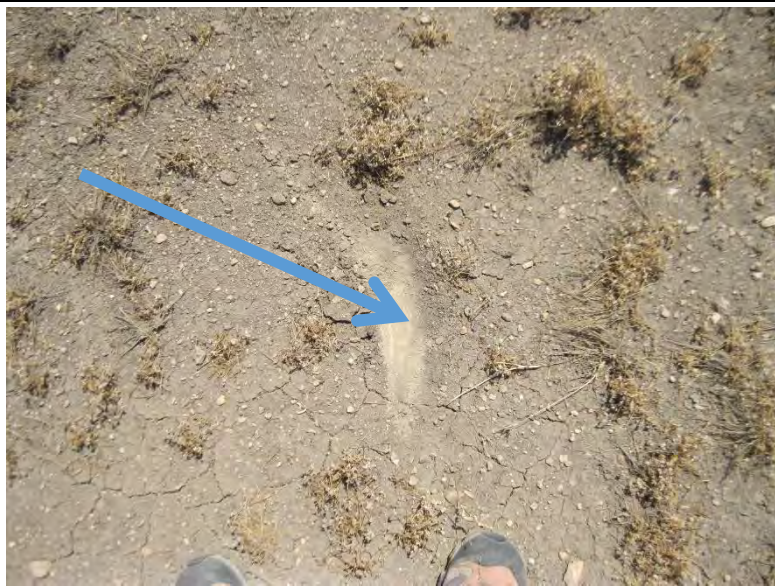
**Photograph 14**

Close up view of apparent native soil beneath thin layer of discolored soil.

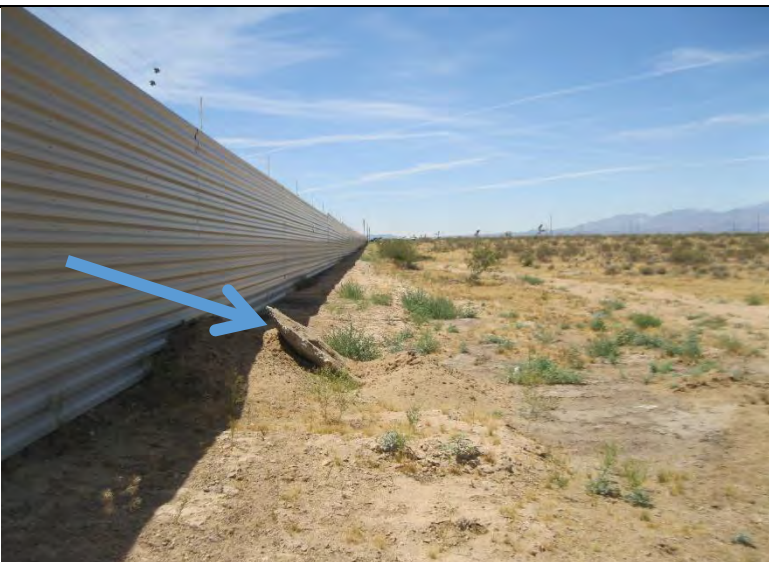
**Photograph 15**

View of the southern boundary of the Site with LKQ. Apparent source of stormwater runoff onto the Site. Soil appears to have been placed along the wall to prevent future discharge.
