## INDUSTRIAL ACTIVITIES STORMWATER POLLUTION PREVENTION PLAN (SWPPP)

LKQ 1711 - Lakenor Auto & Truck Salvage, Inc.

11200 Alden Road

June 24, 2024

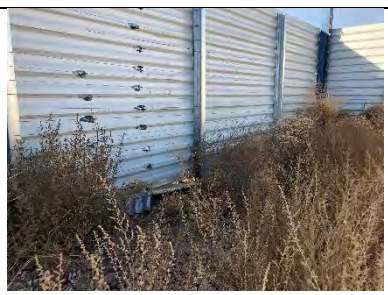
| Table 4-1<br>Discharge / Outfall Locations | | | | |
|---|---|---|---|---|
| Outfall 1<br>(Sample Location 1) | Sheet flow through the corner of the fence | Surface Runoff | Northwestern corner of the facility | |

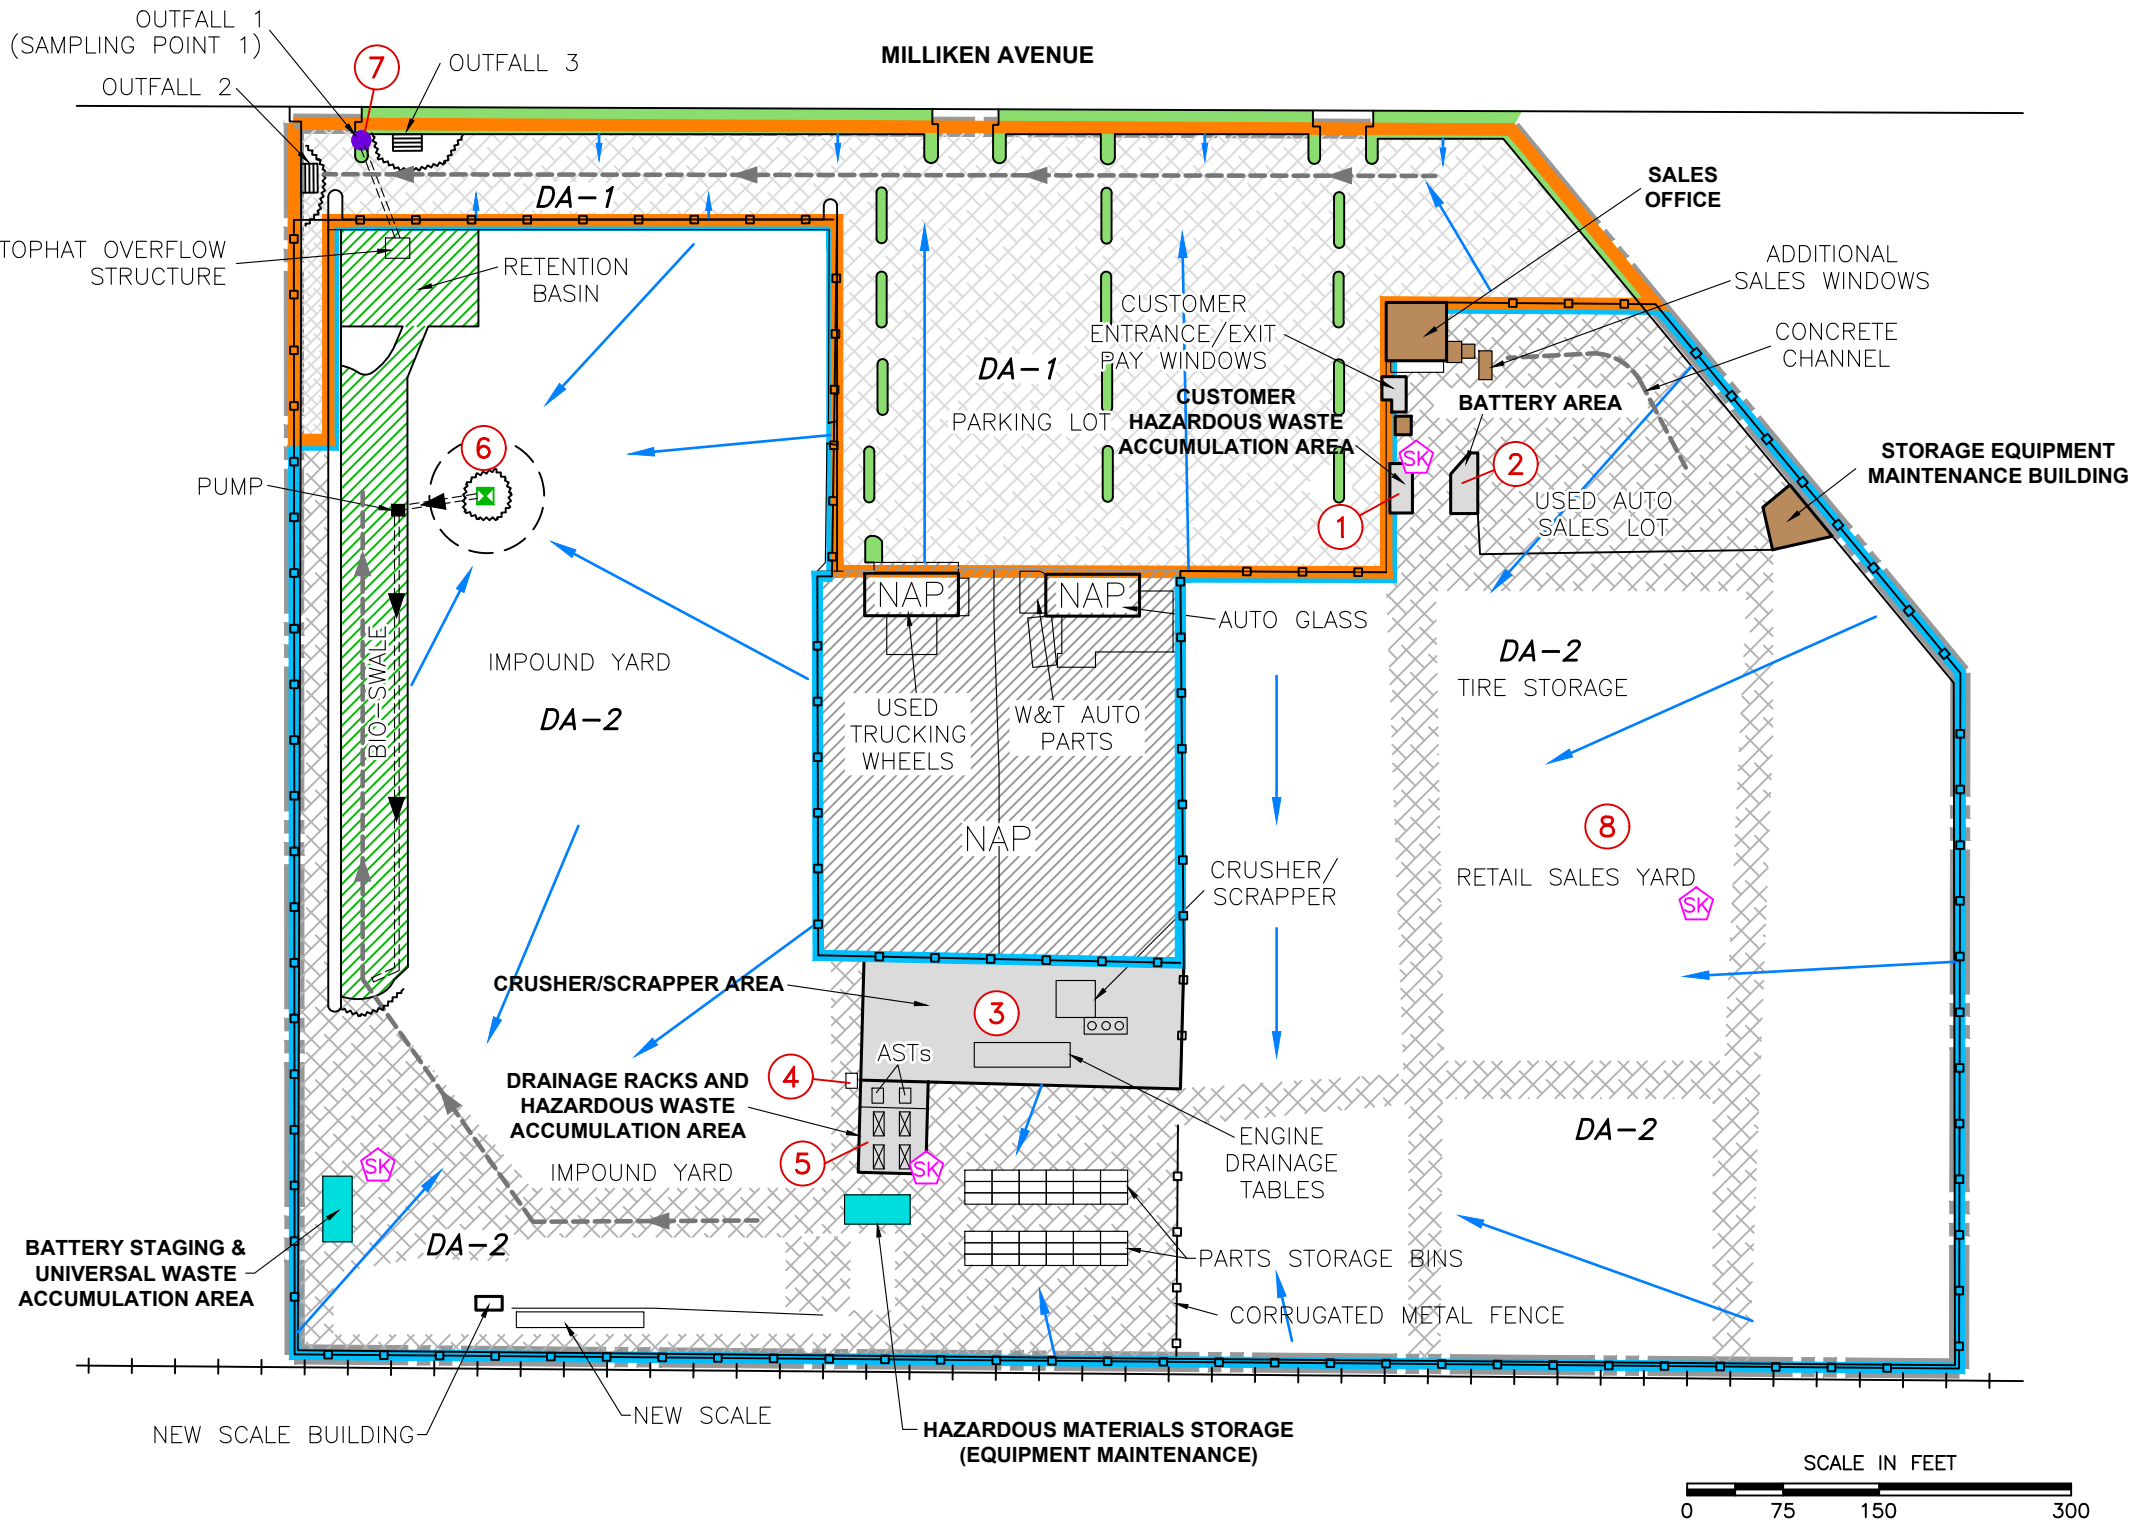
- PROPERTY BOUNDARY
- DRAINAGE AREA 1
- DRAINAGE AREA 2

NOTE: SURFACE AREA NOT DESIGNATED AS PAVED OR VEGETATED IS COMPRISED OF COMPACTED DIRT AND CRUSHED STONE. THE ERODIBLE SURFACES AT THIS FACILITY ARE: COMPACTED DIRT AND CRUSHED STONE AREAS AND THE VEGETATED AREAS.
