PHASE II SUBSURFACE INVESTIGATION REPORT

Molto Properties

Nevada Street and Palmetto Avenue Redlands, California 92374

Partner Project Number: 22-356187.1

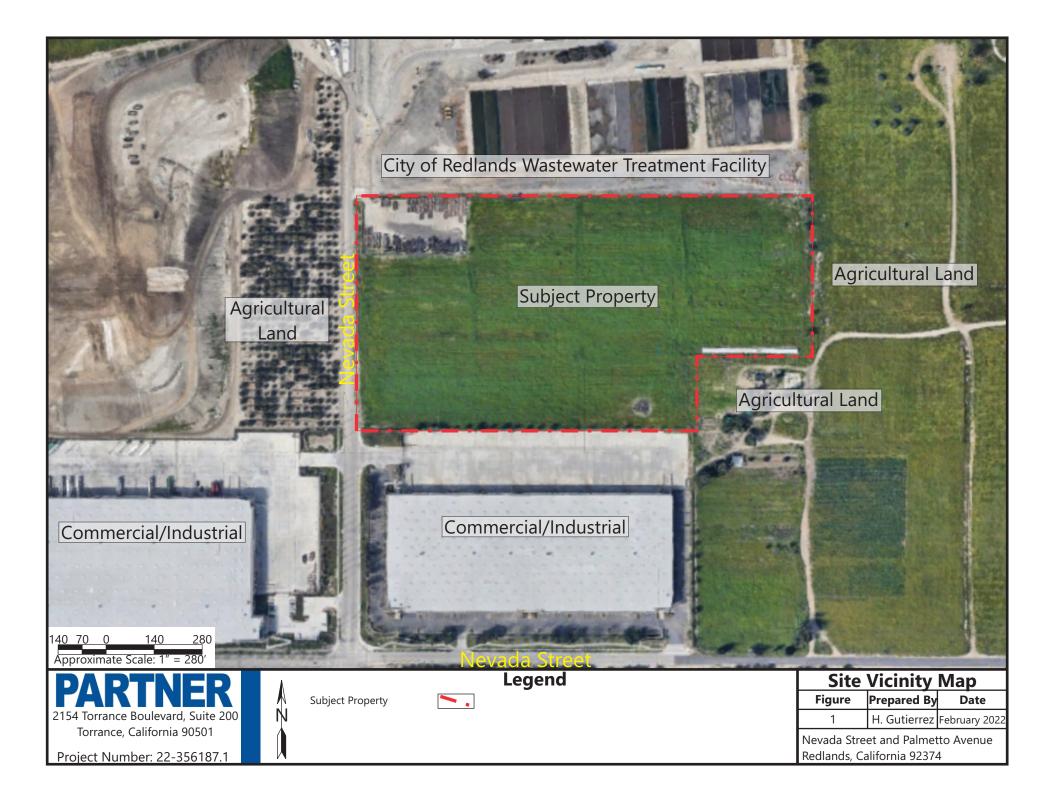
Figures 1. Site Vicinity Map

The Subject Property is bound by City of Redlands Wastewater Treatment Facility to the north, agricultural land to the east, agricultural land and commercial/industrial properties to the south, and agricultural land to the west across Nevada Street. Refer to **Figure 1** for a site vicinity map showing site features and surrounding properties.

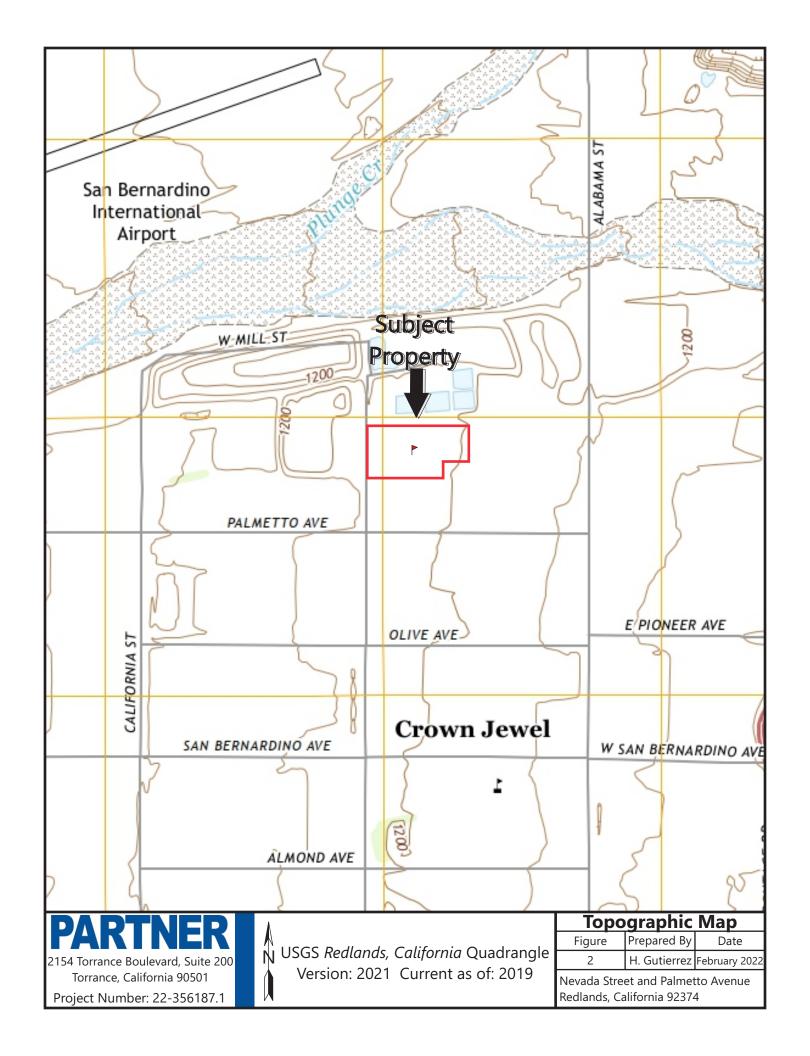
2. Topographic Map

Review of the United States Geological Survey (USGS) *Redlands, California* Quadrangle topographic map indicates the Subject Property is situated approximately 1,190 feet above mean sea level, and the local topography is sloping gently to the west. Refer to **Figure 2** for a topographic map of the site vicinity.

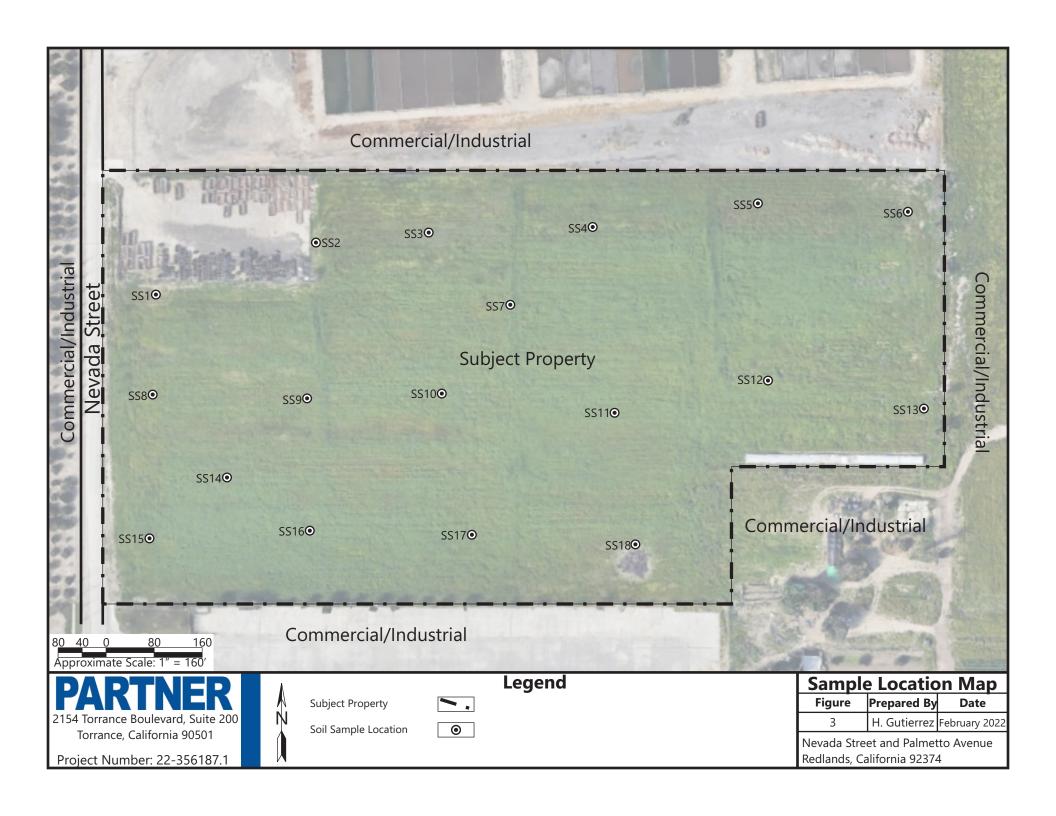
3. Sample Location Map

Discrete samples SS1 through SS18 were collected on one-acre centers between rows of trees, to the extent practicable.

Refer to **Figure 3** for a map depicting sample locations.
