GEOTECHNICAL INVESTIGATION AND WATER INFILTRATION TEST REPORT

BLOOMINGTON ANIMAL SHELTER 18313 Valley Boulevard Bloomington Area of San Bernardino County, California

CONVERSE PROJECT No. 22-81-206-01

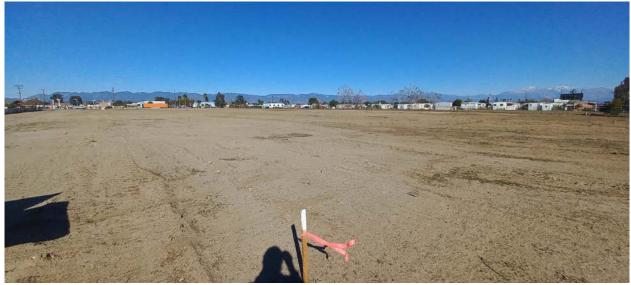
Photograph No. 1, Present site conditions facing northeast from the eastern edge of the infiltration basin.

The subject site terrain is almost flat, gently slopes southward toward concrete storm drain channel along I-10. The site is presently fenced off and vacant. Photograph Nos. 1 and 2 depict the present site conditions.

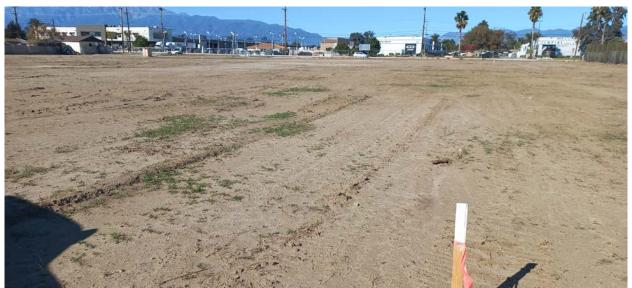
Photograph No. 2, Present site conditions facing north from the proposed cats building

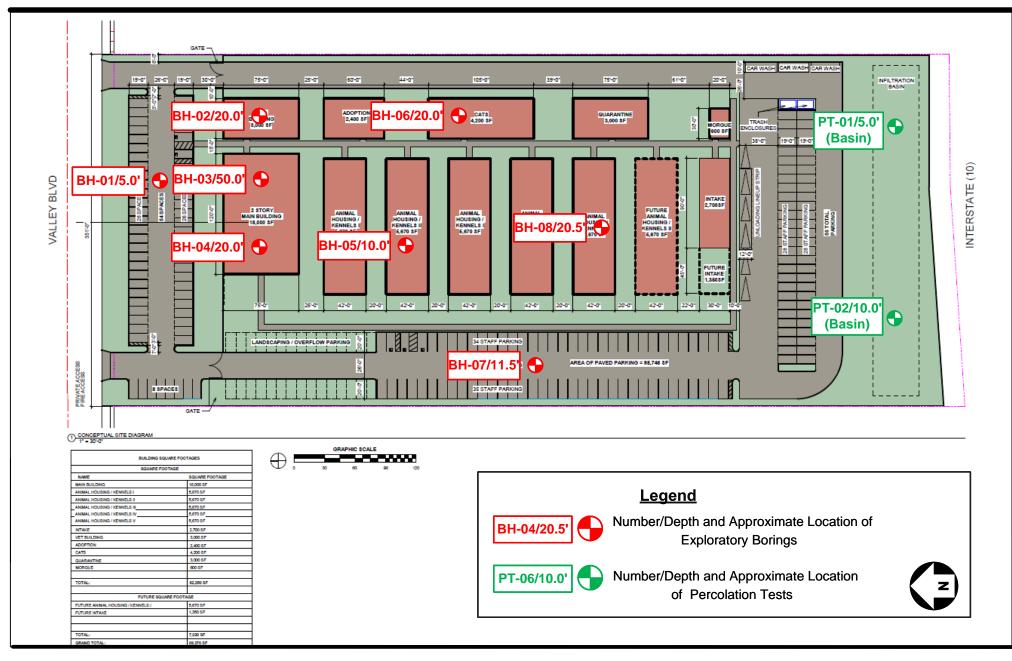
18313 Valley Boulevard Bloomington area of San Bernardino County, California Approximate Boring and Percolation Test **Locations Map**

For location of the borings, see Figure No. 2, Approximate Boring Locations Map.

The approximate locations of the borings are shown on Figure No. 2, *Approximate Boring and Percolation Test Locations Map.* A detailed discussion of subsurface exploration is presented in Appendix A, *Field Exploration*.

For location of the borings, see Figure No. 2, Approximate Boring and Percolation Test Locations Map.

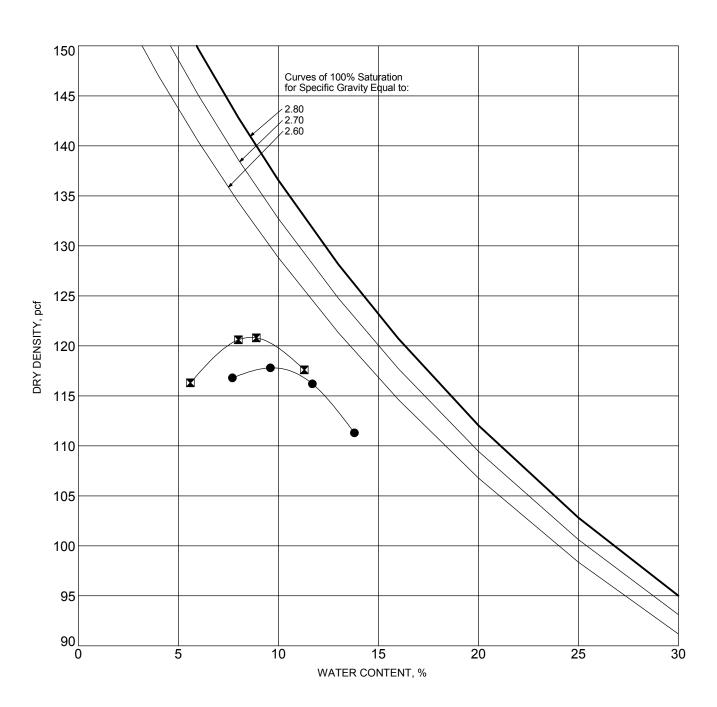
| SYMBOL | BORING NO. | DEPTH (ft) | DESCRIPTION | ASTM TEST METHOD | OPTIMUM WATER, % | MAXIMUM DRY DENSITY, pcf |
| • | BH-03 | 0.0-3.0 | SILTY SAND (SM), BROWN | D1557 Method D | 10.5 | 118.2 |

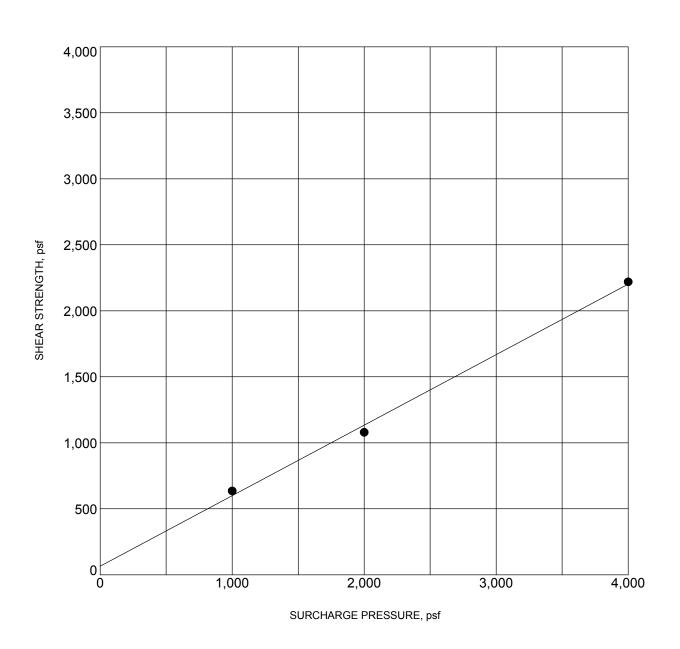
| BORING NO. : | BH-05 | DEPTH (ft) : | 8.0-9.5 |
| DESCRIPTION : | SILTY SAND (SM) | | |

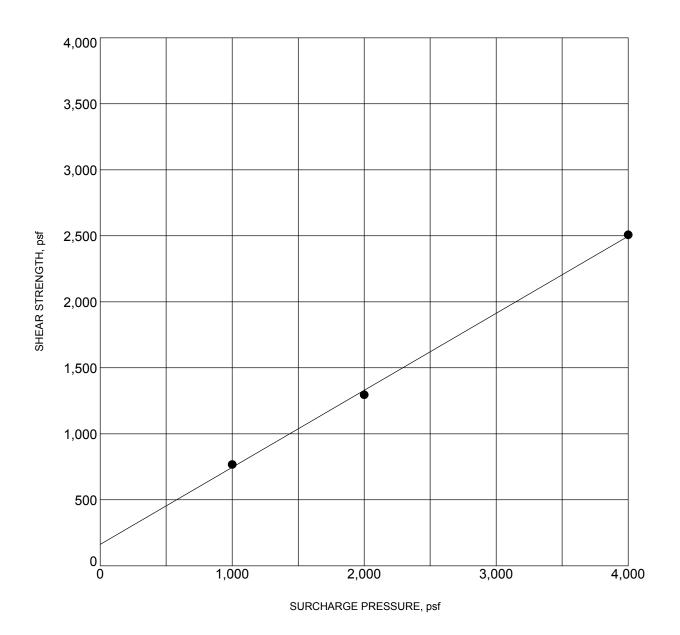
| BORING NO. : | BH-08 | DEPTH (ft) : | 3.0-4.5 |
| DESCRIPTION : | SILTY SAND (SM) | * | |

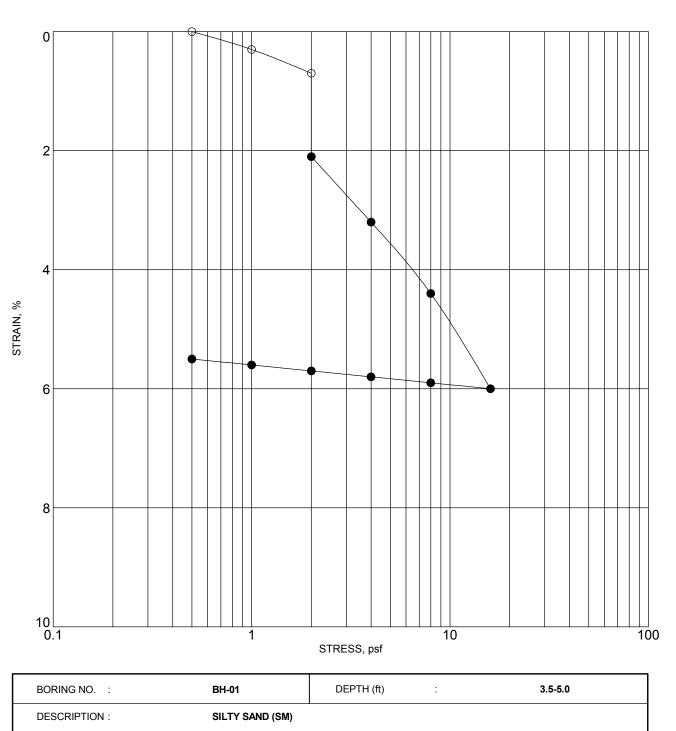
| BORING NO. : | BH-01 | DEPTH (ft) : | 3.5-5.0 |
| DESCRIPTION: | SILTY SAND (SM) | | |

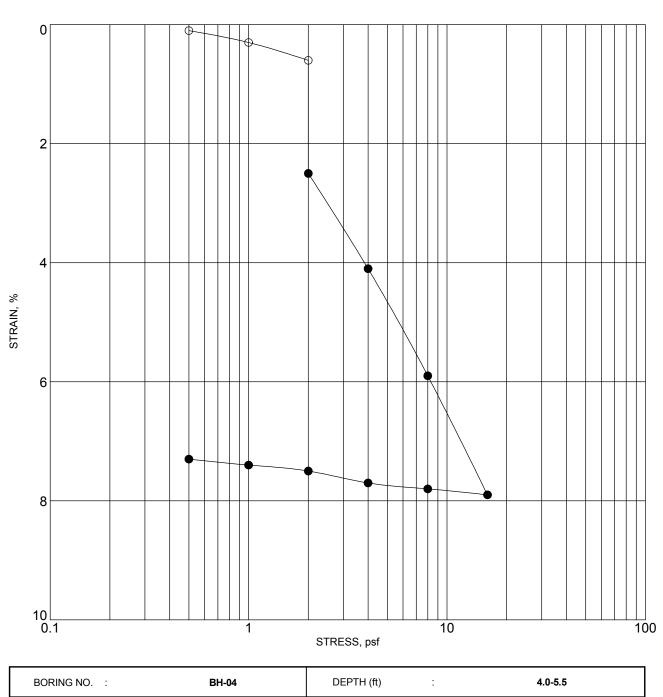
| BORING NO. : | BH-04 | DEPTH (ft) : | 4.0-5.5 |
| DESCRIPTION: | SILTY SAND (SM) | | |

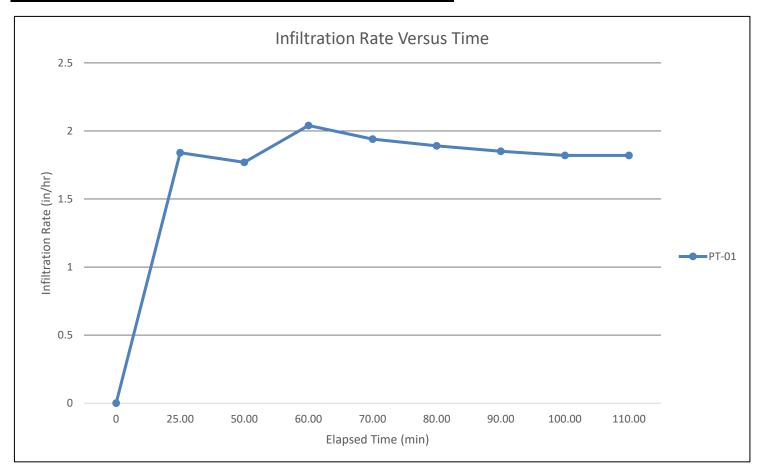
Estimated Infiltration Rate from Percolation Test Data, PT-01

The measured percolation test data, calculations and estimated infiltration rates are shown on Plates No. 1 and 4. The estimated and design infiltration rates at the test holes are presented in the following table.
