UPDATED GEOTECHNICAL REPORT

Summerland Senior Living Facility

13225 Serenity Trail, Chino, California

Project Number: 4219GFS

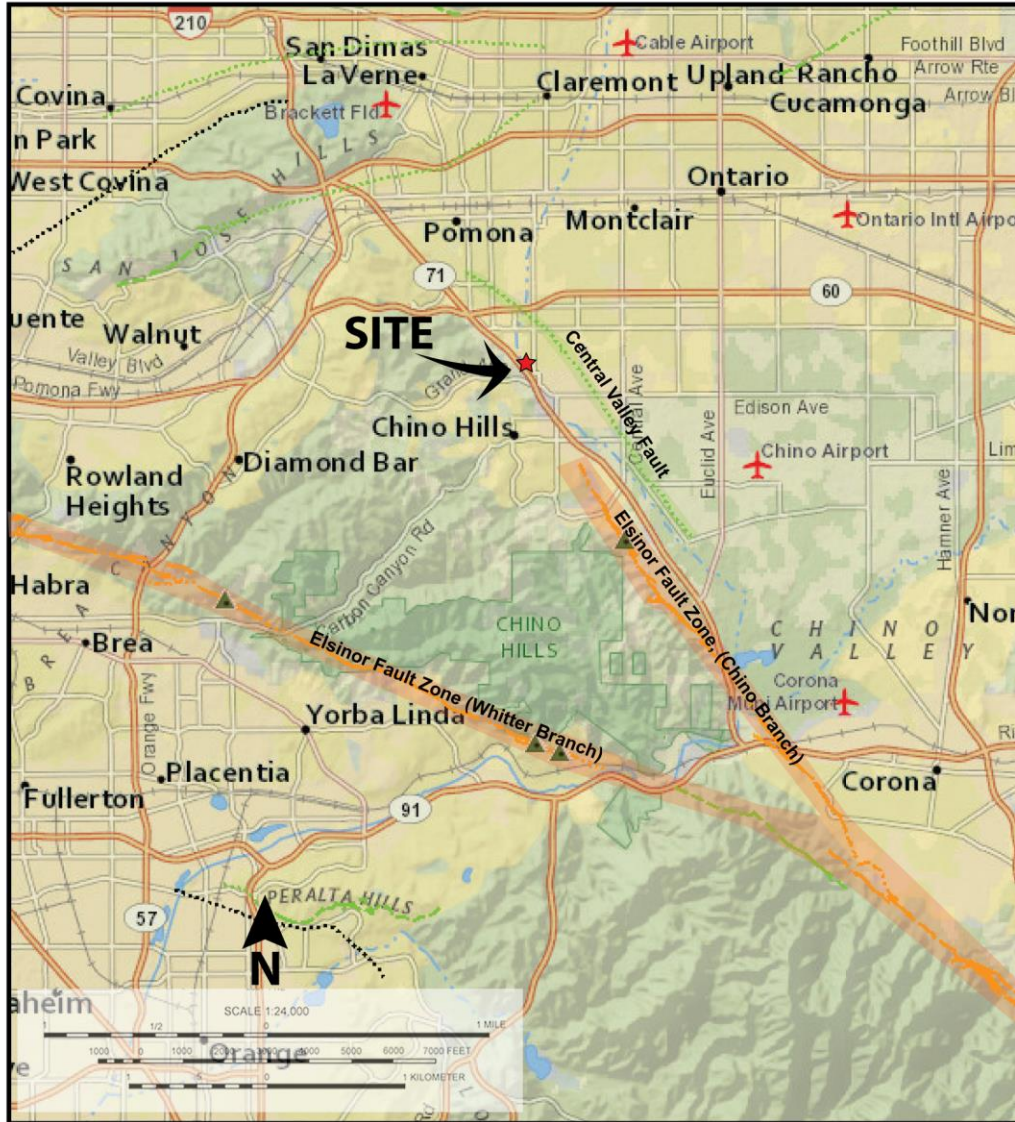
FIGURE 3 - REGIONAL FAULT LOCATION MAP

SOURCE: U.S. Geologic Survey and California Geologic Survey, Quaternary Fault and Fold Database of the United States March 2016 (<http://earthquake.usgs.gov/hazards/qfaults>)

- 7.2 **Faulting:** The site is not located within an Alquist-Priolo Earthquake Fault Zone (AP Zone). No known active faults traverse the property. Several USGS maps and interactive mapping resources were reviewed to locate the subject site relative to known mapped faults (see references in the Appendix to this report). However, the subject site is not mapped on any AP Zone maps. For the purposes of this report Figure 3 was prepared to illustrate the mapped faults near the subject site. The closest mapped fault is the Central Avenue Fault which is mapped approximately $\frac{3}{4}$ of a mile (1.3 kilometers) northeast of the subject site. The northern branch of the Elsinore Fault Zone (Chino Branch – Chino Fault) is mapped approximately 3.1 miles (4.9 km) southwest of the subject site, (see Figure 3).

- 7.3.1 **Seismic Risk:** Well-delineated fault lines cross through the region as shown on the Regional Fault Location Map, (Figure 3). However, no active faults are mapped in the immediate vicinity of the subject site. Therefore, active fault rupture is unlikely to occur at the project site. While fault rupture would most likely occur along previously established fault traces, future fault rupture could occur at other locations.
