PLATE B-2  
**RELATIVE DEBRIS-FLOW  
 RUNOUT POTENTIAL IN THE FOREST FALLS AREA,  
 SAN BERNARDINO COUNTY, CALIFORNIA**

By  
 Siang S. Tan  
 1995  
 (REVISED 2000)  
 by  
 C.J. Wills and S.S. Tan

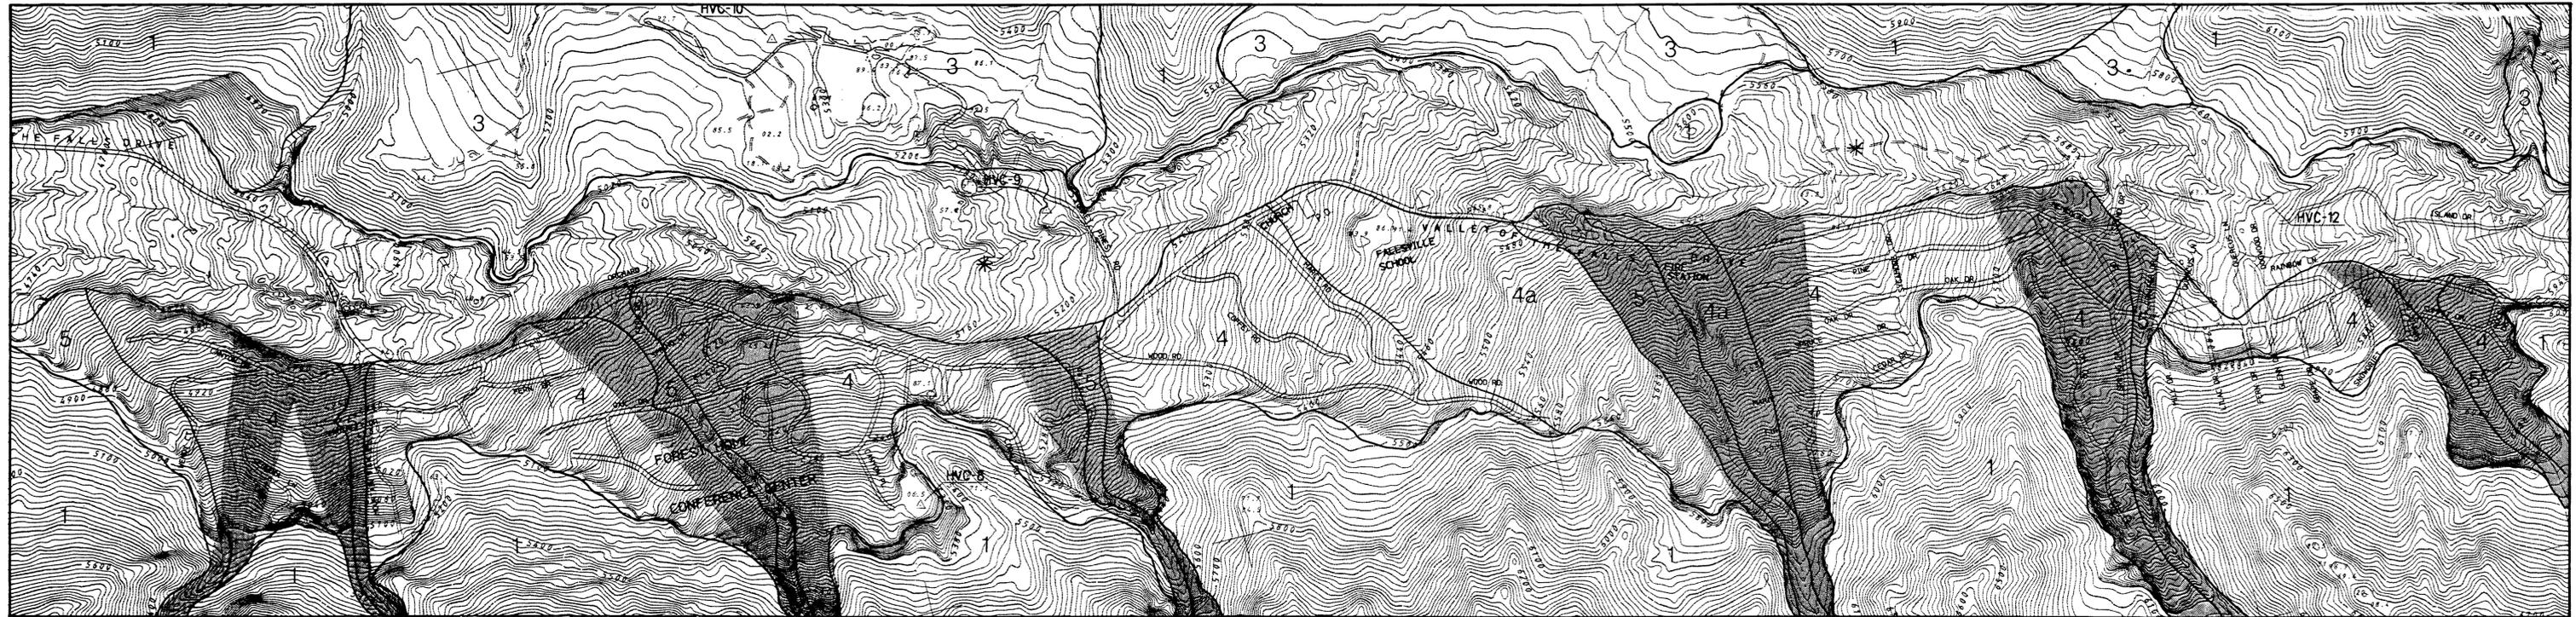
Plate B-2 documents the relative debris-flow runout potential in the Forest Falls area. Debris-flow runout is the process where a debris flow that has formed in very steep terrain flows out from its source areas, slowing and beginning to deposit material. Commonly this begins where the debris flow leaves the steep narrow channel in the mountains and spreads across an alluvial fan. This process has formed the relatively gently sloping land where most structures in the Forest Falls area are built. Deposits of past debris flows underlie this land surface and landforms related to recent debris flows can be found throughout the area. Hazards related to debris-flow runout occur when fast-moving debris impacts man-made structures or roadways. These flows are referred to as "stream-related" debris flow on Plate B-1.

**RELATIVE DEBRIS-FLOW RUNOUT POTENTIAL**

**Very low debris-flow runout potential.** Debris-flow runout hazards are unlikely within this area due to the regional steepness of slopes. However, the susceptibility of slope-related hazard (such as slope failures, landslides, rockfall, avalanche and erosion) is very high in Area 1 as depicted on landslide susceptibility maps of the region (Tan, 1990).

**High debris-flow runout potential.** The area contains areas on either side of Type B drainages and most type C drainage courses on the south side of Mill Creek. These alluvial fans are composed almost entirely of debris-flow deposits. Landforms and vegetation patterns on these fans show evidence for debris flows in the recent past. The area includes gentle to moderate slopes, where slope angles are generally less than 10 degrees. Intense rainfall can cause extensive erosion and small landslides in the steep watersheds of Type B streams, leading to debris flows in their channels. As these debris flows reach the less steep area at Forest Falls they may flow across the upper parts of the fans before slowing and beginning to deposit their sediment. Deposition of debris in the channel may cause later flows to leave the clogged channel and flow through adjacent areas. Area 4 is highly susceptible to debris-flow runout. Most recent debris flows have occurred in areas mapped as Very High potential, area 5, but as channels are filled with debris, areas of debris flow runout and deposition shift. Most of area 4 is not in the current path of debris flow runout, but has been in the past and will be in the future as the pattern of flow changes. The large alluvial fan between the Fallsvale School and the fire station appears to be particularly unstable. Many recent debris flows have occurred and several have left the well-developed channels. This area where debris flows appear to be less confined to the existing channels is shown on the map as area 4a.

**Very High debris flow runout potential.** The area contains the channels of Type B (intermediate) and some type C (minor) drainage courses as shown on Plate 1. These channels have been areas of debris flow deposition and areas affected by debris flows in the recent past. The area includes gentle to moderate slopes, where slope angles are generally less than 10 degrees. Most recent debris flows have been confined to the intermediate channels but locally have spread out on the lower parts of the fans, particularly in the area southwest of the fire station. The debris flow hazards are greatest along these relatively narrow areas from the mouths of the canyons to the channel of Mill Creek. Overflowing of Type B drainages onto paved roads (such as the Valley of Falls Drive highway) is particularly hazardous and possibly life-threatening. Runoff is not thoroughly channeled and major spills onto streets create potentially hazardous conditions due to the high speed of high-density flow on less resistant surfaces of paved roads.

**Potential debris avalanche area:** Exceptionally fast-moving debris flows (called debris avalanches) may leave the channels by jumping the channel at a bend; the 1999 fatality occurred in this type of condition. Because only one flow of this type has been recorded, the frequency of this type of event is unknown. Debris avalanches can occur in areas that are directly below the mouths of canyons of type B drainages as shown by the pattern on the map.
