HISTORIC RESOURCES INVENTORY

1. Common name: \_\_\_\_\_
2. Historic name: \_\_\_\_\_
3. Street or rural address: 506 7th Street  
City Huntington Beach Zip 92648 County Orange
4. Parcel number: 024-131-08
5. Present Owner: Harry Treadwell Address: 506 7th Street  
City Huntington Beach Zip 92648 Ownership is: Public \_\_\_\_\_ Private X
6. Present Use: Residence Original use: Residence

- 7a. Architectural style: Transitional Bungalow
- 7b. Briefly describe the present *physical description* of the site or structure and describe any major alterations from its original condition:

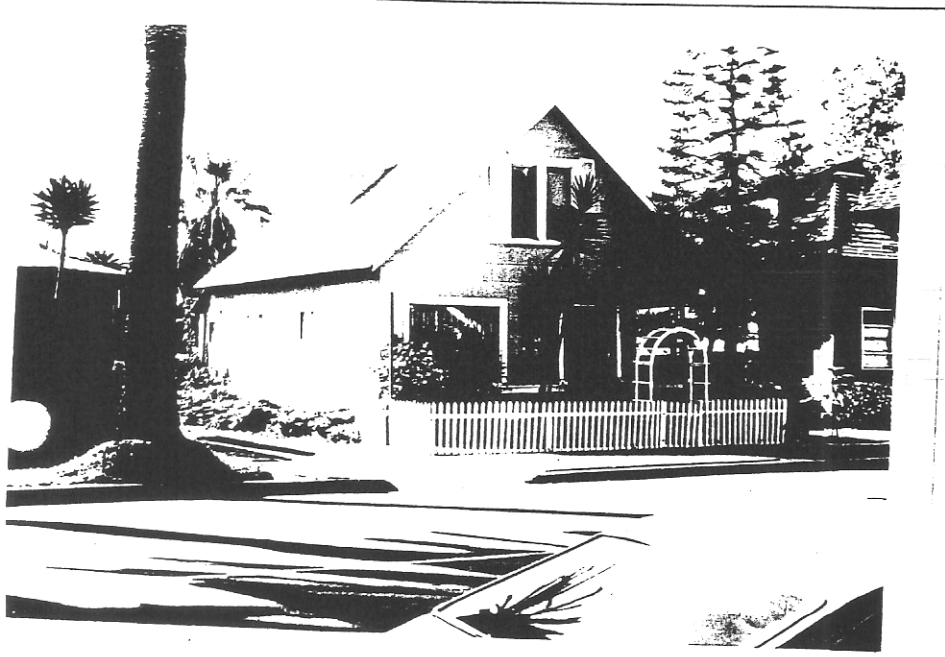
A high front-facing gabled roof, featuring small shed-style dormers on the sides, caps the 1½ story house shown below. The exterior is now covered with asbestos shingles. A pair of casement windows, flanked with shutters, is centered in the front gable facade. A recessed porch occupies the eastern half of the first floor and is supported by round wooden columns. A large stationary plate glass window occupies the center of the west half of the front facade. Double-hung windows are used throughout the rest of the house with the exception of two sets of small casement windows. A shed-style back porch, located at the rear has been enclosed. A picket fence, with an arched arbor over the entry, encloses the front yard.

13. Condition: Excellent \_\_\_ Good X Fair \_\_\_ Deteriorated \_\_\_ No longer in existence \_\_\_
14. Alterations: Shutters, gable window and dormers, small casement windows
15. Surroundings: (Check more than one if necessary) Open land \_\_\_ Scattered buildings \_\_\_ Densely built-up \_\_\_  
Residential X Industrial \_\_\_ Commercial \_\_\_ Other: \_\_\_
16. Threats to site: None known \_\_\_ Private development X Zoning \_\_\_ Vandalism \_\_\_  
Public Works project \_\_\_ Other: \_\_\_
17. Is the structure: On its original site? \_\_\_ Moved? \_\_\_ Unknown? X
18. Related features: Picket fence and arbor in front
