Land Use Services Building and Safety Division Information Bulletin	Number: IB-0011
		Code References: 2025 CBC 2025 CRC
Building Official Signature: <i>Maged Soliman</i>	Maged Soliman, PE, CBO	Original Effective Date: August 2, 2019
Subject: Repair of Earthquake-Damaged Masonry Fireplace Chimneys		Updated: January 1, 2026

Subject: Repair of Earthquake-Damaged Masonry Fireplace Chimneys

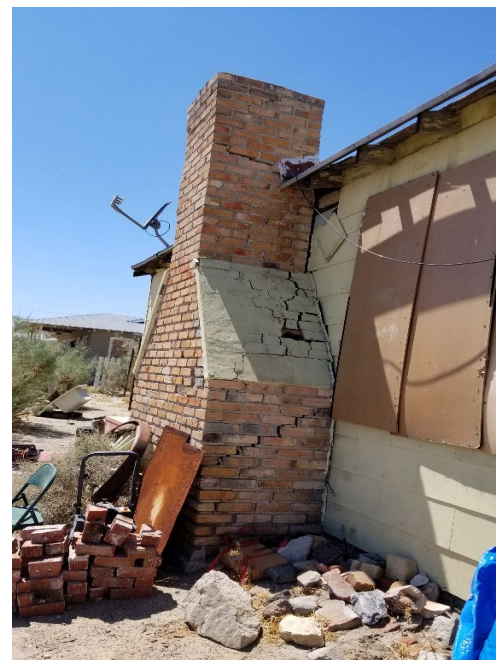
Figure 2: Chimney damaged in Trona Earthquake

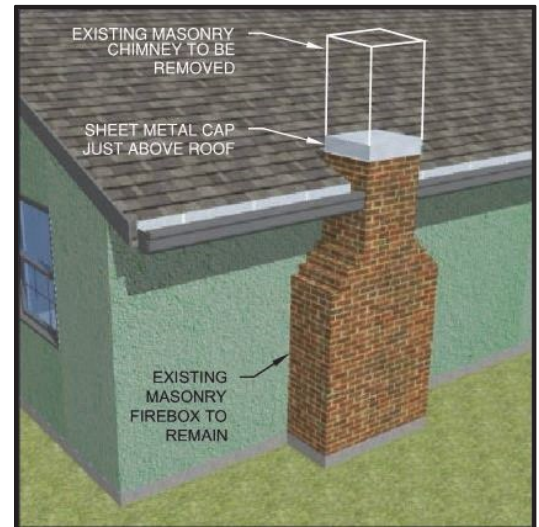
For single story dwellings, where the chimney is damaged at or above the roof level and it is not intended that the fireplace be used in the future, it is possible to remove the chimney down to the roof line and install a sheet metal cap over the chimney for weather protection.

It is recommended that the chimney be removed to a distance of three to six inches above the adjacent roof. This will permit a sheet metal cap that extends several inches down each side of the chimney to be installed, providing a flashing. The cap should be secured to the masonry.

Figure 3: Dwelling with a chimney capped at the roof line

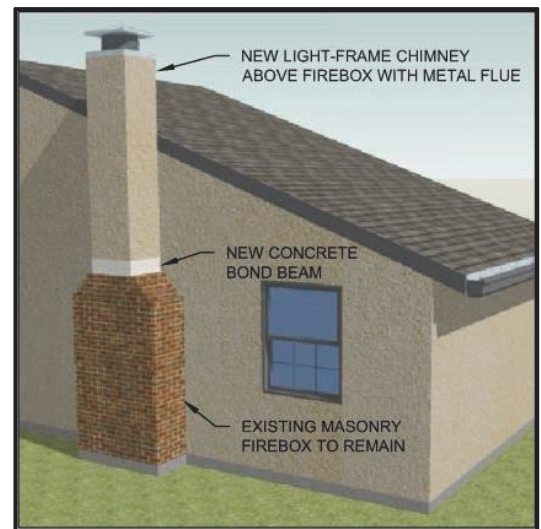
Alternative B permits continued use of an undamaged firebox in combination with a new chimney. Instead of using a conventional masonry chimney with a clay flue liner, the new chimney is constructed using a lightweight metal flue contained in a cold-formed steel stud chimney enclosure, as shown in Figure 4. This lightweight, flexible construction is much more resistant to damage in future earthquakes. Although the remaining masonry firebox could be damaged in a future earthquake, the firebox is much less vulnerable to damage than the original masonry chimney. As a result, the risk of collapse and the associated risk to life safety are greatly reduced when this reconstruction alternative is implemented.

Figure 4: Dwelling with the chimney reconstructed from the firebox up

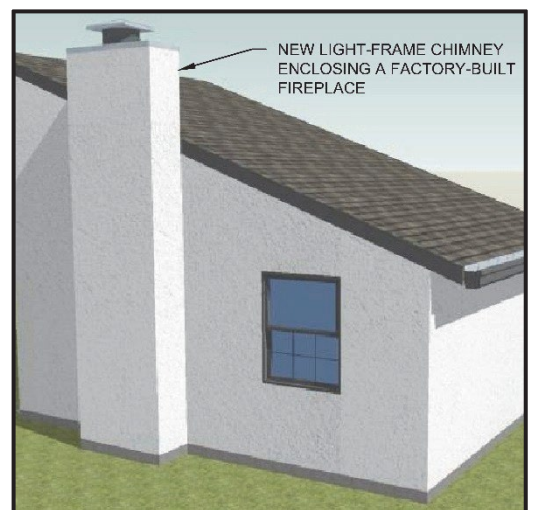
If earthquake damage extends below the shoulder of the firebox or if complete removal of all masonry is preferred, the entire firebox and chimney can be replaced from the top of foundation up. This involves installing a factory-built fireplace and metal flue inside a cold-formed steel stud chimney chase, as seen in Figure 9. This type of lighter and more flexible construction avoids many of the issues that have made masonry fireplaces and chimneys vulnerable to damage in past earthquakes. If preserving the architectural aesthetic of masonry is important, adhered masonry veneer can be used.

Figure 10: Replacement of entire firebox and chimney with light-frame construction
